HYDRAULIC MODEL STUDIES OF THE SPILLWAYS
AND OUTLET WORKS--GLEN CANYON DAM
COLORADO RIVER STORAGE PROJECT, ARIZONA

Report No. Hyd-469

Hydraulics Branch
DIVISION OF RESEARCH

February 18, 1964

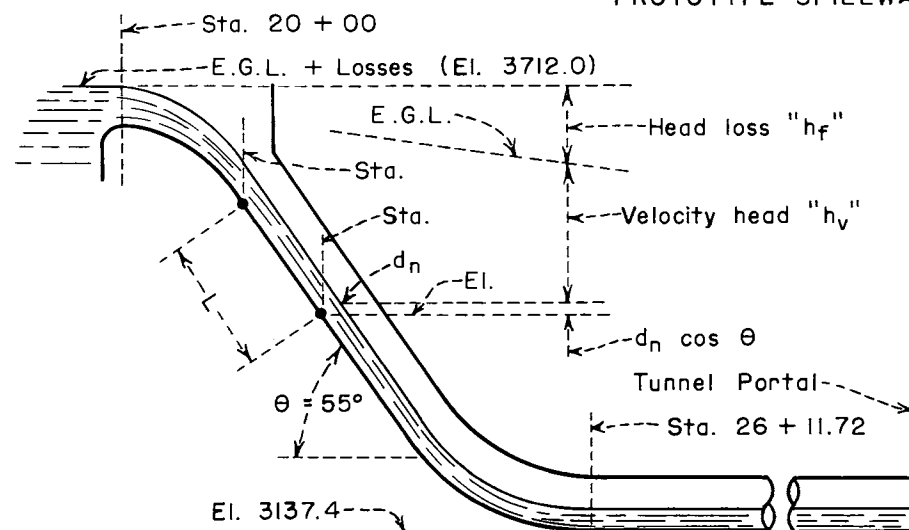
FORMULAS

$$V = \frac{Q}{A}; \quad h_v = \frac{V^2}{2g}; \quad S = \frac{n^2 V^2}{2.208 r^{4/3}}; \quad h_f = S_{av} L$$

1	2	3	4	5	6	7	8	9	10	11	12	13	14	15
Station	Elevation	d_n	$d_n \cos \theta$	A	V	h_v	r	S	S_{av}	L	h_f	$\sum h_f$	$d_n \cos \theta + h_v + \sum h_f$	Elevation + (14)
20+32.33	3642.9	46.08	46.08	1843.2	38.52	23.04	13.95	0.003924	—	—	—	—	69.12	3712.0
21+46.38	3543.5	34.91	20.02	1462.5	97.09	146.37	14.80	.025939	0.014931	153.89	2.30	2.30	168.69	3712.19
22+10.91	3451.3	30.20	17.32	1148.7	123.62	237.30	13.23	.043340	.034640	112.49	3.90	6.20	260.82	3712.12
22+75.43	3359.2	28.45	16.32	982.7	144.50	324.23	12.16	.066319	.054830	112.49	6.17	12.37	352.92	3712.12
23+26.24	3286.6	26.30	15.09	894.3	158.78	391.41	11.73	.083893	.075106	88.58	6.65	19.02	425.52	3712.12
24+50.20	3177.1	24.17	21.42	810.2	175.26	478.92	11.28	.108154	.096025	167.38	16.07	35.09	535.43	3712.63
26+11.72	3137.4	23.80	23.80	793.4	178.97	497.36	11.19	.113680	.110917	167.38	18.56	53.65	574.81	3712.21
28+11.72	3136.7	24.25	24.25	811.9	174.89	474.95	11.28	.107257	.110468	200.00	22.09	75.74	574.94	3711.64

32+11.72	3135.3	25.15	25.15	848.9	167.27	434.46	11.48	.095886	.101572	400.00	40.63	116.37	575.98	3711.28
34+51.72	3134.2	25.70	25.70	870.8	163.08	412.97	11.60	.089838	.092862	240.00	22.29	138.66	577.33	3711.53

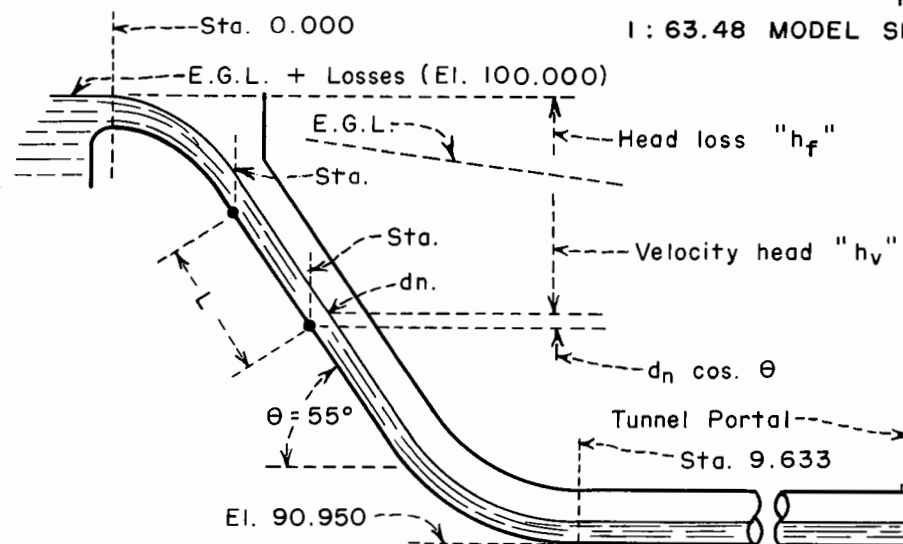
FORMULAS

$$V = \frac{Q}{A}; h_v = \frac{v^2}{2g}; S = \frac{n^2 v^2}{2.208 r^{4/3}}; h_f = S_{av} L$$

1	2	3	4	5	6	7	8	9	10	11	12	13	14	15
Station	Elevation	d_n	$d_n \cos \theta$	A	V	h_v	r	S	S_{av}	L	h_f	$\sum h_f$	$d_n \cos \theta + h_v + \sum h_f$	Elevation + (14)

0.510	98.911	0.726	0.726	0.457	4.84	0.363	0.220	0.0080	—	—	—	—	1.089	100.00
2.305	97.346	.553	.317	.365	12.12	2.28	.234	.0461	.0270	2.423	0.0655	0.0655	2.662	100.01

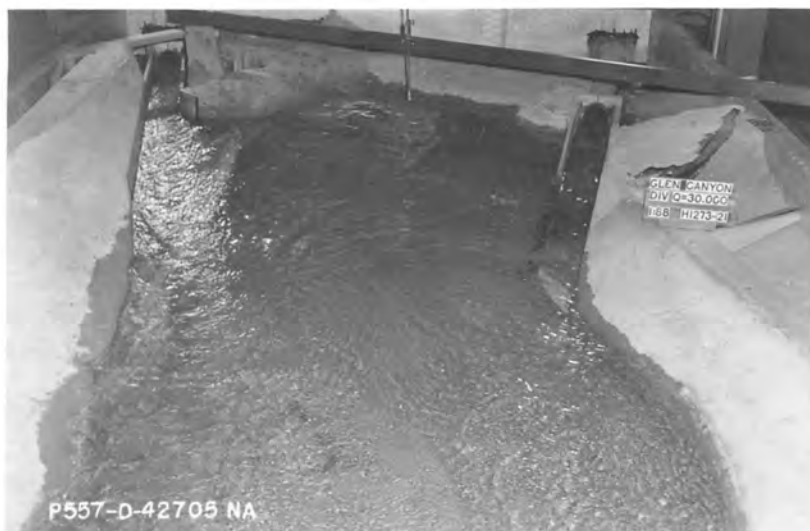
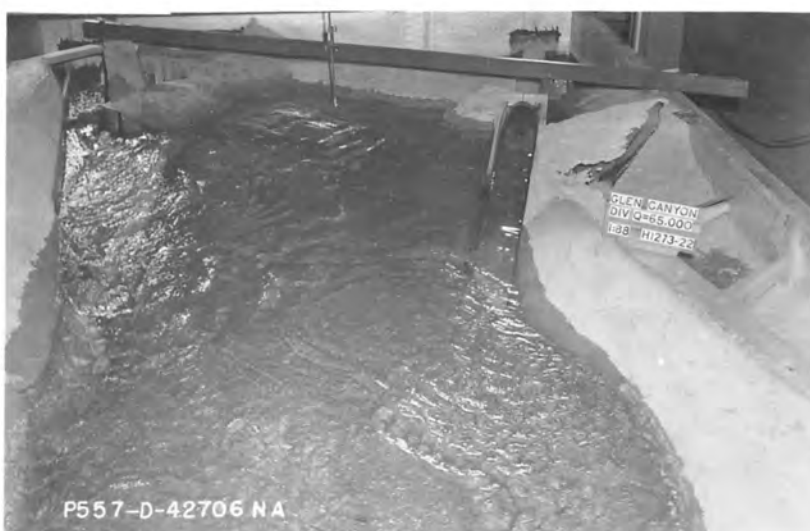
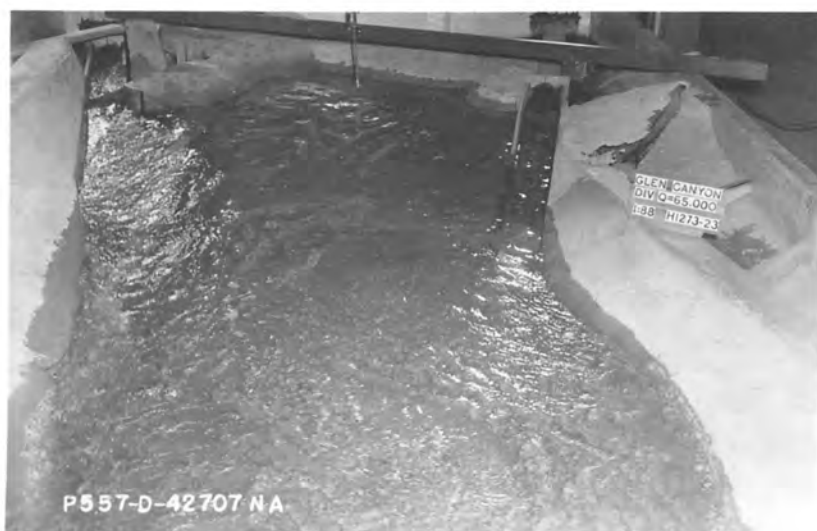
Figure 9
Report Hyd-469

Discharge = 30,000 cfs
T. W. Elev. = 3043.6

Discharge = 65,000 cfs
T. W. Elev. = 3048.2

Discharge = 65,000 cfs
T. W. Elev. = 3053.1

GLEN CANYON DAM SPILLWAYS
1:88 Scale Model
Diversion Studies
Flow Conditions with Right Tunnel Operating

The investigations showed that, in general, the tunnel alignment and grade were satisfactory for diversion flows. The curved exit wall downstream from the right tunnel caused some eddies in that vicinity, but when the curved wall was replaced by a straight wall the eddies were eliminated and the flow was entirely satisfactory. Figures 9 and 10 show the flow conditions in the river channel during diversion.

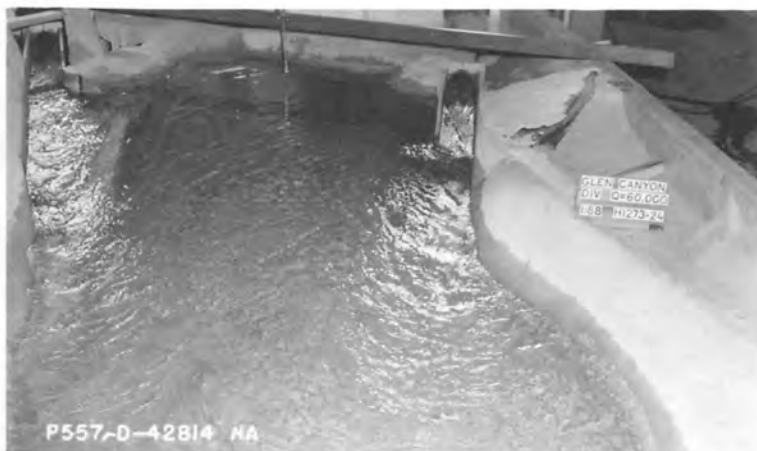
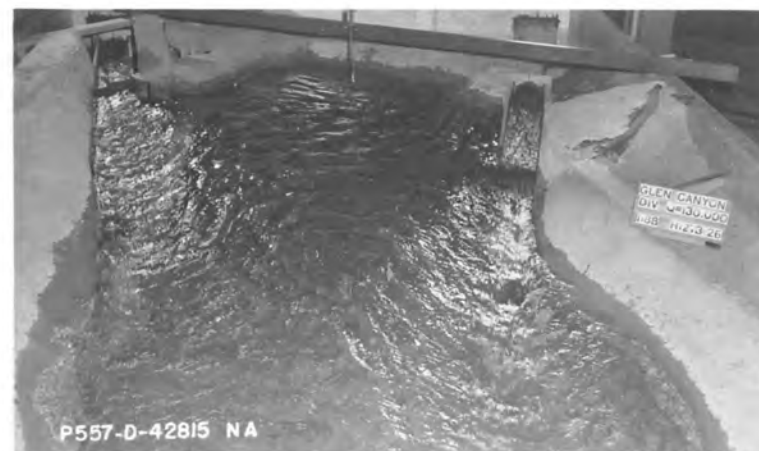
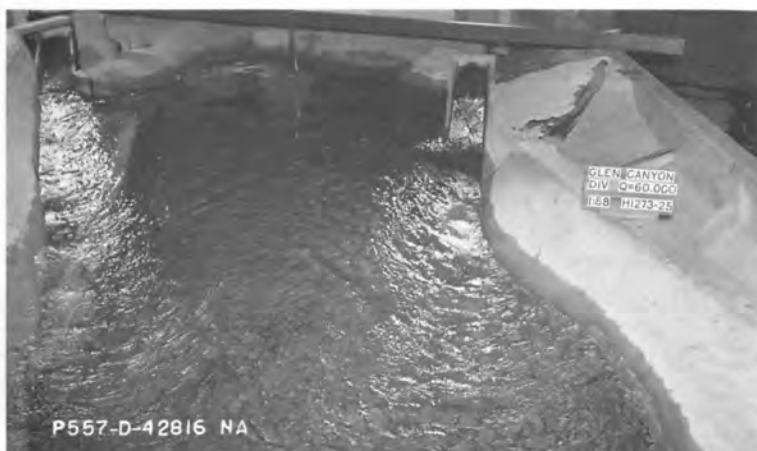
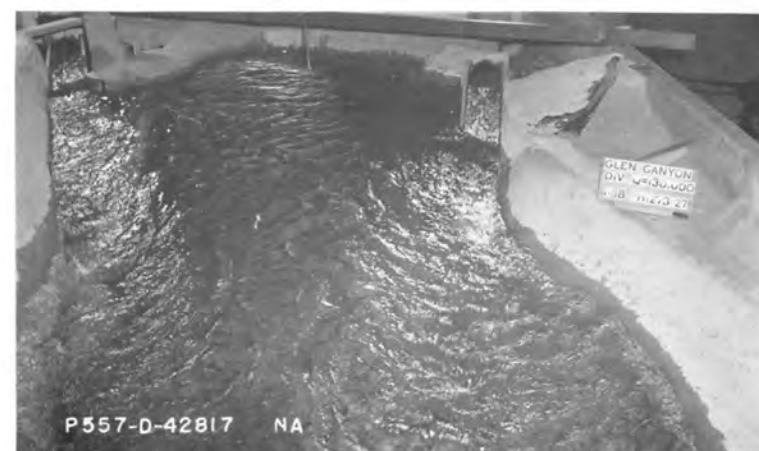
Q = 60,000 cfs T. W. Elev. = 3047.7

Q = 130,000 cfs T. W. Elev. = 3054.5

Q = 60,000 cfs T. W. Elev. = 3052.4

Q = 130,000 cfs T. W. Elev. = 3064.0

GLEN CANYON DAM SPILLWAYS

1:88 Scale Model
 Diversion Studies
 Flow Conditions with Both Tunnels Operating

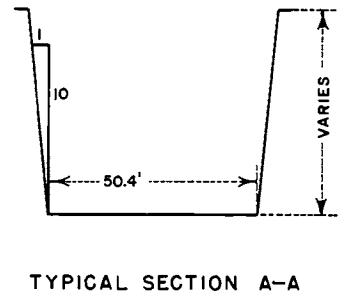
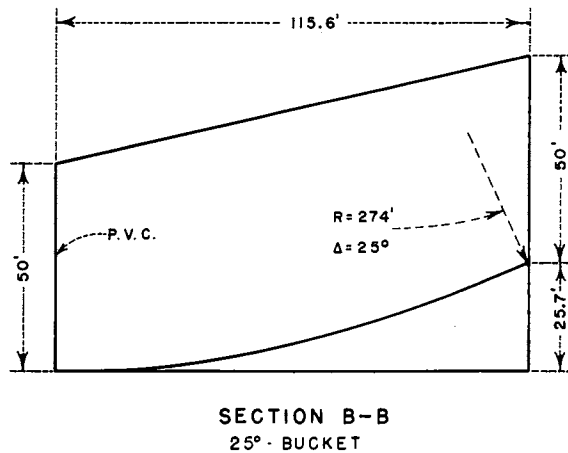
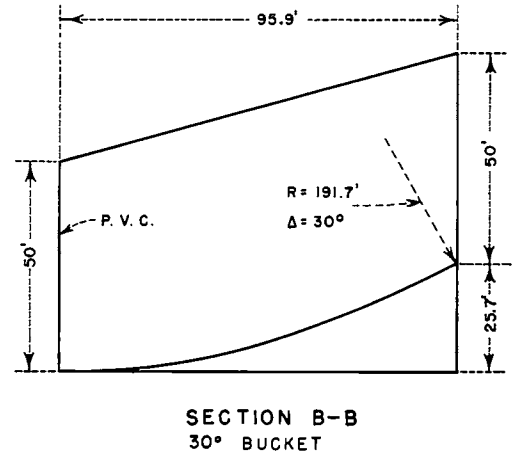
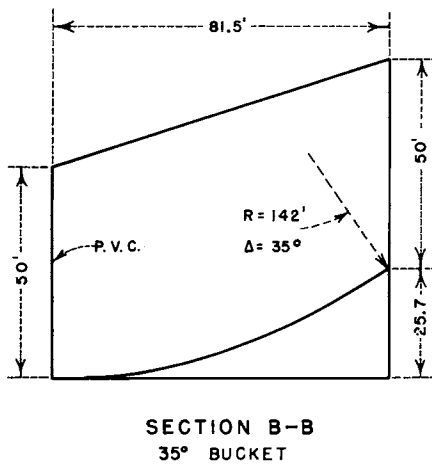
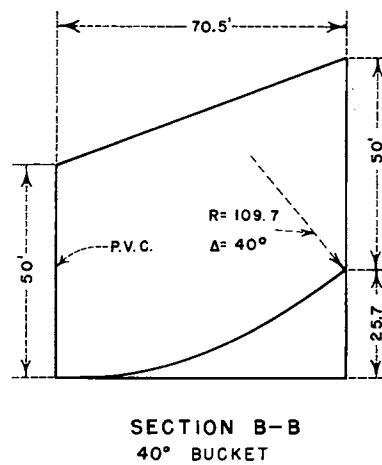
GLEN CANYON DAM SPILLWAYS
1:63.48 SCALE MODEL
PRELIMINARY FLIP BUCKETS

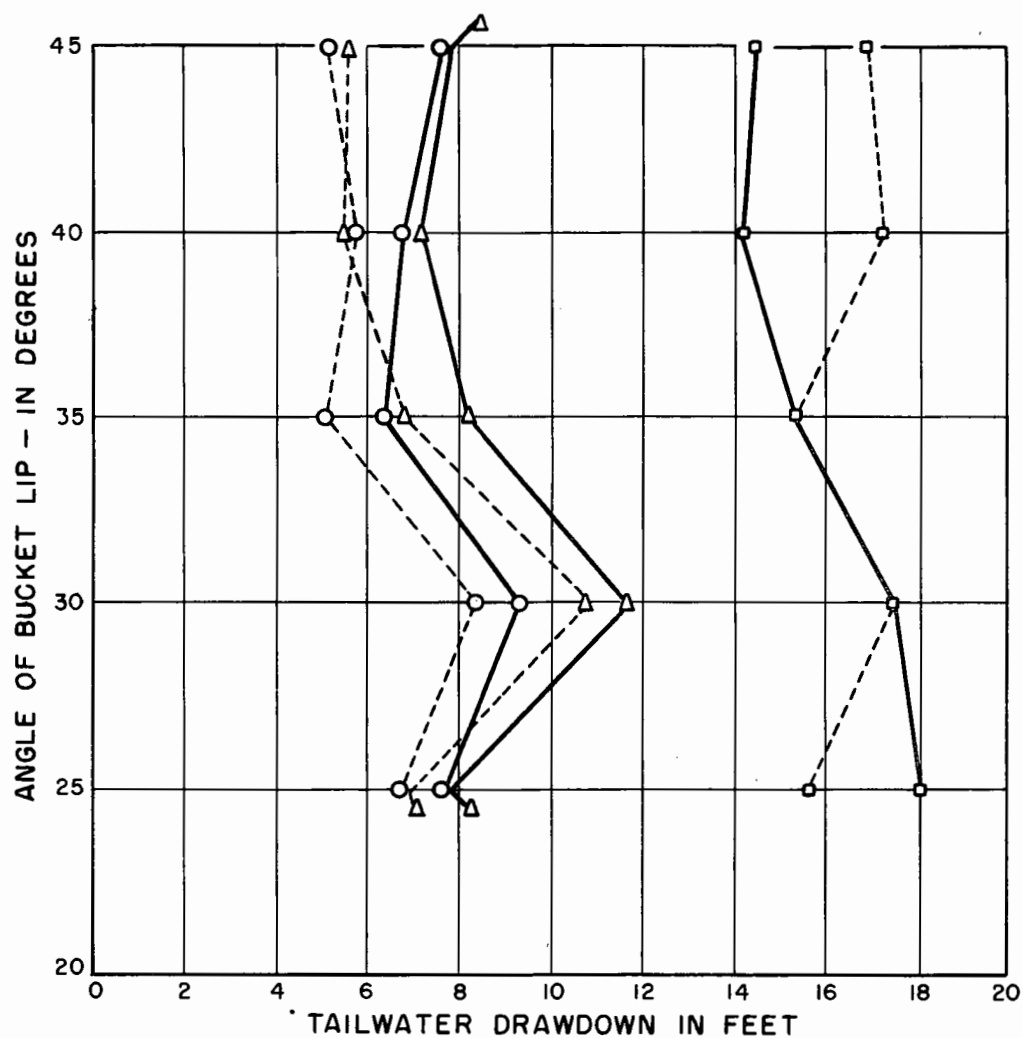
FIGURE 12
REPORT HYD. 469

NOTES

MARBLE CANYON T.W.	LEE'S FERRY T.W.
RIGHT BUCKET	○ ——— ○	○ - - - - ○
LEFT BUCKET	△ ——— △	△ - - - - △
BOTH BUCKETS	□ ——— □	□ - - - - □

TAILWATER DRAWDOWN FOR VARIOUS LIP ANGLES

The curves on Figure 12 show the water surface drawdown for the different flip buckets. The curves indicate that for single-tunnel operation, the greatest drawdown occurred with the 30° flip bucket and the least drawdown with the 35° bucket. Due to the relative position of the buckets and their alinement with the river channel, the drawdown for the 30° and 35° buckets was greater when the left tunnel was operating than when the right tunnel was operating. For the 25°, 40°, and 45° buckets, the drawdown was about the same when either tunnel was operating. During single-tunnel operation, there was greater water surface drawdown with the higher tailwater elevation.

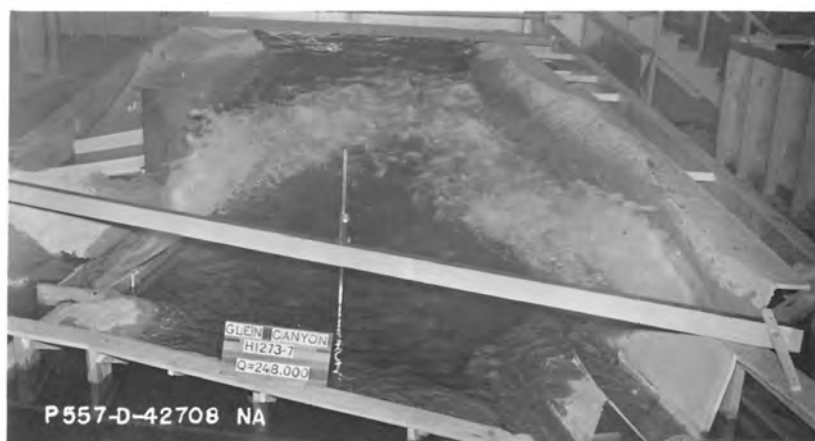
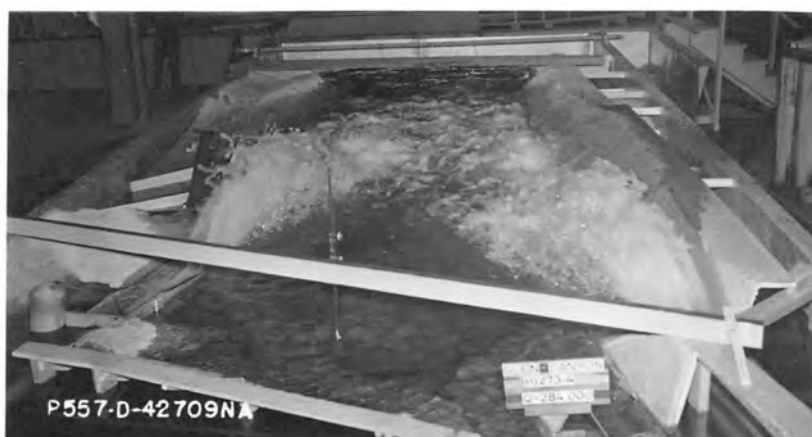
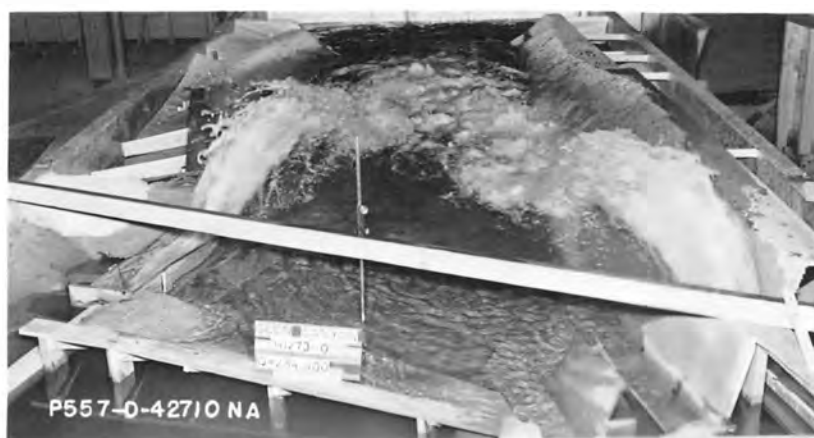
Figure 13
Report Hyd-469

25° Flip Angle

35° Flip Angle

45° Flip Angle

Discharge = 121,000 cfs each tunnel
T. W. Elev. = 3182.0

GLEN CANYON DAM SPILLWAYS

1:88 Scale Model
Preliminary Flip Bucket Operation

On the basis of the drawdown measurements and the general flow appearance, it was decided to use the 35° flip curve for both tunnel spillways. Figure 13 shows the operation of three of the buckets during maximum discharge and the Marble Canyon (high) tailwater elevations.

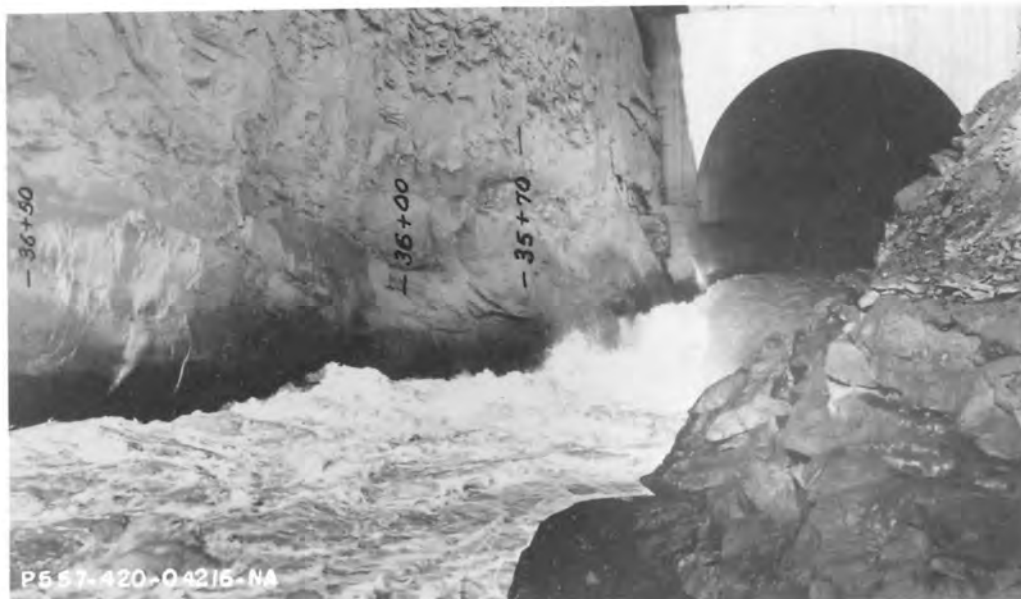
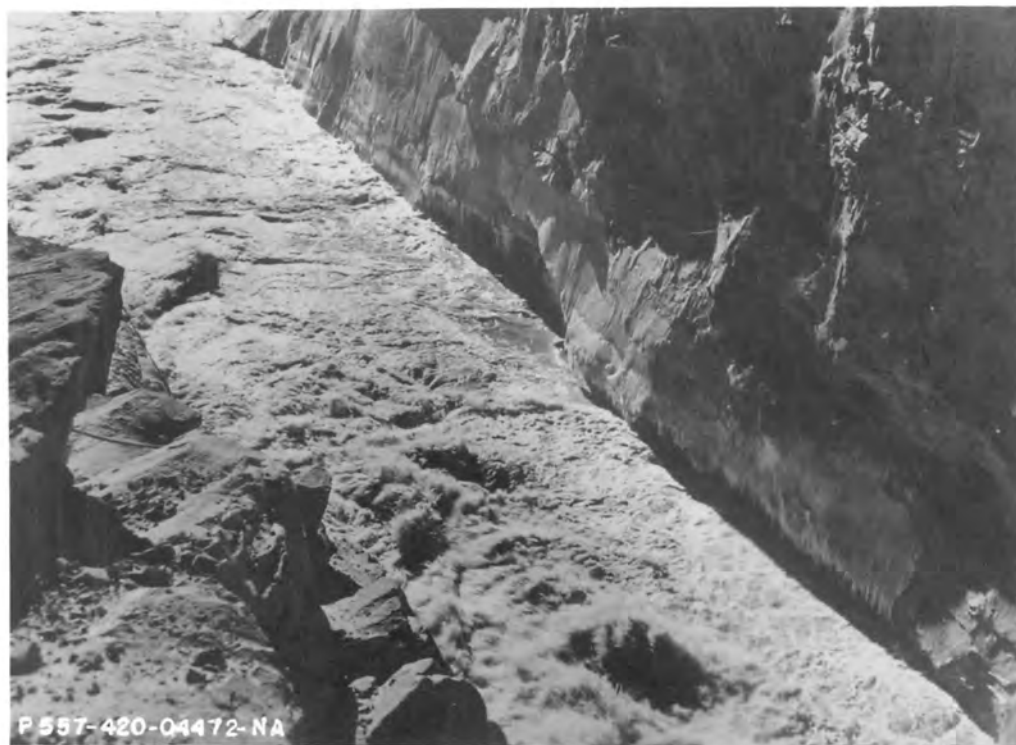
GLEN CANYON DAM

Project photographs of undercutting of right
canyon wall during river diversion Dec. 1959
Jan. 1960

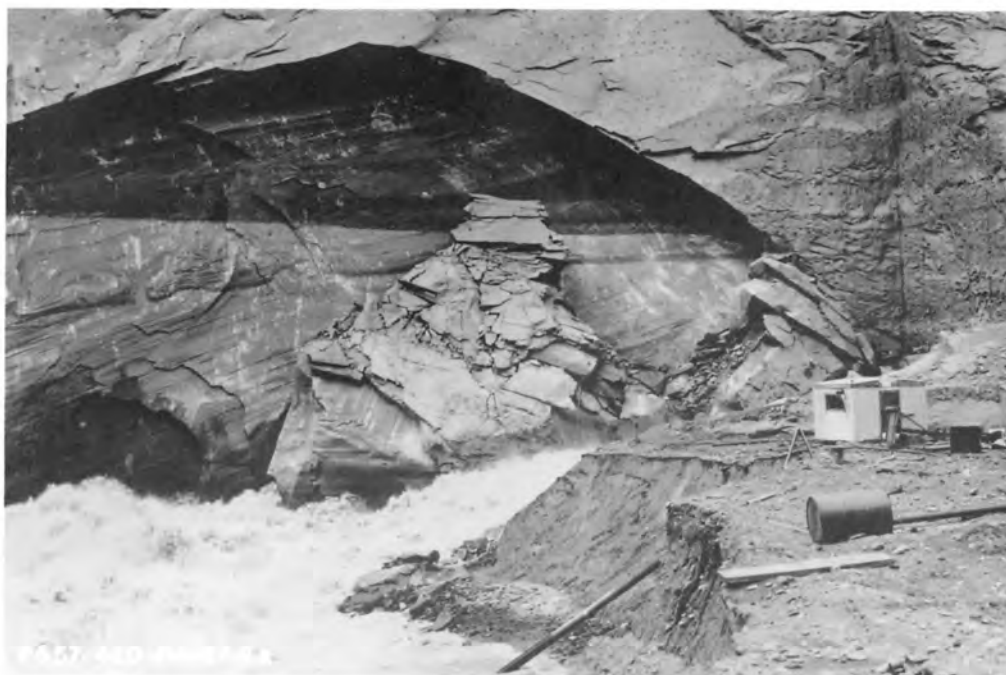
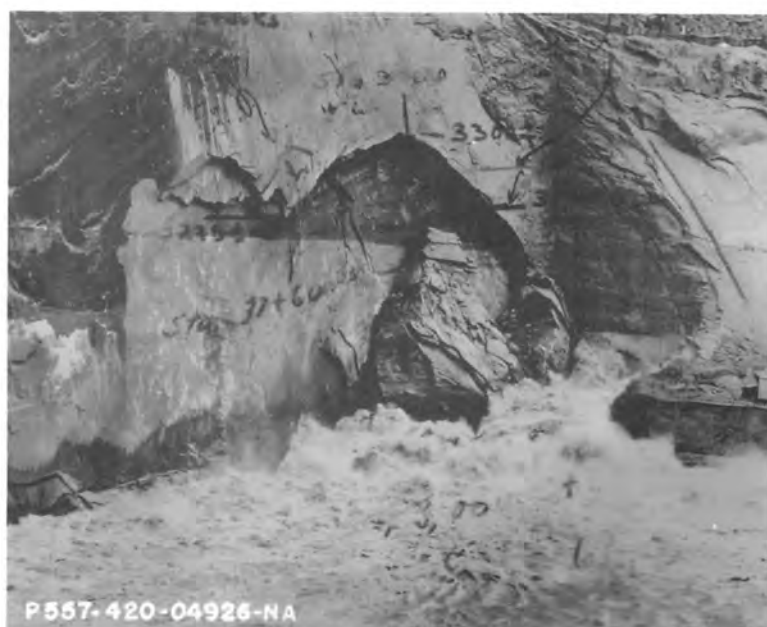
GLEN CANYON DAM SPILLWAYS

Project photographs of canyon wall failure
Right Diversion Tunnel Portal. June 13, 1960

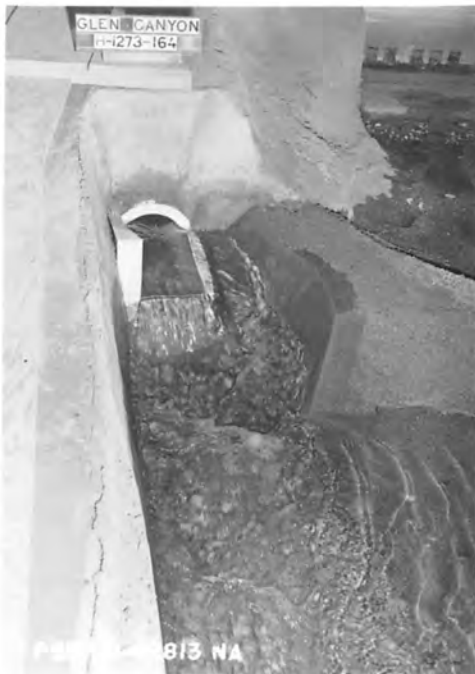
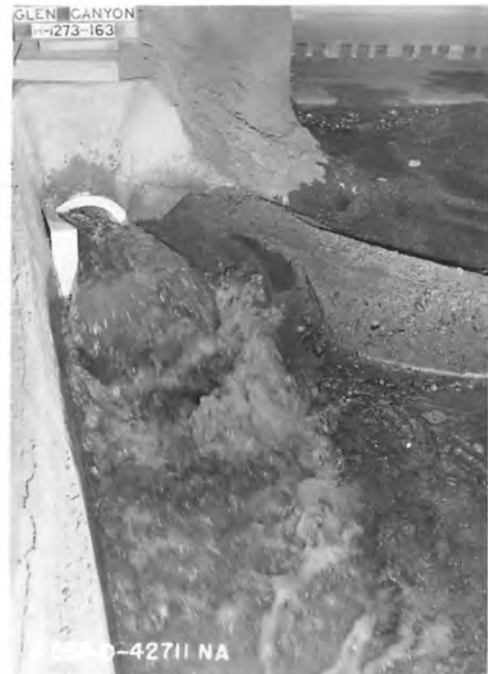
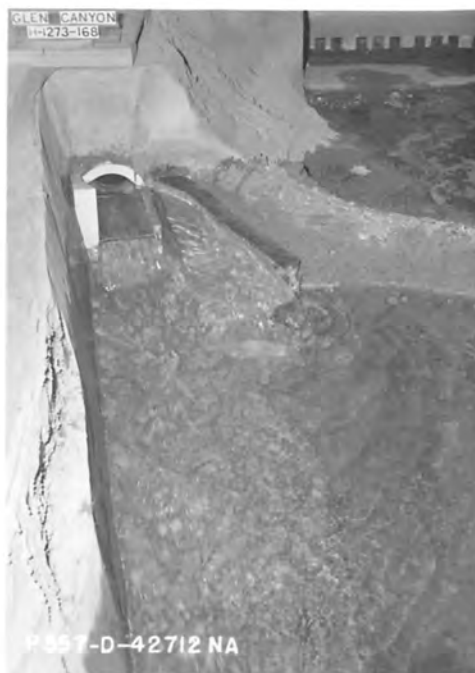
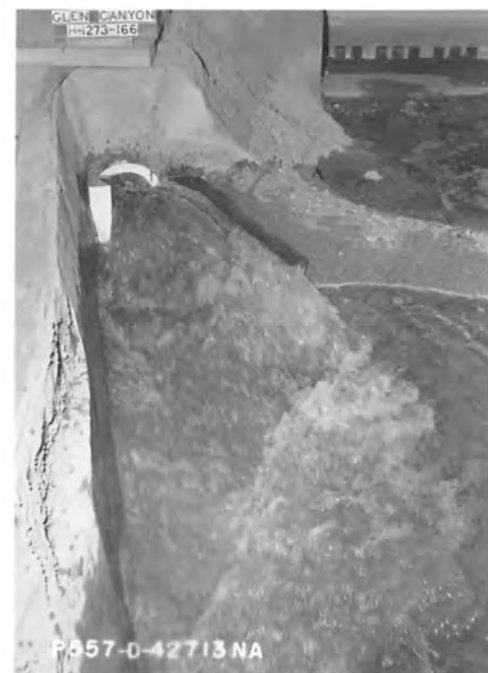
15,000 cfs

50,000 cfs

A. Preliminary Side Channel

B. Modified Side Channel

1:63.48 Scale Model
Flow at right diversion tunnel with side channels.

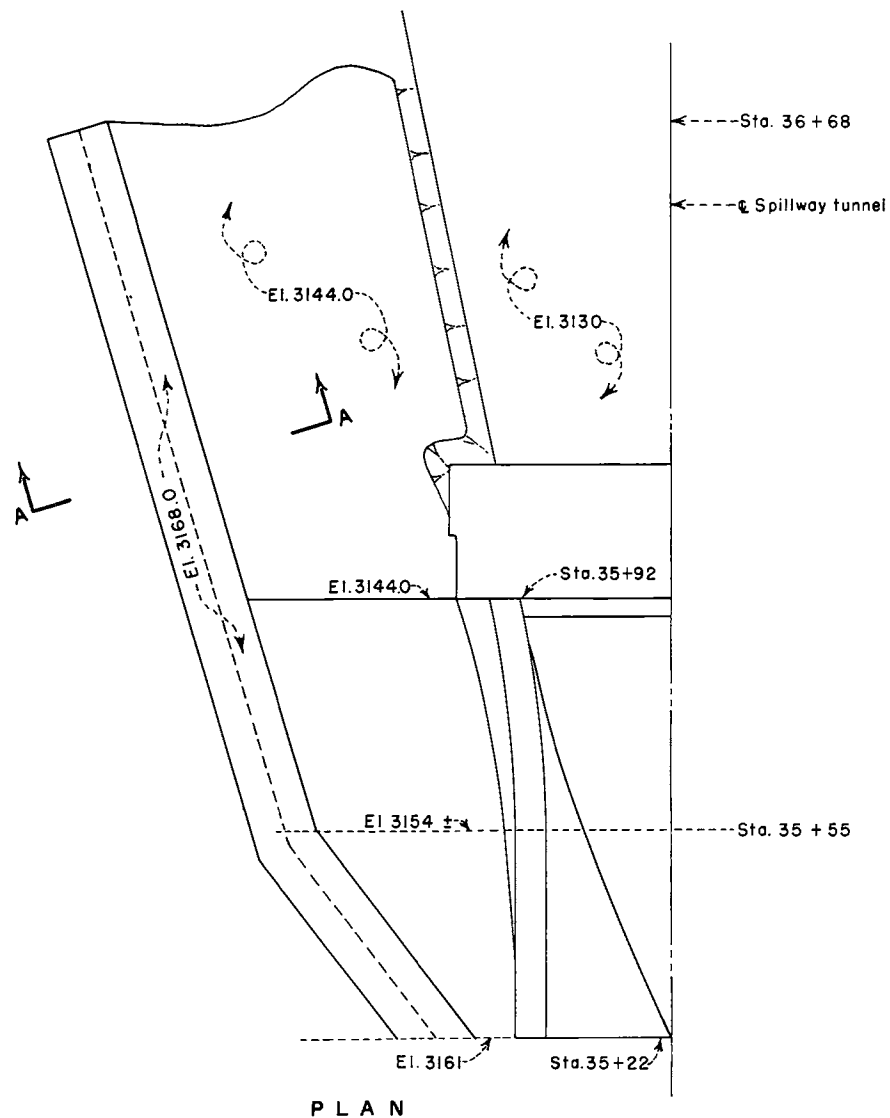
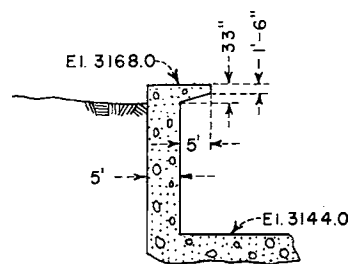
FIGURE 17
REPORT HYD. 469

P L A N

SECTION A-A

GLEN CANYON DAM SPILLWAYS
1:63.48 SCALE MODEL
RIGHT DIVERSION TUNNEL-SIDE CHANNEL STUDY
FIRST MODIFICATION

The side channel spillway was redesigned so that it was wider and the left wall was curved toward the river. A 5-foot-wide seawall or coping strip was placed on top of the wall to deflect the flow downward, Figure 17. This protective device performed exceptionally well and protected the cofferdam against damage for flows up to 100,000 cfs, Figure 16. In addition to directing the flow away from the cofferdam, the jet spread into the river channel and relieved some of the pressure against the right canyon wall.

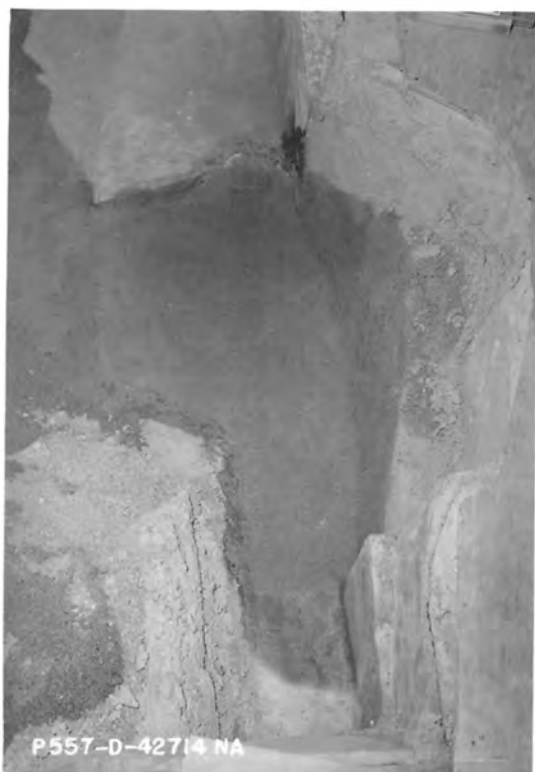
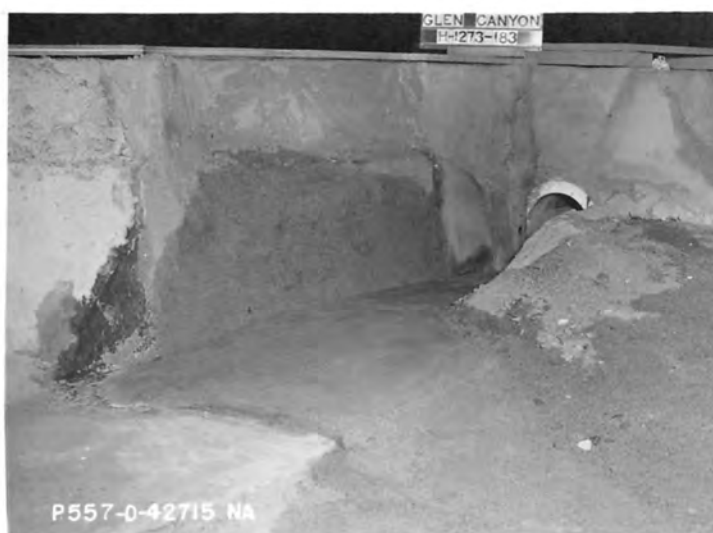
50-foot long deflector wall on right side at tunnel portal. Canyon wall and riverbed molded in erodible sand-cement mixture.

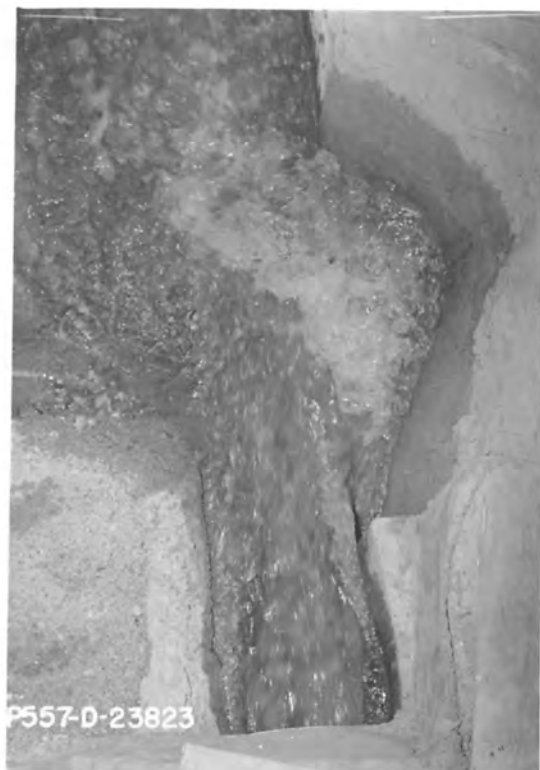
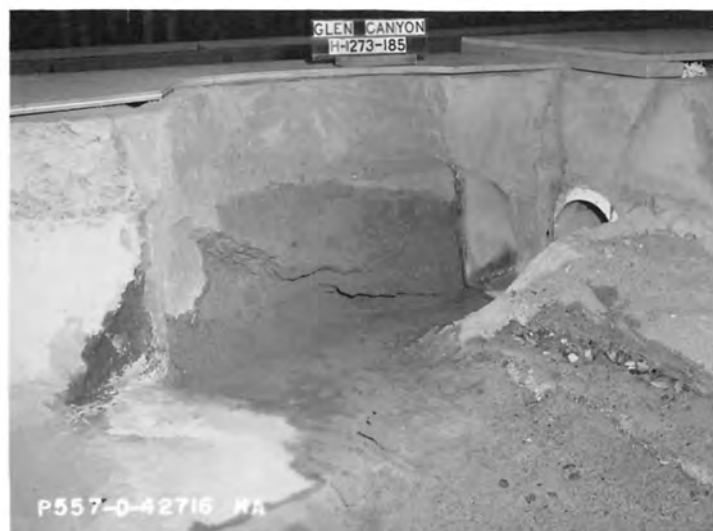
Extent of canyon wall erosion after 30 minutes operation at 50,000 cfs.

Discharge = 50,000 cfs

GLEN CANYON DAM SPILLWAYS

1:63.48 Scale Model
Right Diversion Tunnel Deflector Wall Studies

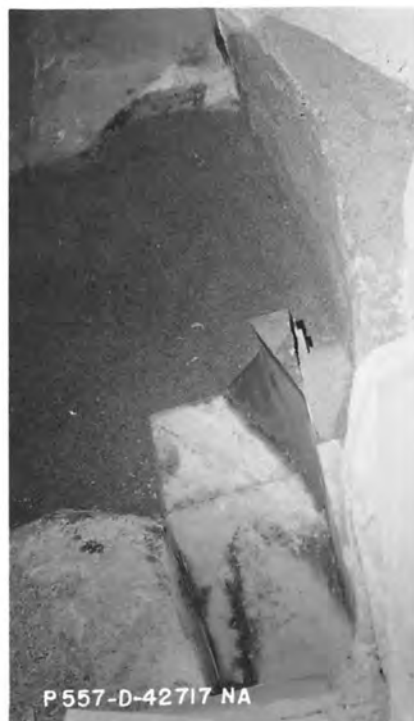
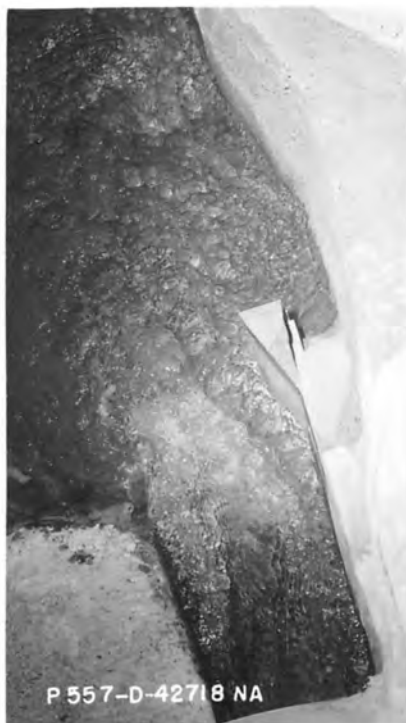
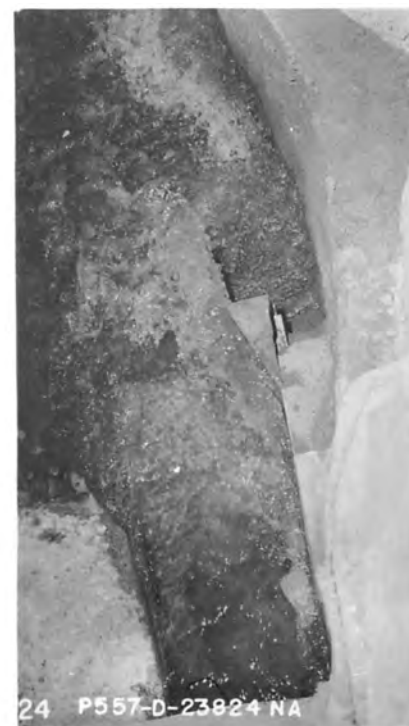
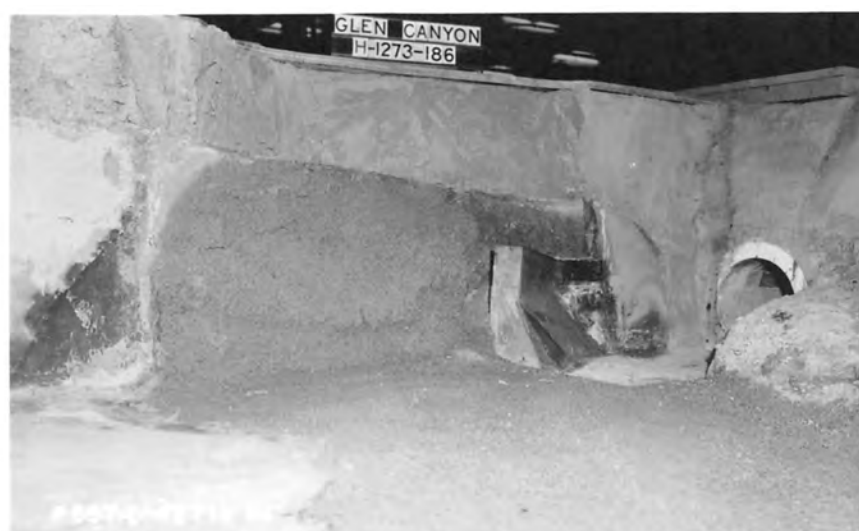
$Q = 15,000$ cfs

$Q = 50,000$ cfs

**Superelevated extension wall downstream
from deflector wall.**

GLEN CANYON DAM SPILLWAYS

1:63.48 Scale Model

Right Diversion Tunnel Superelevated Deflector Wall

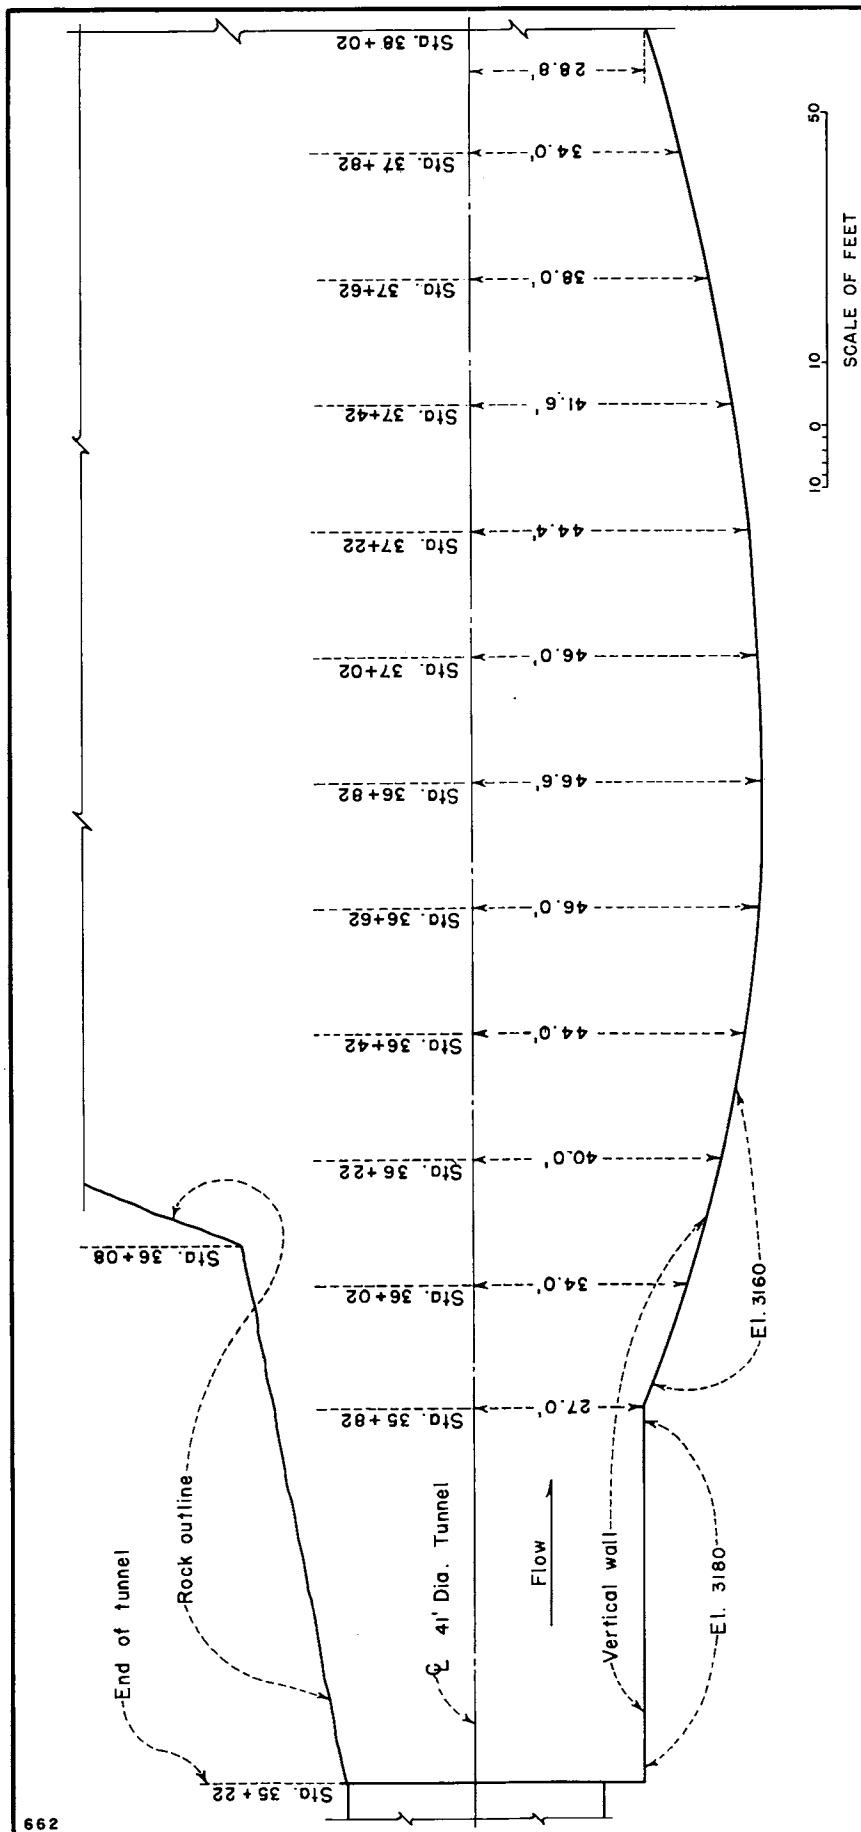
GLEN CANYON DAM SPILLWAYS
1:63.48 SCALE MODEL
LOW CURVED WALL ON RIGHT SIDE
PORTAL OF RIGHT DIVERSION TUNNEL

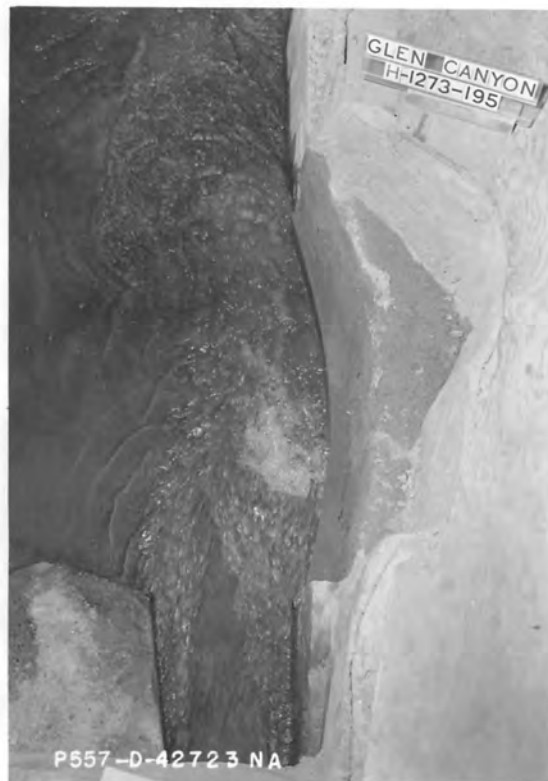
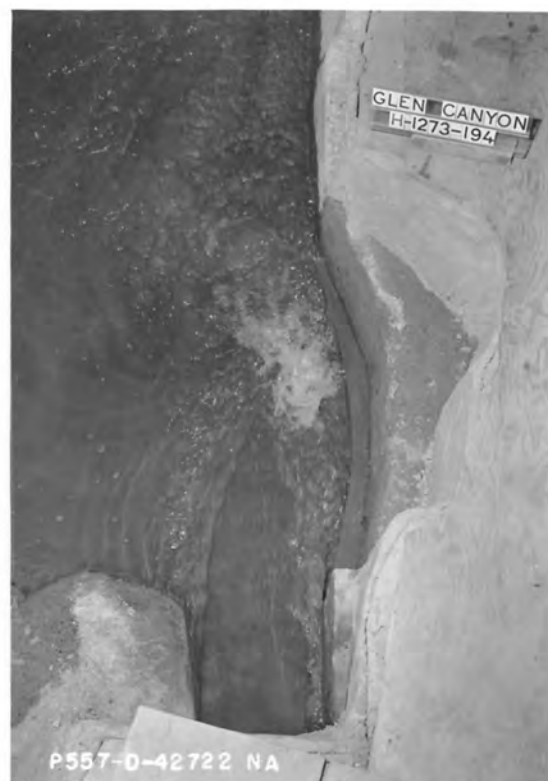
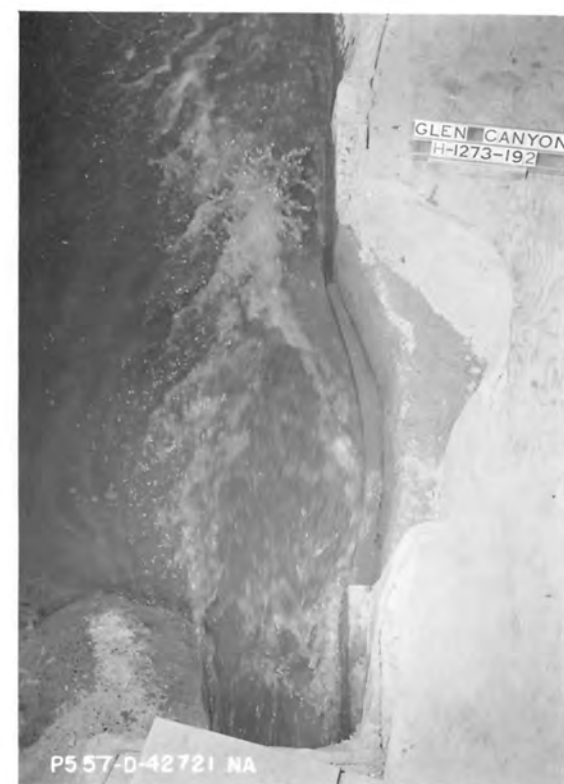
Discharge = 15,000 cfs

Discharge = 35,000 cfs

Discharge = 70,000 cfs

GLEN CANYON DAM SPILLWAYS

1:63.48 Scale Model
 Right Diversion Tunnel
 Flow conditions with low curved wall
 protecting right canyon wall

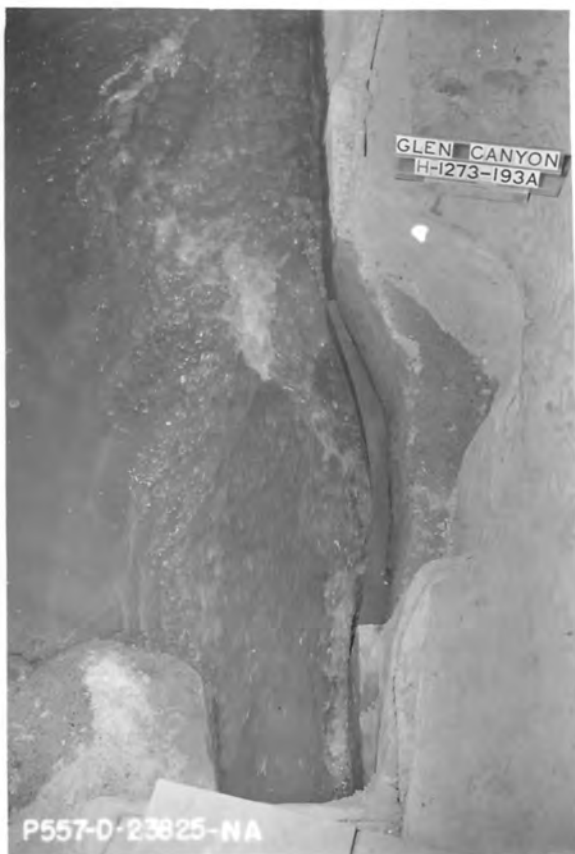
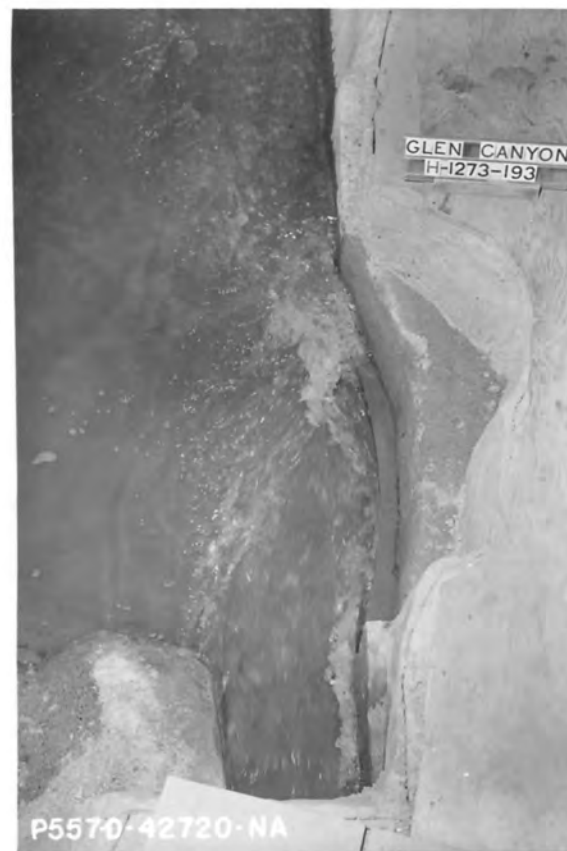
Normal flow from tunnel.

Jet deflected by tailwater surging.

Discharge = 50,000 cfs

Right Diversion Tunnel

Surging action caused by tailwater conditions

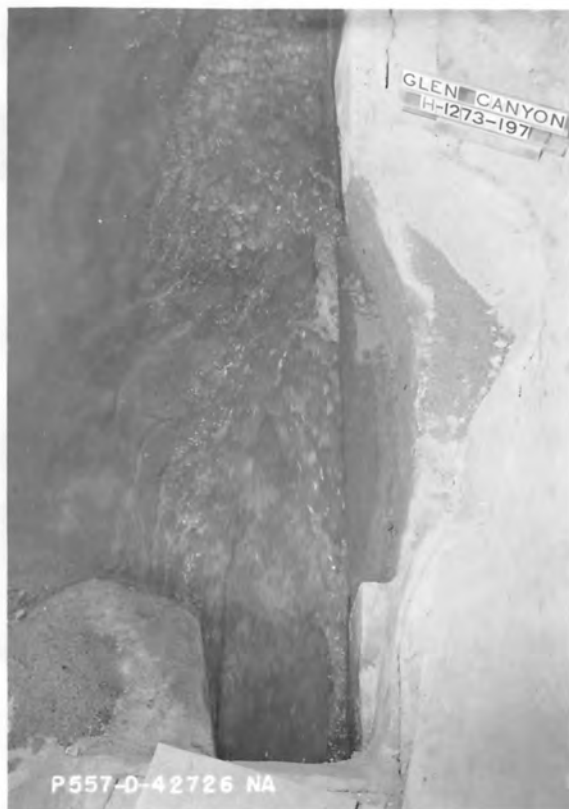
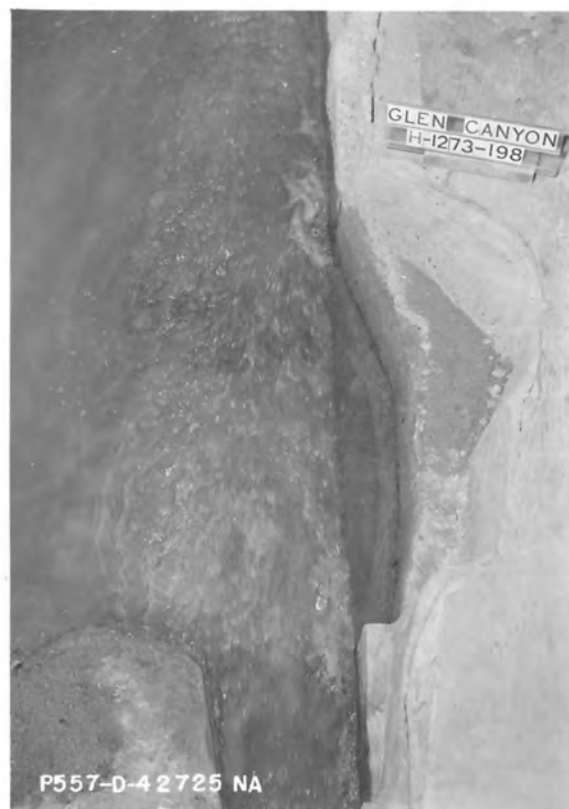
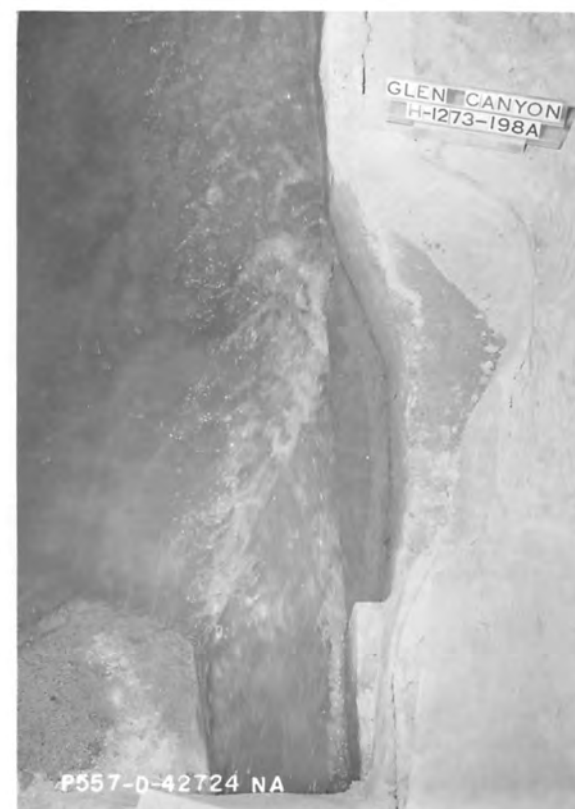
Discharge = 35,000 cfs

Normal flow from tunnel.

Jet deflected by tailwater surging.

Discharge = 50,000 cfs

GLEN CANYON DAM SPILLWAYS

1:63.48 Scale Model
Right Diversion Tunnel
Flow conditions with low straight wall
protecting right canyon wall
