HYDRAULIC MODEL STUDIES OF THE SPILLWAYS
AND OUTLET WORKS--GLEN CANYON DAM
COLORADO RIVER STORAGE PROJECT, ARIZONA

Report No. Hyd-469

Hydraulics Branch
DIVISION OF RESEARCH

February 18, 1964

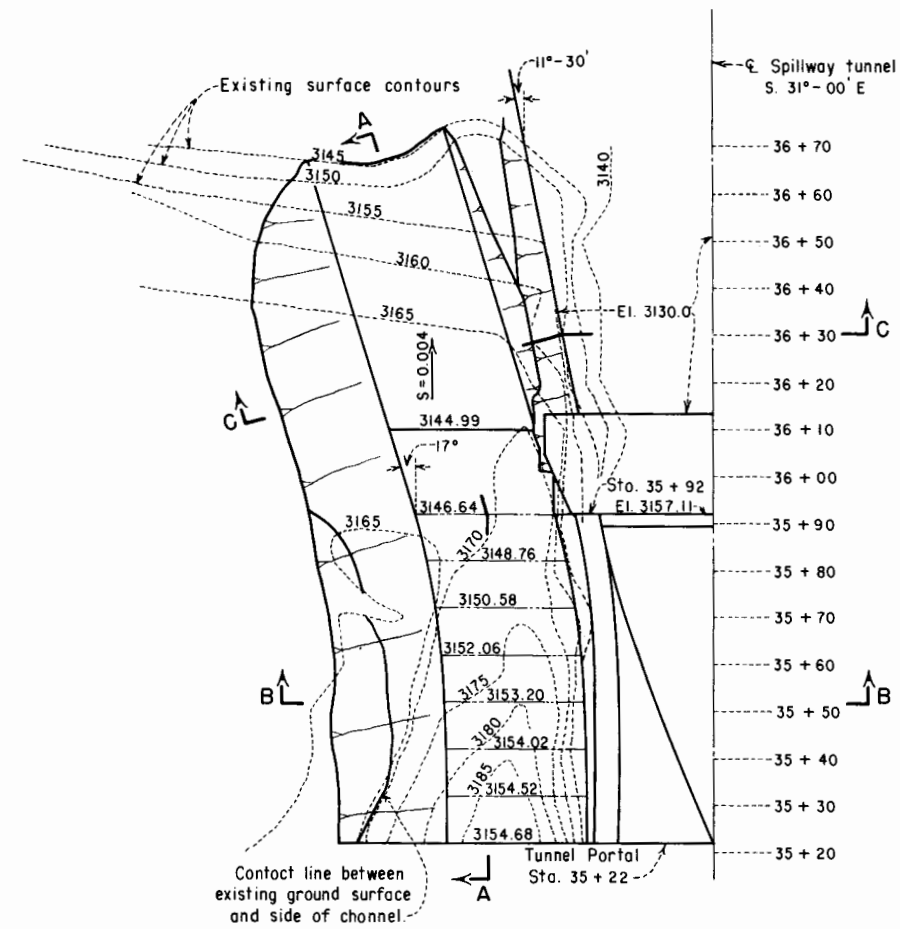
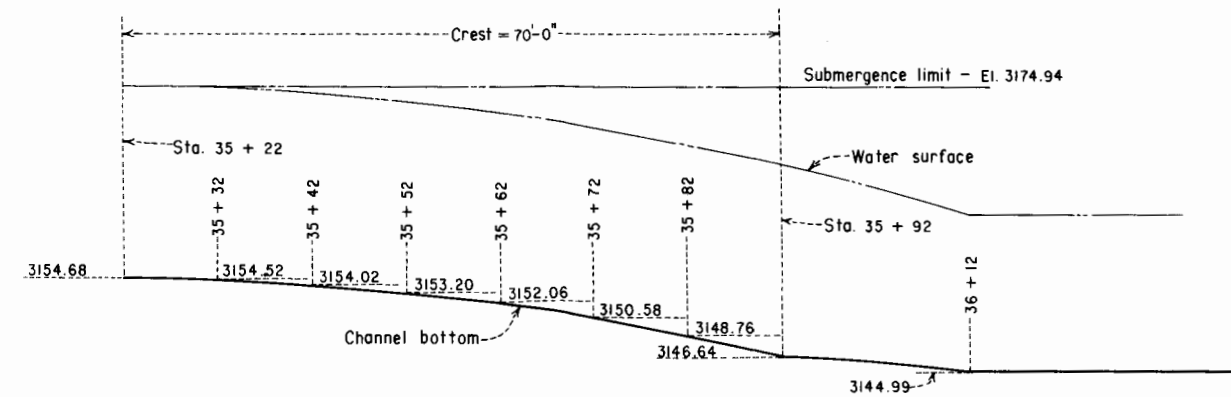
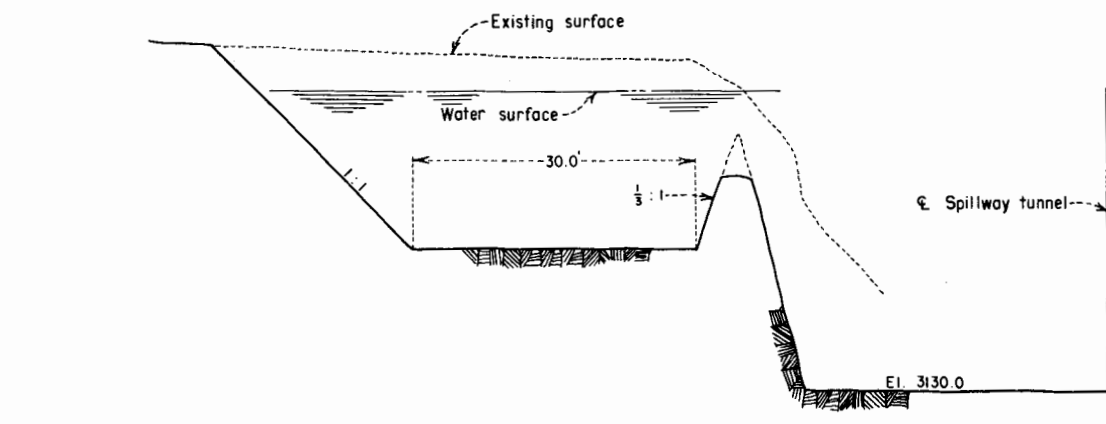
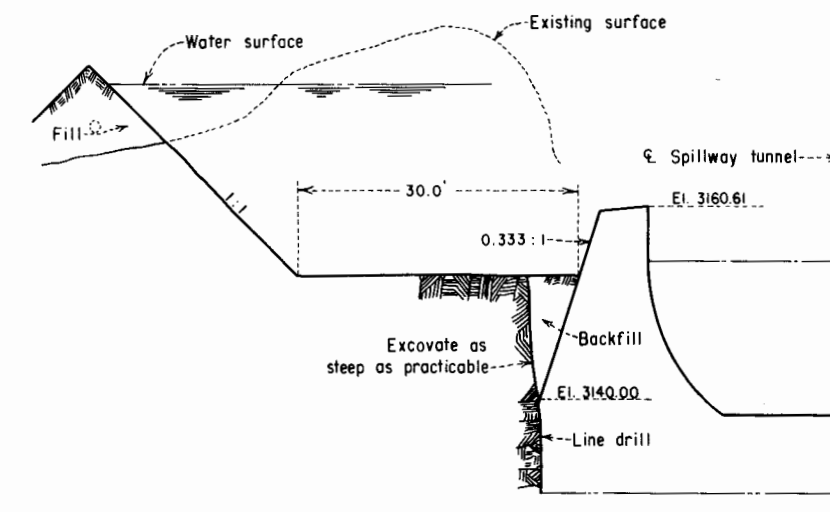
PLAN

SECTION A-A

SECTION C-C

SECTION B-B

Q in side channel = 14210 c.f.s.
n = 1.00
a = 0.23

GLEN CANYON DAM SPILLWAYS
1:63.48 SCALE MODEL
RIGHT DIVERSION TUNNEL-SIDE CHANNEL STUDIES

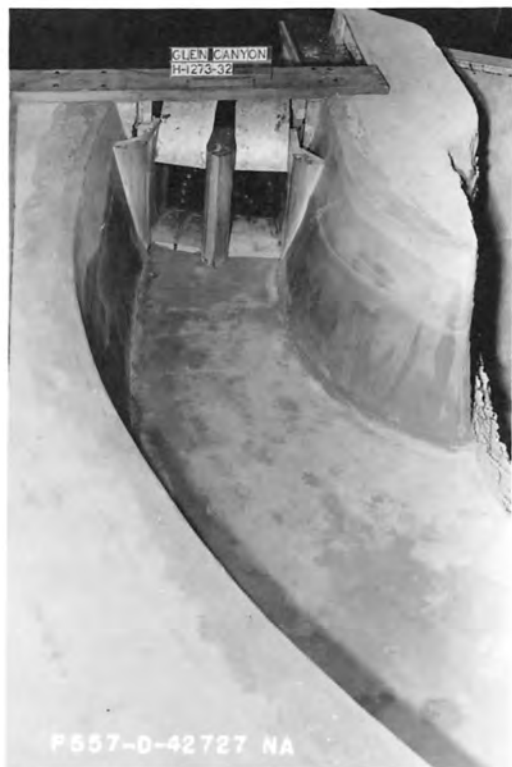
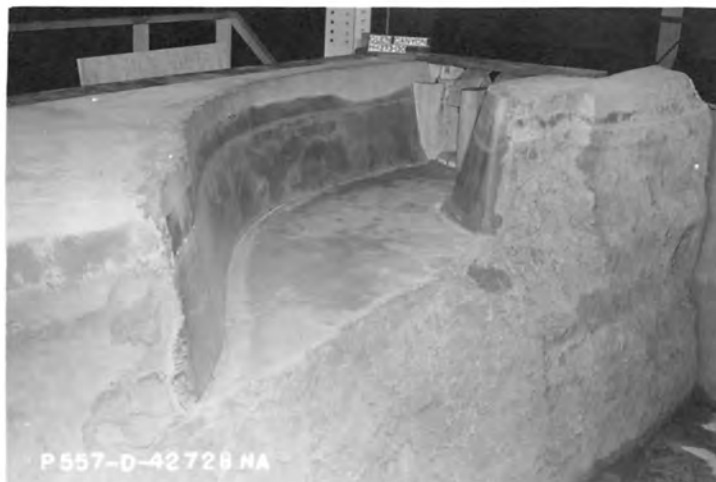
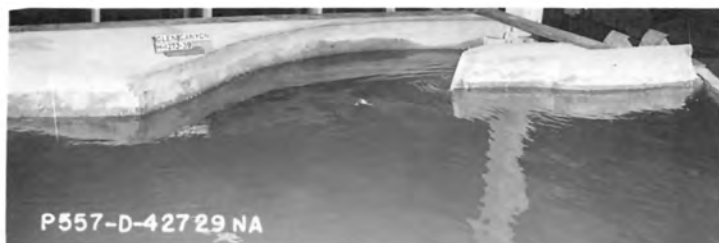
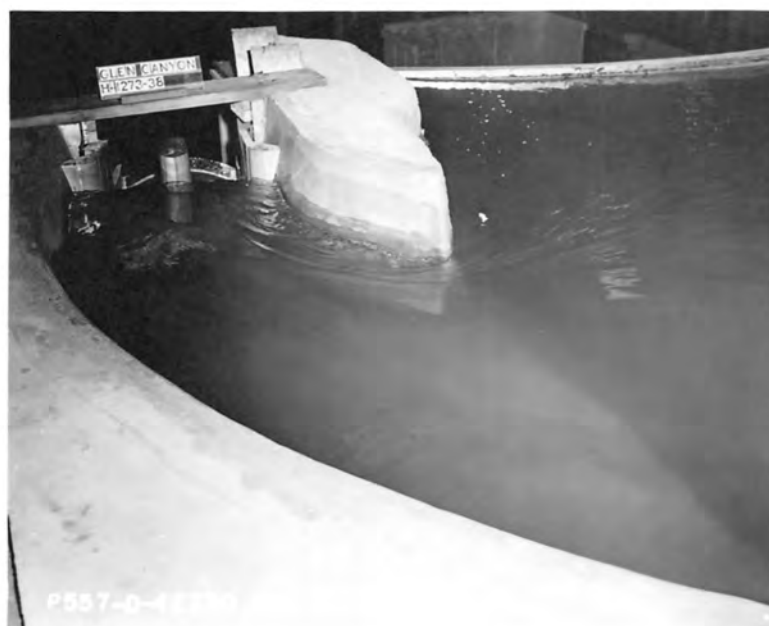
Discharge = 138,000 cfs
Reservoir Elev. 3711.0

GLEN CANYON DAM SPILLWAYS
1:63.48 Scale Model
Preliminary Left Spillway Approach Channel

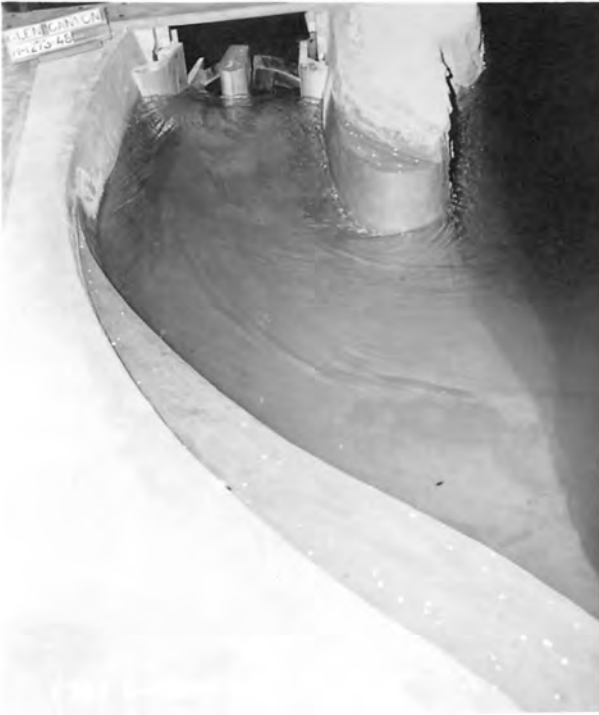
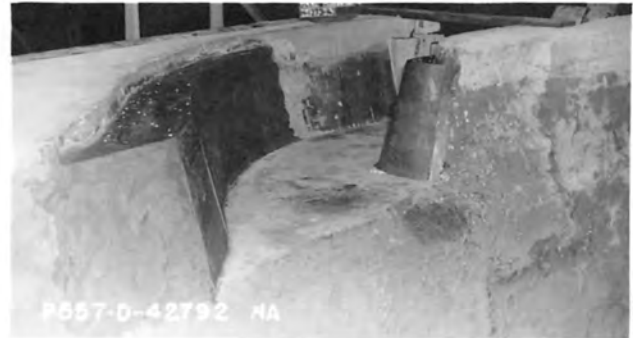
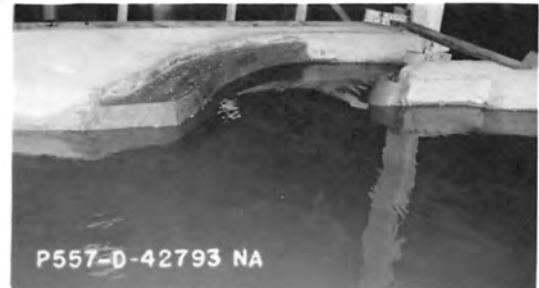
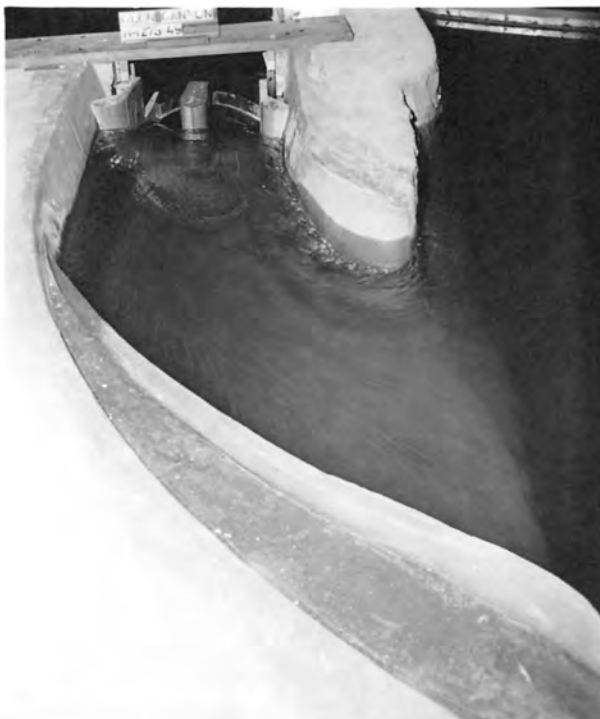
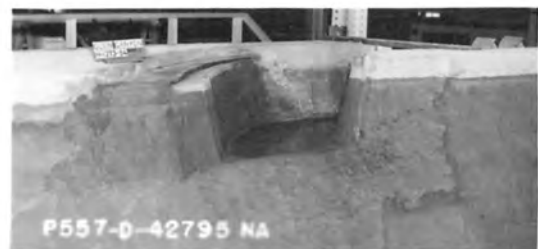
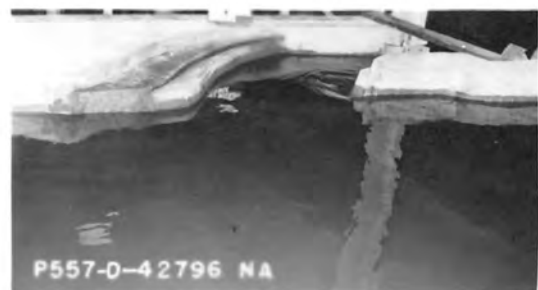
A. First Revision

Discharge = 138,000 cfs
Reservoir Elev. 3711.0

B. Second Revision

GLEN CANYON DAM SPILLWAYS
1:63.48 Scale Model
Revised Left Spillway Approach Channel

First revision. --The channel width was reduced by moving the left wall in about 70 feet at the canyon rim and fairing it into the original wall about 100 feet upstream from the gate section. The right side of the channel was modified by using a short-radius curve at the canyon edge, thus providing a more curved and abrupt entrance, Figure 26.

Second revision. --Since excellent flow conditions still existed in the approach channel, it appeared that the channel width could be further reduced without adversely affecting the flow conditions. Accordingly, the left wall at the canyon entrance was extended downstream an additional 50 feet and faired into the original boundary about 50 feet upstream from the spillway entrance, Figure 26. The right wall was further modified by using a longer radius curve at the canyon edge and a comparatively straight approach to the spillway entrance.

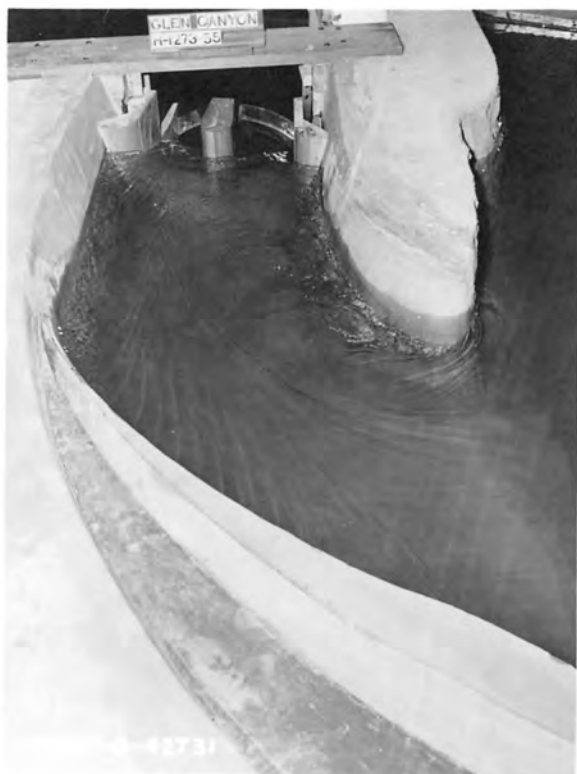
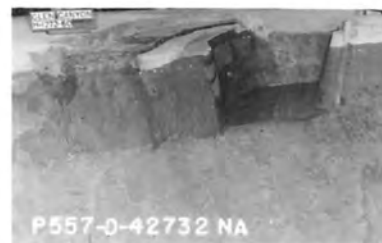
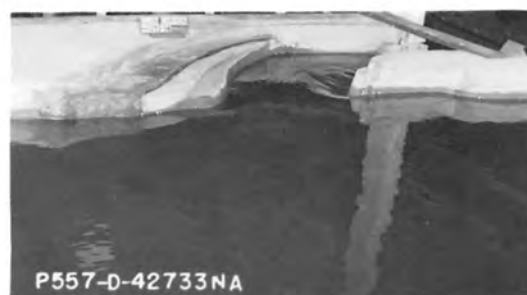
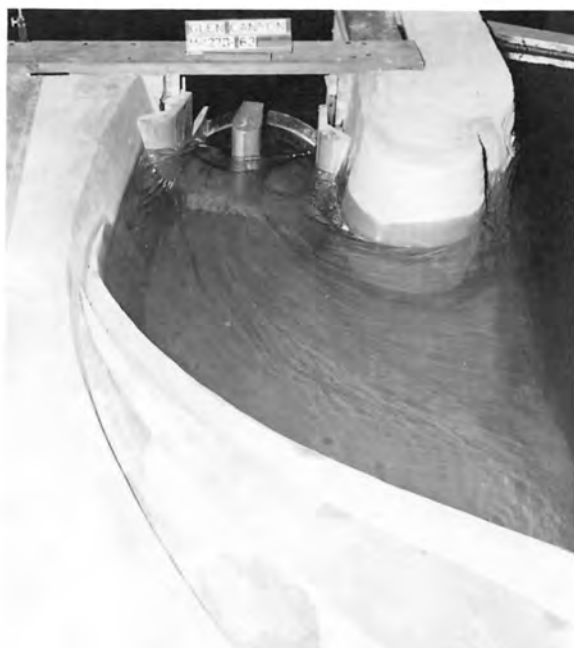
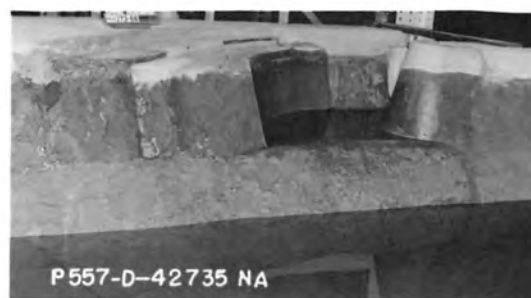
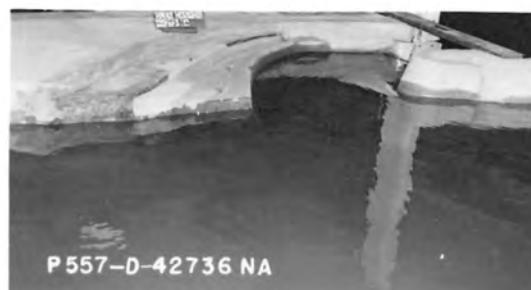
A. Third Revision

Discharge = 138,000 cfs
Reservoir Elev. = 3711.0

B. Recommended

GLEN CANYON DAM SPILLWAYS

1:63.48 Scale Model
Revised Left Spillway Approach Channel

Third revision. --The width of the approach channel was further reduced by moving the left wall an additional 20 feet downstream at the canyon rim; the right wall was not altered in this revision, Figure 26.

Fourth revision. --The only undesirable feature in the revised left channel was the flow appearance along the right wall. Although detracting in overall operating appearance, the water surface drawdown at the upstream end and the reverse flow eddy currents between the point of drawdown and the gate section did not affect the hydraulic characteristics of the entrance. The tests indicated that these conditions probably could be alleviated by modifying the right side of the approach channel. Therefore, the comparatively abrupt curvature of the right wall was cut back and replaced with a long-radius curved wall from the reservoir to the gate section. This change substantially reduced the length of the right sidewall, Figure 26.

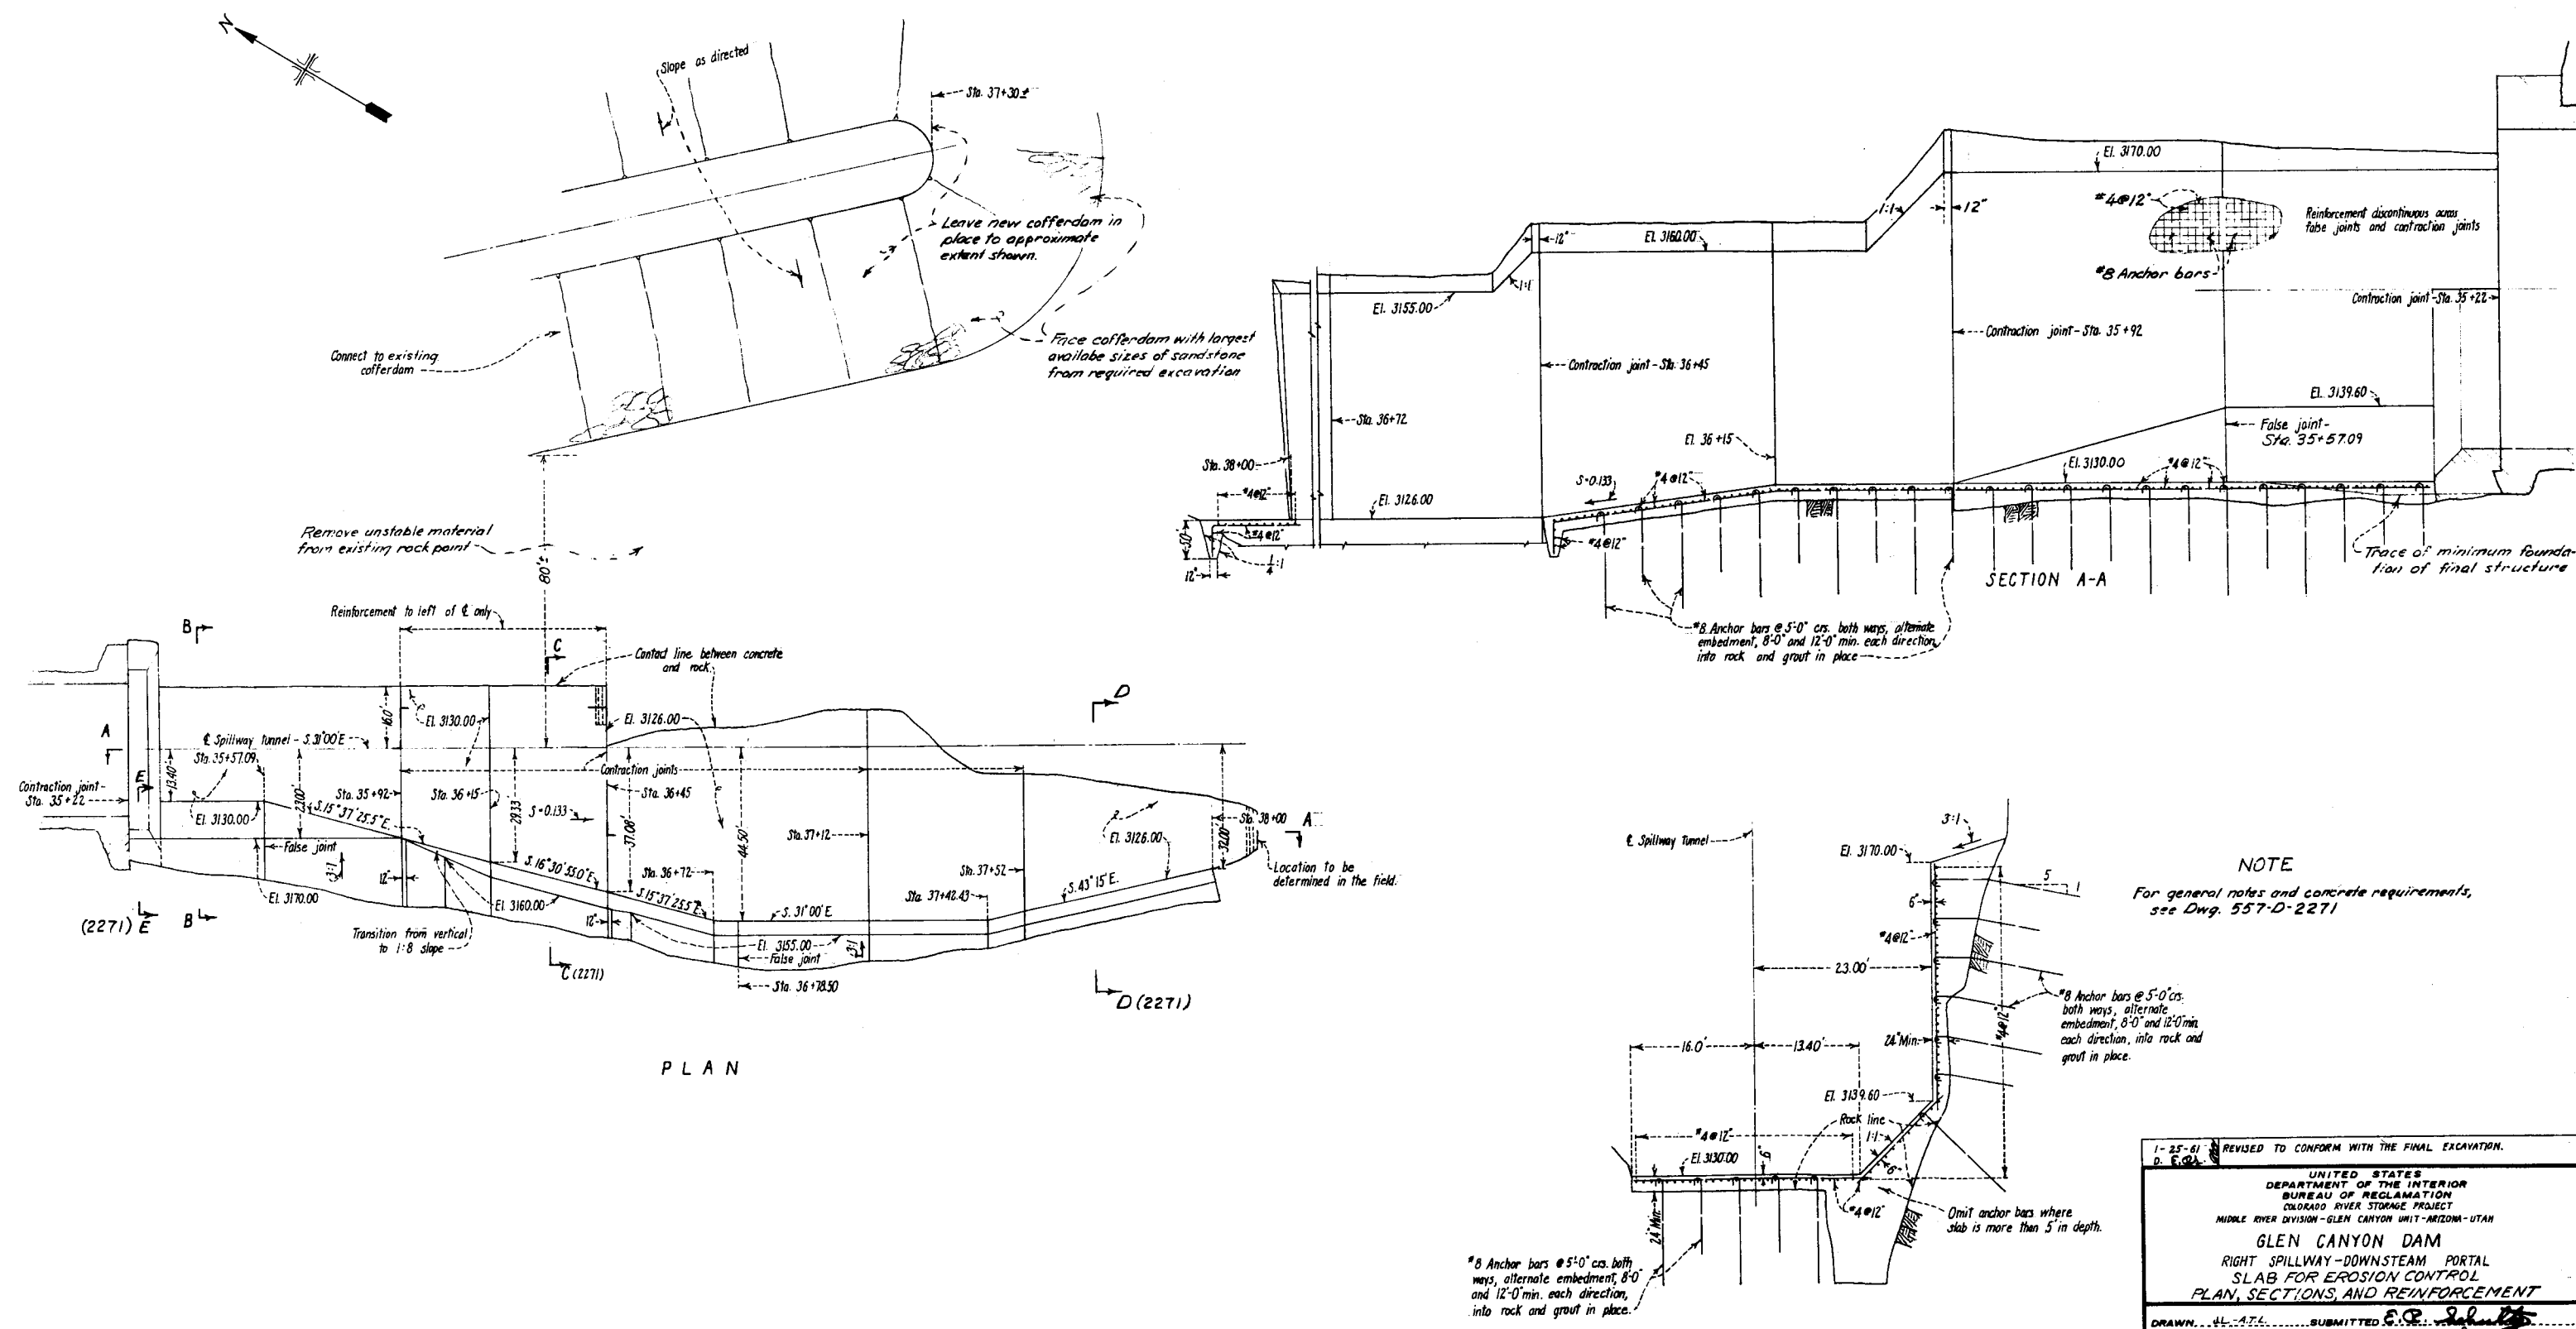
1-25-61 D. E. 2271		REVISED TO CONFORM WITH THE FINAL EXCAVATION.	
UNITED STATES DEPARTMENT OF THE INTERIOR BUREAU OF RECLAMATION COLORADO RIVER STORAGE PROJECT MIDDLE RIVER DIVISION - GLEN CANYON UNIT - ARIZONA-UTAH			
GLEN CANYON DAM RIGHT SPILLWAY - DOWNSTREAM PORTAL SLAB FOR EROSION CONTROL PLAN, SECTIONS, AND REINFORCEMENT			
DRAWN BY	DATE	SUBMITTED BY	DATE
TRACED	DATE	RECOMMENDED BY	DATE
CHECKED	DATE	APPROVED BY	DATE
DENVER, COLORADO, NOVEMBER 30, 1960		SHEET 1 OF 2	
557-D-2270

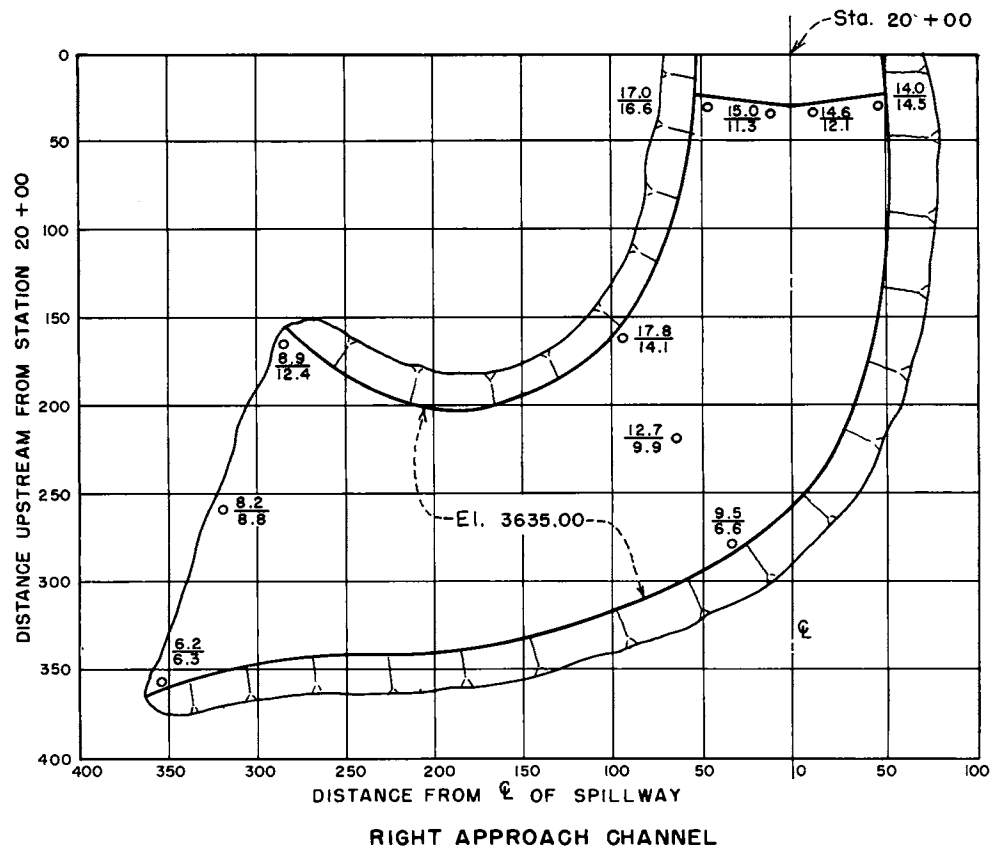
FIGURE 32
REPORT HYD. 469

1. $\circ \frac{V @ El. 3697}{V @ El. 3639}$
2. Velocities are in feet per second.
3. Velocities measured for $Q = 138,000$ c.f.s. per spillway.
Reservoir elevation 3711.

1:63.48 SCALE MODEL

VELOCITY DISTRIBUTION IN RECOMMENDED APPROACH CHANNELS

Preliminary channel. --The arrangements of the preliminary right and left approach channels were similar. The gate section and tunnel portal of the right spillway were set a greater distance back from the canyon edge than the left spillway gate section. This difference permitted a more gradual or longer radius curve for the left wall of the right approach channel. The outside or right boundary of the right approach channel was in the form of a moderate "s" or reverse curve between the canyon edge and the gate section. The bottom width of the right channel was 460 feet at the canyon rim and reduced to about 110 feet wide at the gate section, Figure 32.

face, Figure 33. Velocities at the channel entrance were about 3.9 fps near the right side, 3.7 fps in the center, and 4.5 fps near the left side. In front of the spillway entrance, the velocities were about 14.6 fps on the right side, 15.1 fps in the center, and 15.8 fps on the left side. The velocity distribution for the maximum discharge in the preliminary channel is shown on Figure 32.

First revision. --The preliminary channel was modified by moving the right boundary downstream about 100 feet at the canyon rim and fairing it into the preliminary boundary about 100 feet upstream from the gate section, Figure 32. The left side of the channel was not modified.

Second revision. --The right wall was moved 75 feet farther downstream at the entrance and faired into the preliminary wall similar to the first revision, Figure 32. No changes were made to the left side.

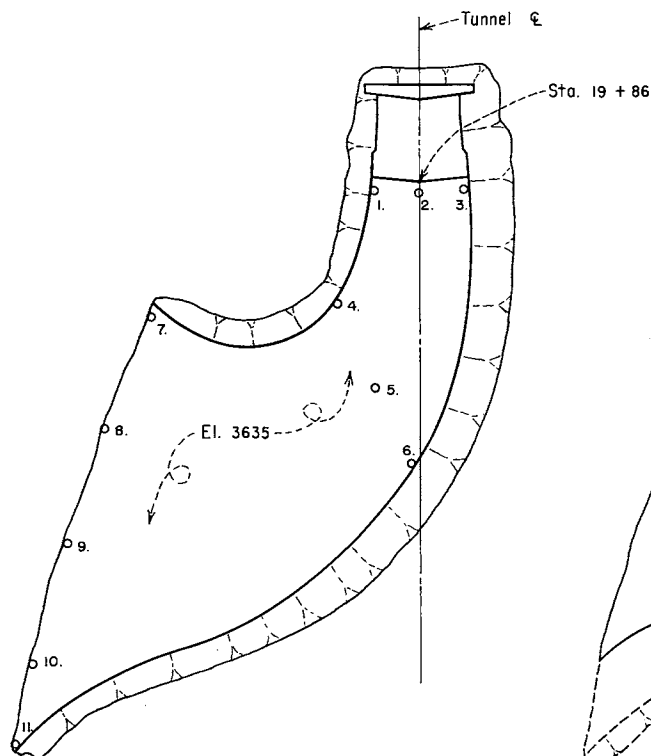
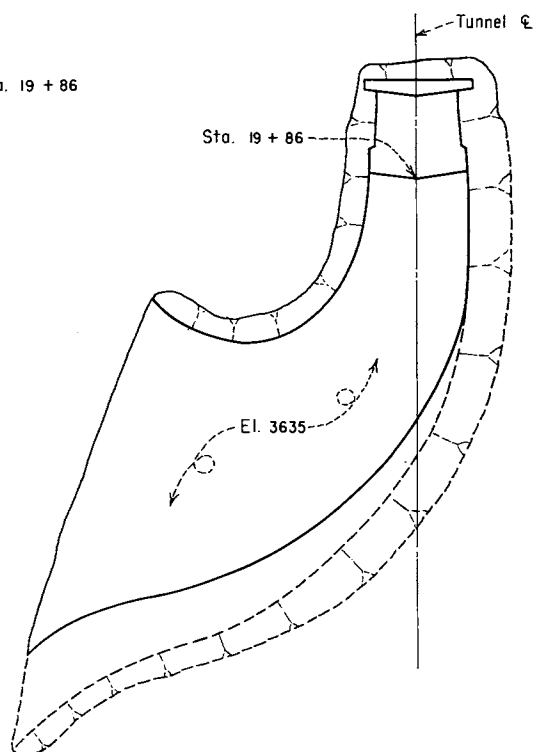
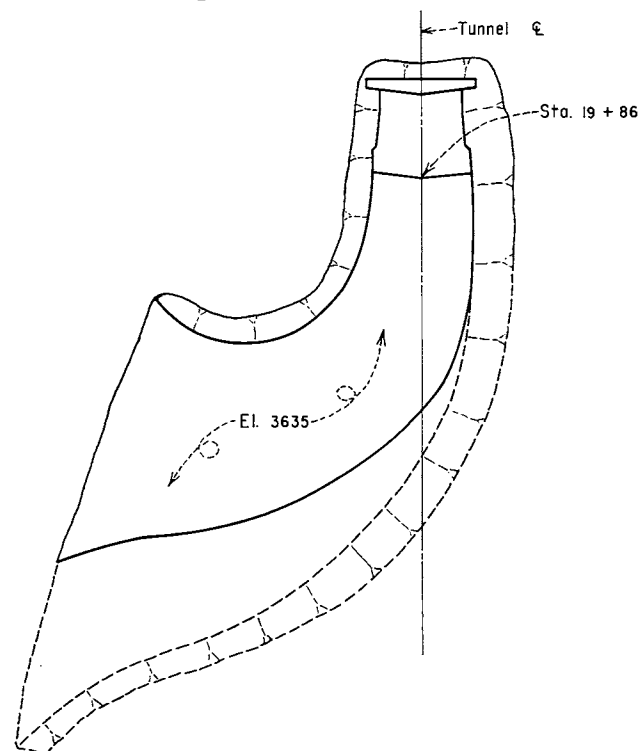
PRELIMINARY

1ST. REVISION

2 ND. REVISION

VELOCITY DISTRIBUTION IN PRELIMINARY APPROACH		
LOCATION	V @ EL. 3697	V @ EL. 3639
o 1	16.0	15.6
o 2	15.4	14.8
o 3	13.9	15.4
o 4	14.1	11.4
o 5	10.0	8.0
o 6	7.0	6.5
o 7	4.9	4.0
o 8	4.4	3.6
o 9	4.2	3.2
o 10	3.8	3.1
o 11	4.2	3.6

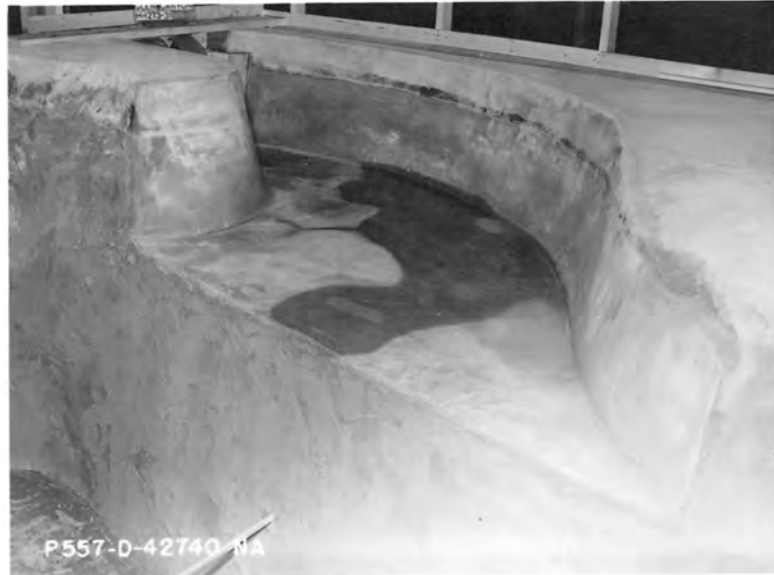
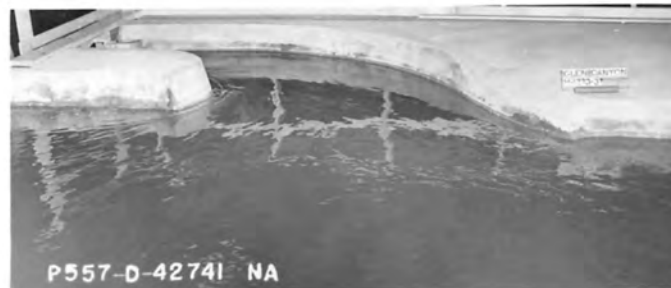
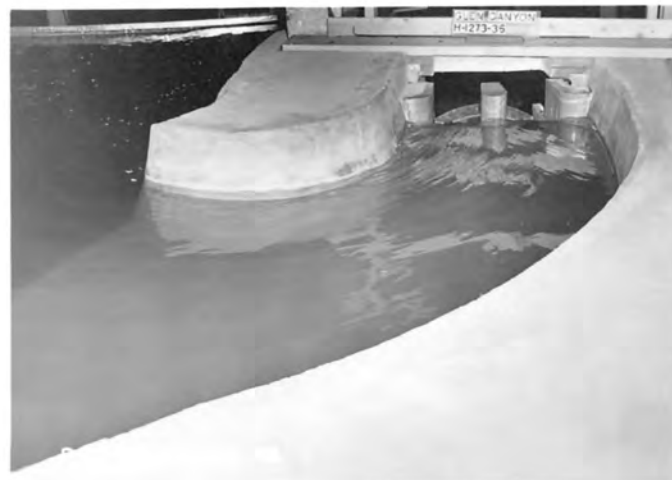
Figure 33
Report Hyd-469

Discharge = 138,000 cfs
Reservoir Elev. 3711.0

GLEN CANYON DAM SPILLWAYS
1:63.48 Scale Model
Preliminary Right Spillway Approach Channel

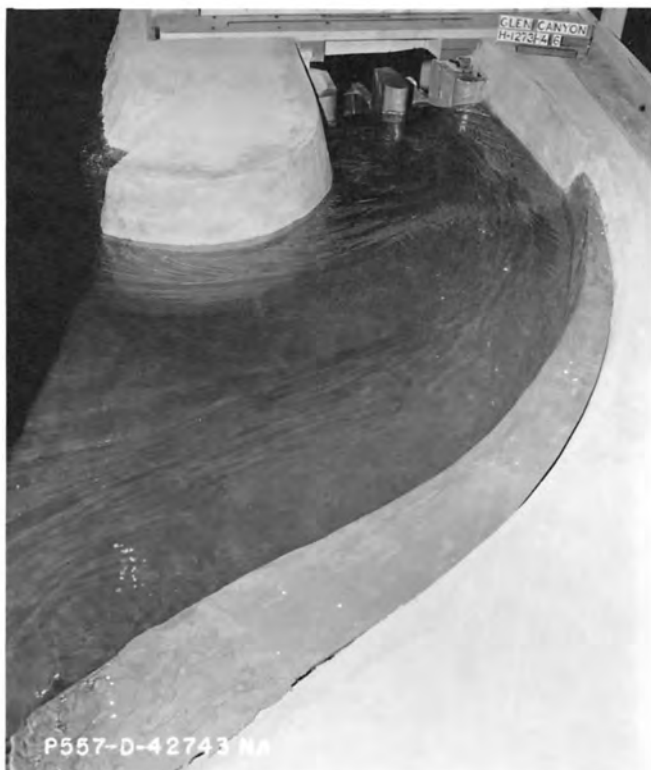
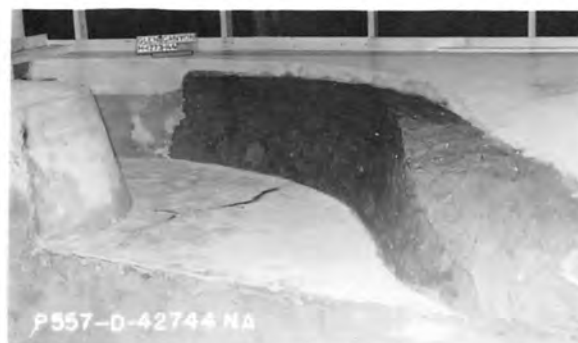
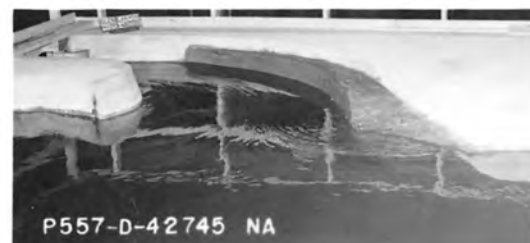
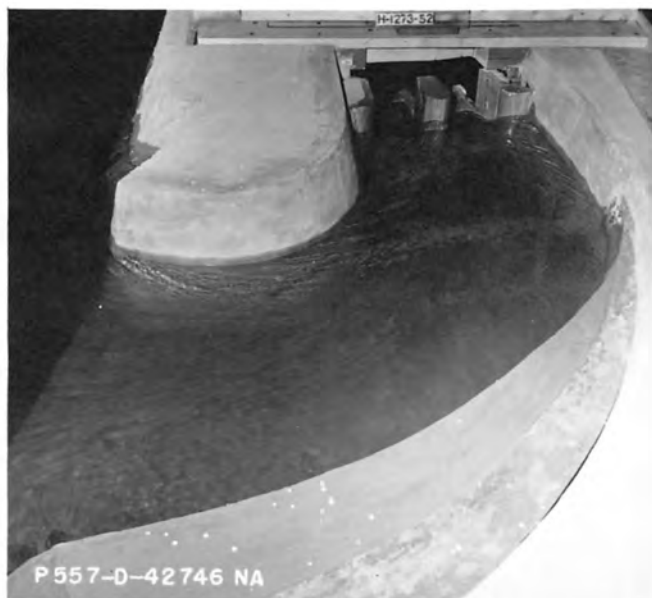
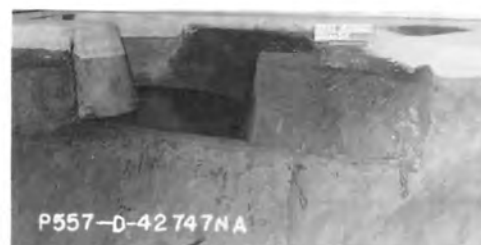
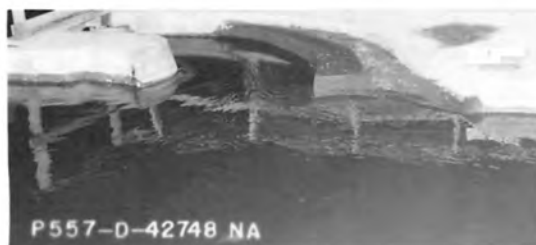
Discharge = 138,000 cfs
Reservoir Elev. = 3711.0

A. First Revision

B. Second Revision

1:63.48 Scale Model
Revisions to Right Spillway Approach Channel

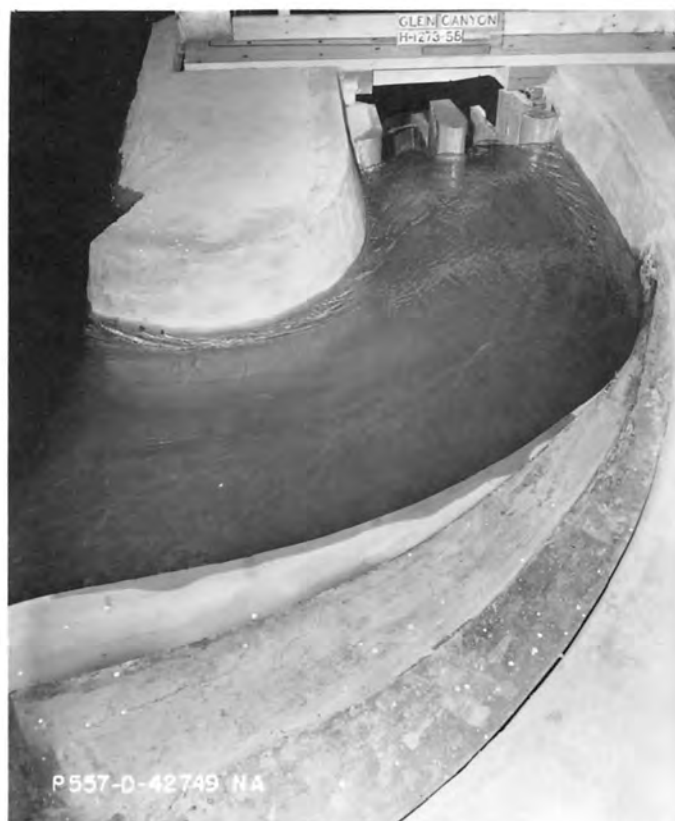
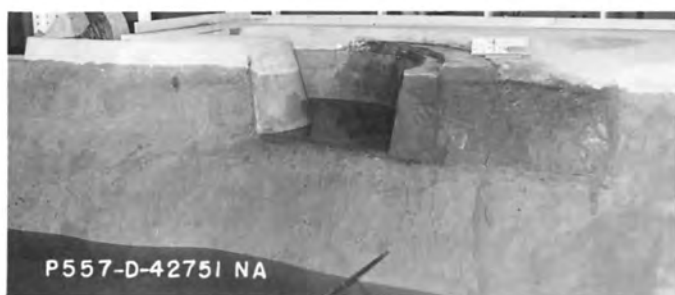
Figure 35
Report Hyd-469

Discharge = 138,000 cfs
Reservoir Elev. 3711.0

1:63.48 Scale Model
Recommended Right Spillway Approach Channel

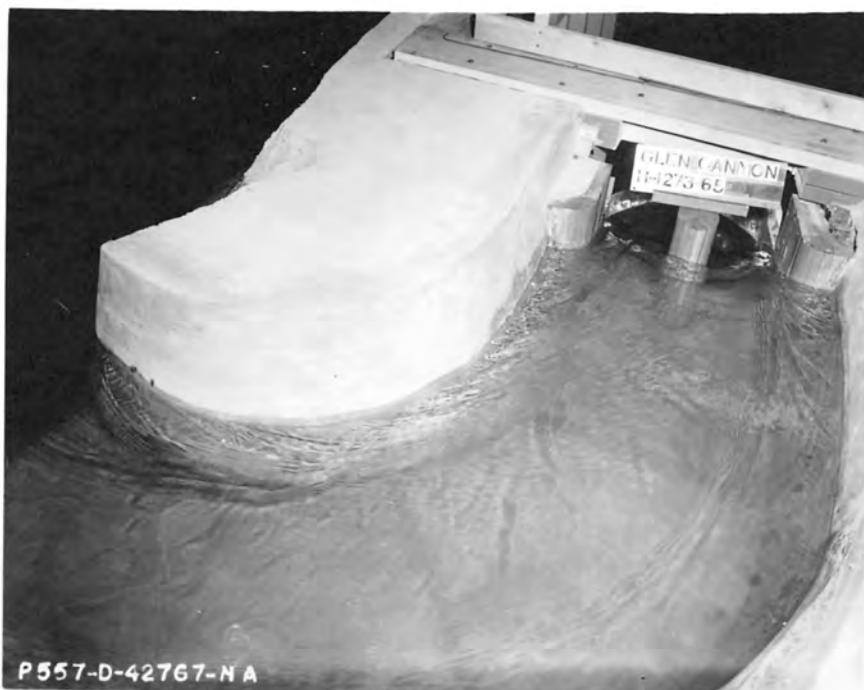
Discharge = 138,000 cfs
Reservoir Elev. = 3711.0

1:63.48 Scale Model
Flow with superelevated floor in
recommended approach channel

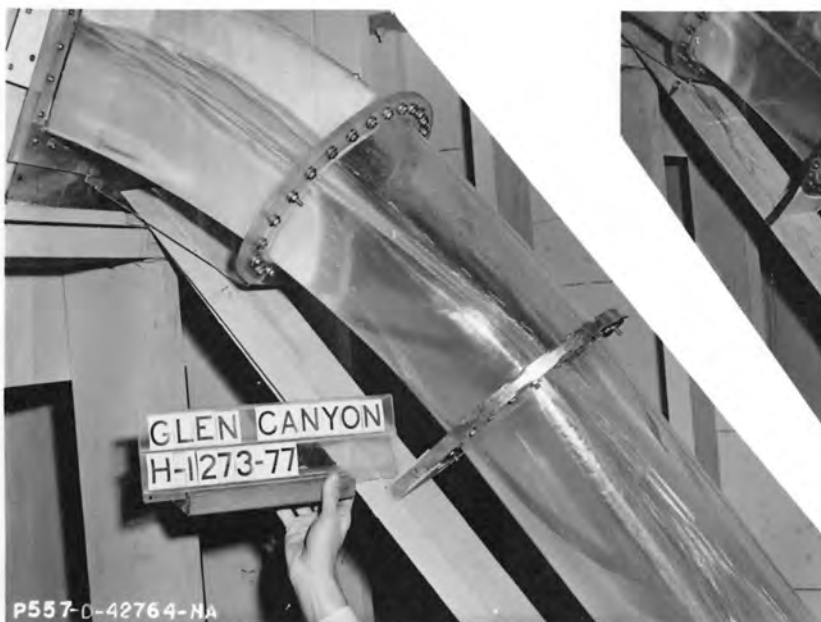
FIGURE 40
REPORT HYD. 469

Flow appearance in transition

No separation

Flow separated from wall

Flow appearance downstream from transition

**1:63.48 Scale Model
Flow Conditions in Preliminary Transition**

In side elevation, the transition invert, spring lines of the upper and lower radii, and the crown of the transition were parabolic curves as shown on Figure 40. In plan, the sides converged in a straight line.

Preliminary. -- In the preliminary layout, 41-foot-wide open channels extended downstream from the transitions terminating in flip buckets. The combined length of the open channel and flip bucket was 251.5 feet in the right tunnel and 280 feet in the left tunnel, Figures 40 and 46. The bottom slopes of the channels were the same as the circular tunnels. The inverts of the flip buckets consisted of segments of a 109.92-foot radius circle. The flip angle of both buckets was 35° above the channel floor, or approximately 35° -12' above the horizontal, Figure 40.

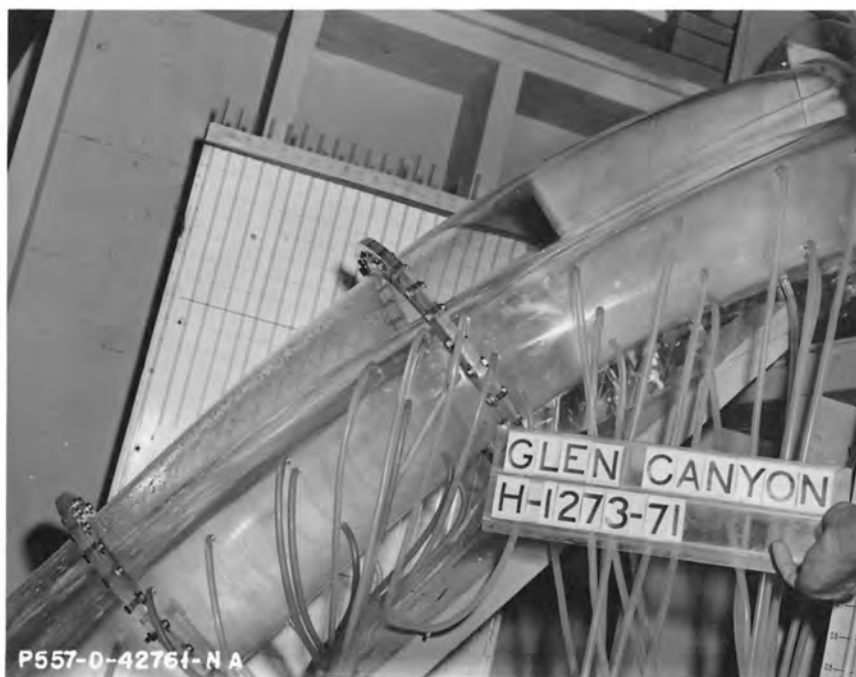
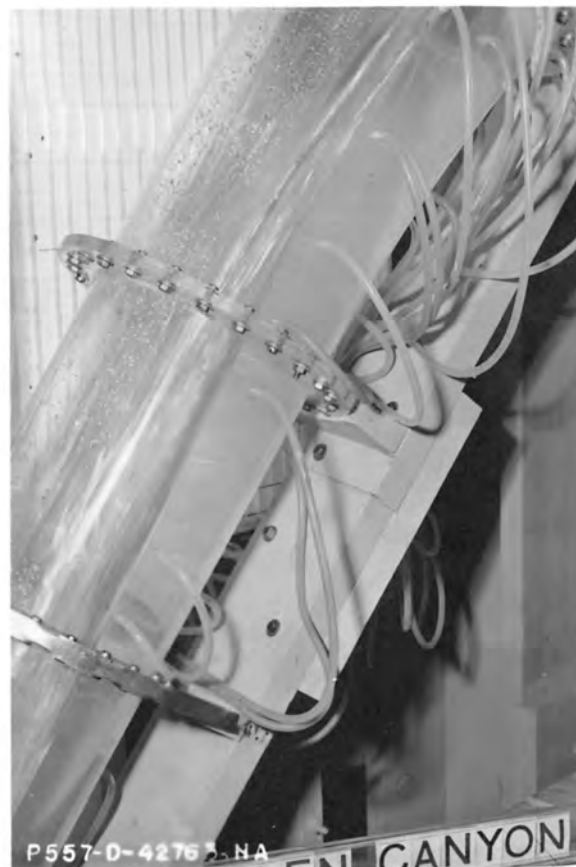
Flow in transition. Note small surface fin.

No separation.

Occasional separation from wall.

Flow Downstream from Transition
GLEN CANYON DAM SPILLWAYS

1:63.48 Scale Model
Flow in Recommended Transition

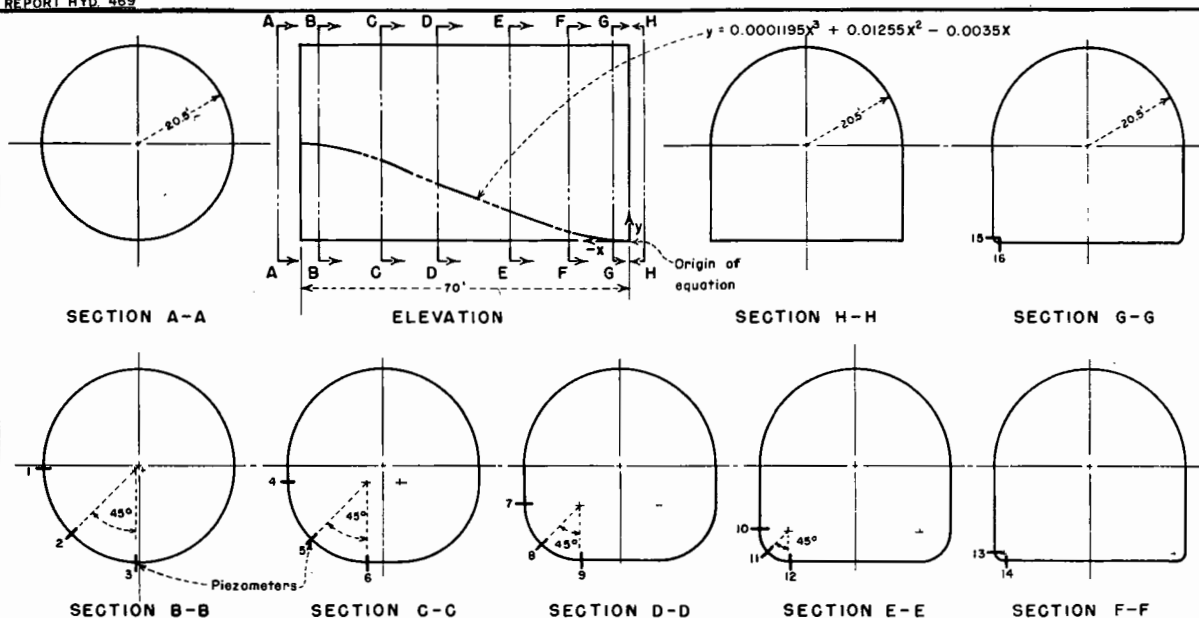
A. PRELIMINARY

PIEZ. NO.	1	2	3	4	5	6	7	8	9	10	11	12	13	14	15	16
PRESSURE	7.5	-24.7	15.2	-4.4	-14.5	15.1	13.9	26.9	40.5	52.6	66.7	64.9	69.9	71.2	64.7	63.7

GLEN CANYON DAM SPILLWAYS
1:63.48 SCALE MODEL
TRANSITION AT DOWNSTREAM TUNNEL PORTAL

A transition was planned for the downstream end of each tunnel to guide the flow from the circular conduit to the rectangular channel between the tunnel portal and the flip bucket. Details of the preliminary transition, which was 70 feet long, are shown in Figure 45A.

The flow appearance in the transition was very good. However, piezometers along the lower corner of the transition indicated subatmospheric pressures in the cavitation range. Piezometers were installed as shown in Figure 45A. The piezometers along the bottom tangent line indicated above atmospheric pressures for the full length. The piezometers along the side tangent line showed above atmospheric pressures at the upstream end of the transition, 4 feet of water below atmospheric about 17 feet downstream from the start, and a steep increase to 13 feet of water above atmospheric at the third piezometer 11 feet farther downstream. The center row of piezometers indicated severe subatmospheric for the first 17 feet, the lowest pressure being 23 feet of water below atmospheric 3.5 feet downstream from the start of the transition. The pressure 29 feet downstream from the start of the transition increased to about 26 feet above atmospheric; pressures remained above atmospheric through the remainder of the transition, Figure 45A.

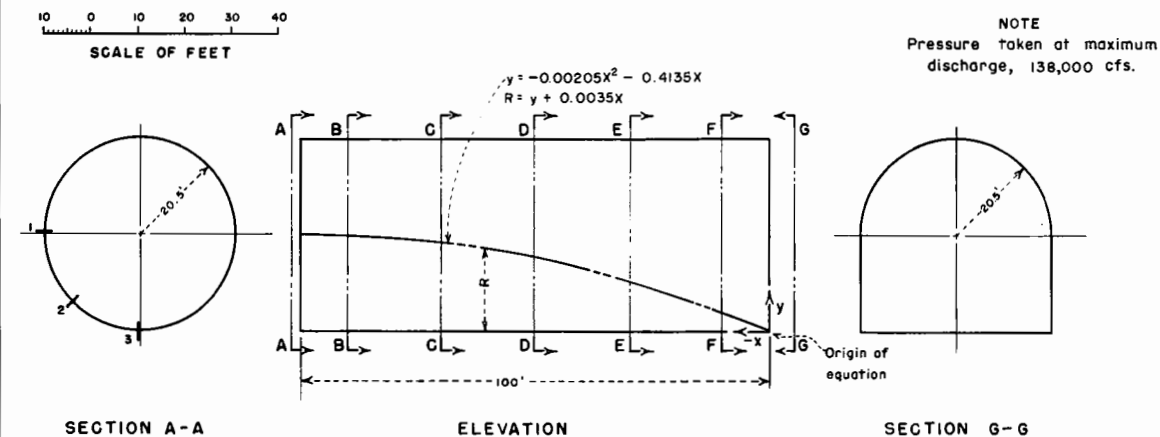
B. REVISED

PIEZ. NO.	1	2	3	4	5	6	7	8	9	10	11	12	13	14	15	16	17	18
PRESSURE	5.8	6.2	22.0	5.5	12.8	16.6	5.7	9.5	18.2	8.0	14.2	28.1	23.6	33.7	41.4	63.6	67.8	66.4

The subatmospheric pressures indicated that the change in cross section in the transition was too abrupt. Accordingly, the transition was modified so that it was 100 feet long with the centers of the radii on each side tracing a parabola, Figure 45B.

The appearance of the flow in the modified transition was excellent. Pressure readings from piezometers in locations similar to those in the preliminary transition were above atmospheric along the full length, Figure 45B. On the basis of these tests, the second transition was considered satisfactory for the field installation. However, during subsequent model investigations of the flip buckets downstream from the transition, it was determined that better bucket performance could be obtained if the semicircular invert of the tunnel was continued downstream and allowed to intercept the upward curve of the flip bucket. This not only provided good

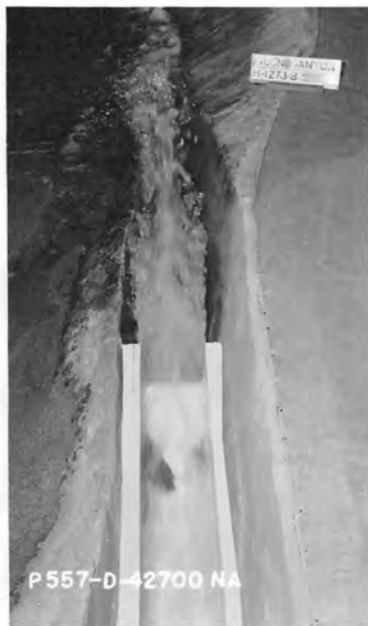
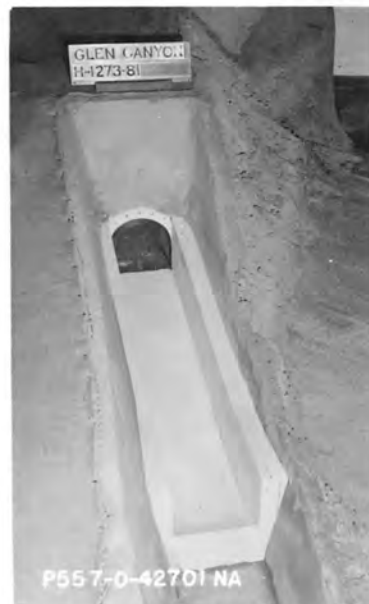
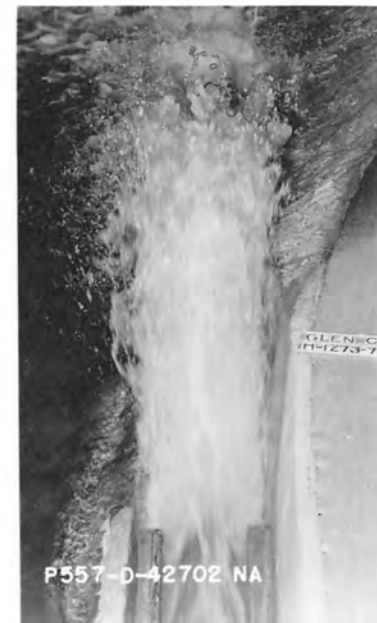
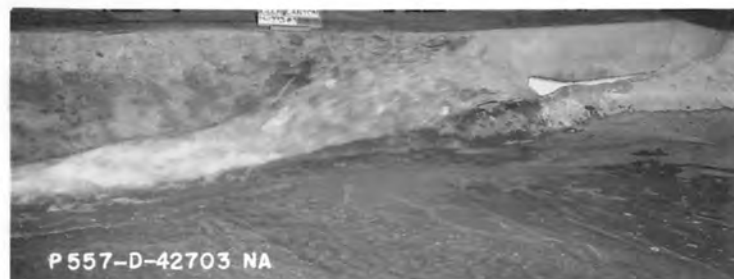
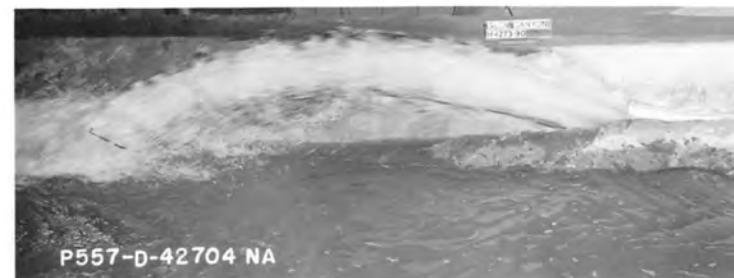
Discharge = 138,000 cfs

GLEN CANYON DAM SPILLWAYS
1:63.48 Scale Model
Flow in Preliminary Left Flip Bucket
