HYDRAULIC MODEL STUDIES OF THE SPILLWAYS
AND OUTLET WORKS--GLEN CANYON DAM
COLORADO RIVER STORAGE PROJECT, ARIZONA

Report No. Hyd-469

Hydraulics Branch
DIVISION OF RESEARCH

February 18, 1964

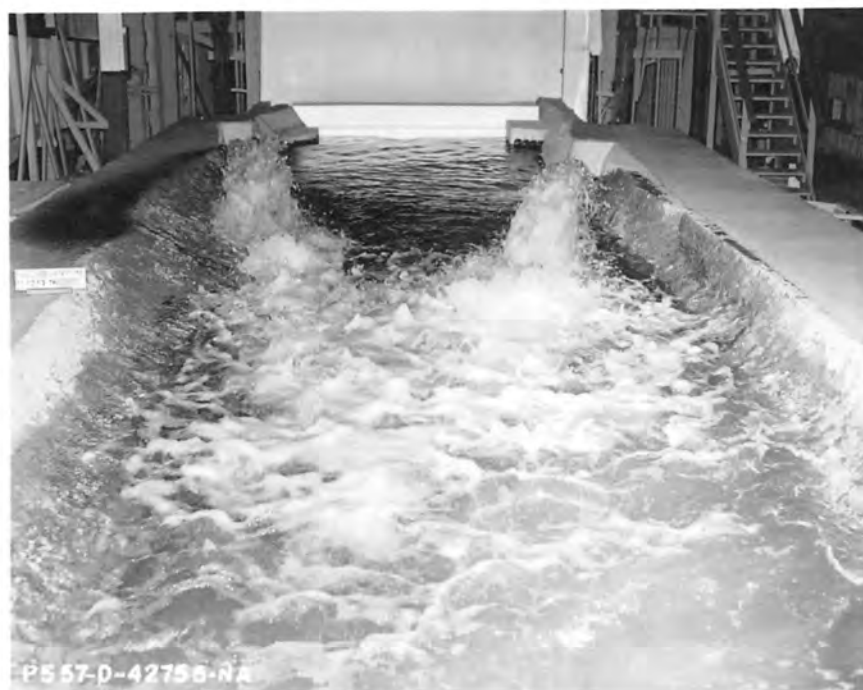
Discharge = 25,000 cfs

Discharge = 138,000 cfs

GLEN CANYON DAM SPILLWAYS
1:63.48 Scale Model
Flow in Preliminary Right Flip Bucket

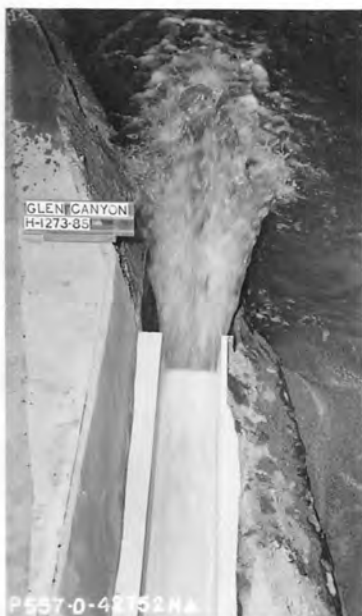
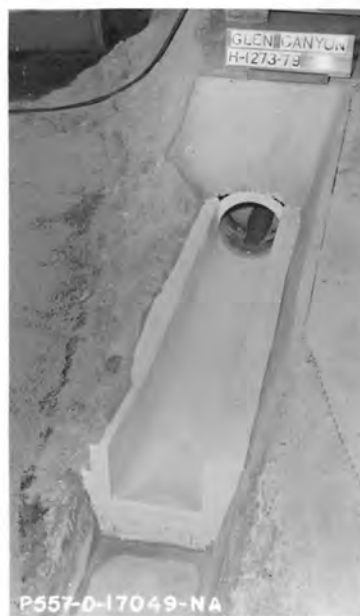
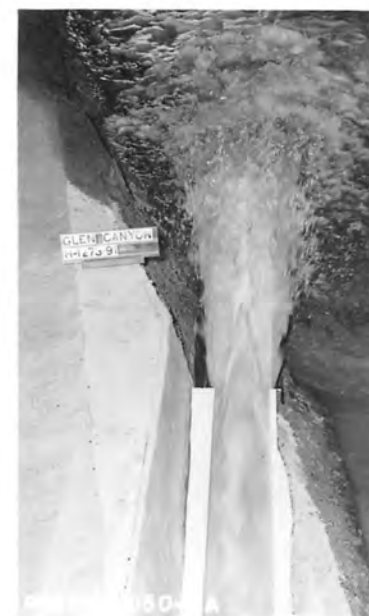
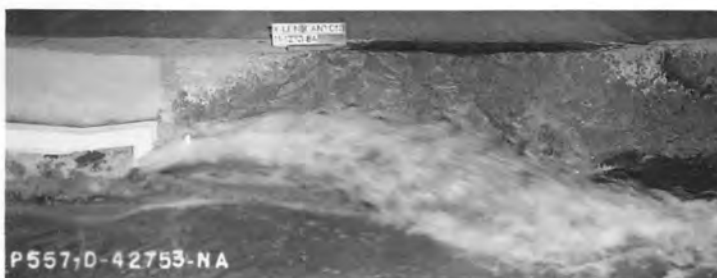
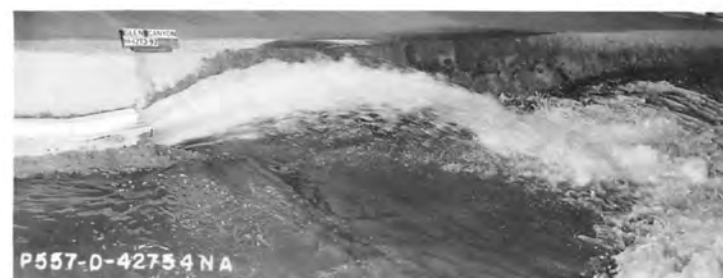
Discharge = 25,000 cfs

Discharge = 138,000 cfs

GLEN CANYON DAM SPILLWAYS
 1:63.48 Scale Model
 Flow in Left Flip Bucket - First Revision

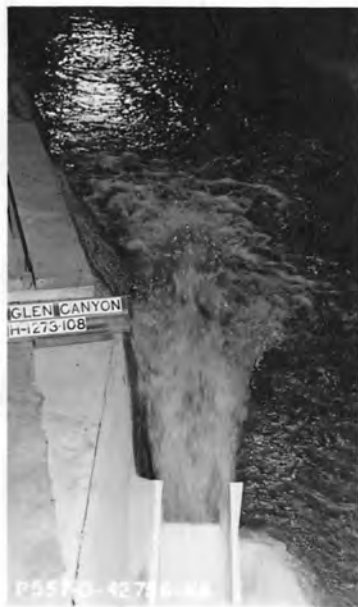
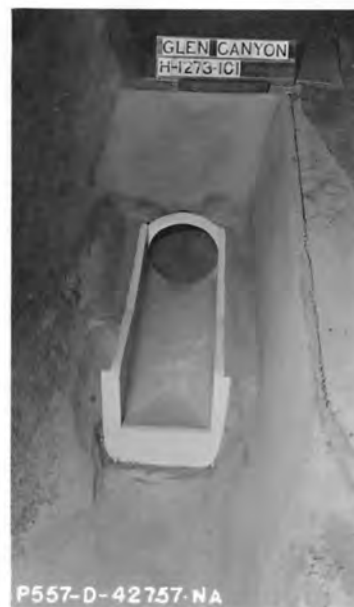
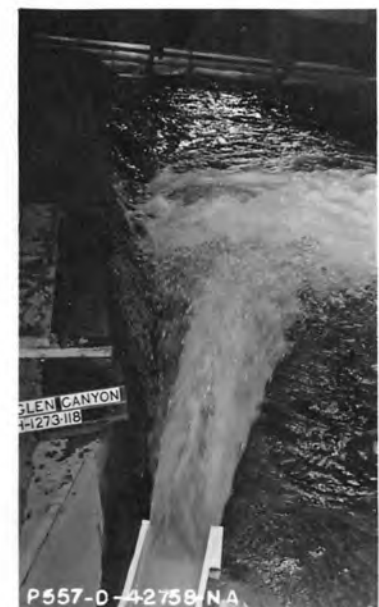
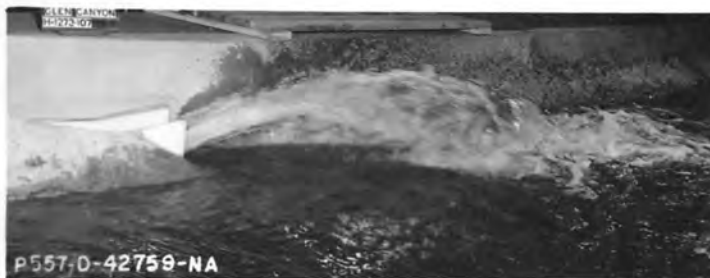
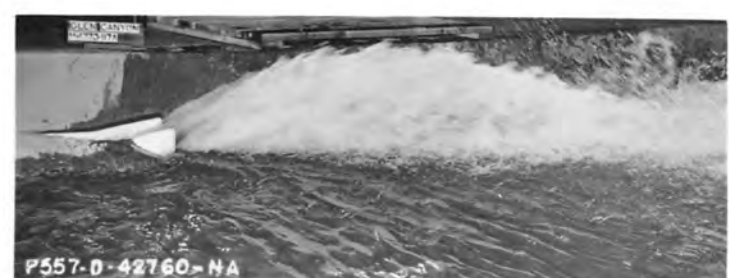
Discharge = 25,000 cfs

Discharge = 138,000 cfs
Jet intermittently depressed by
tailwater surges.

GLEN CANYON DAM SPILLWAYS
1:63.48 Scale Model
Flow in Left Flip Bucket - Second Revision

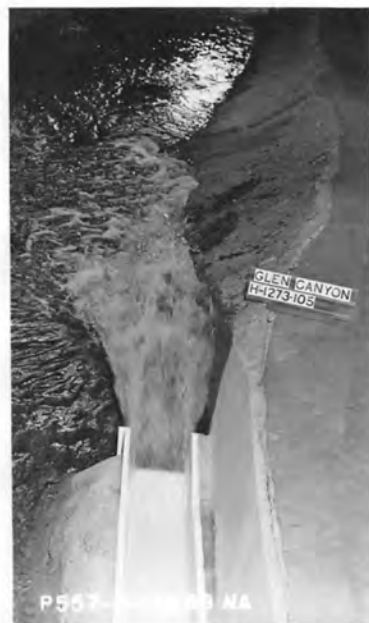
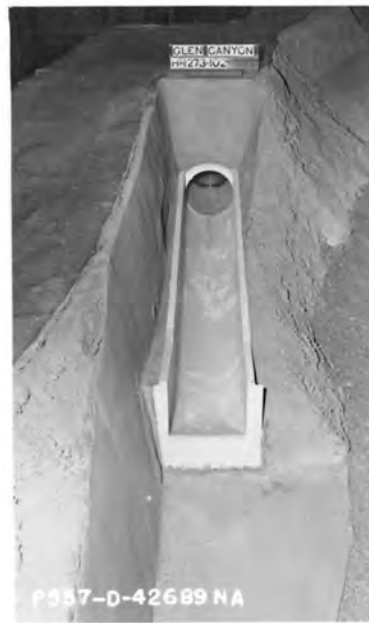
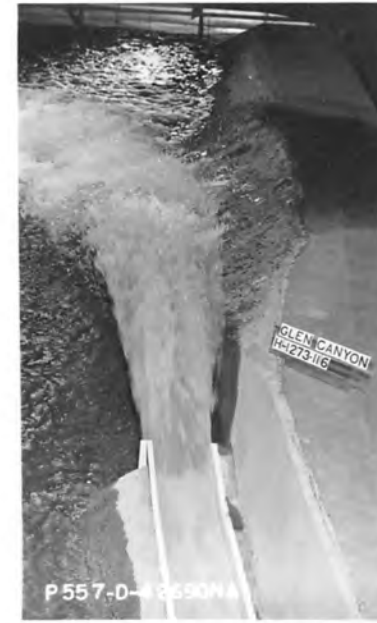
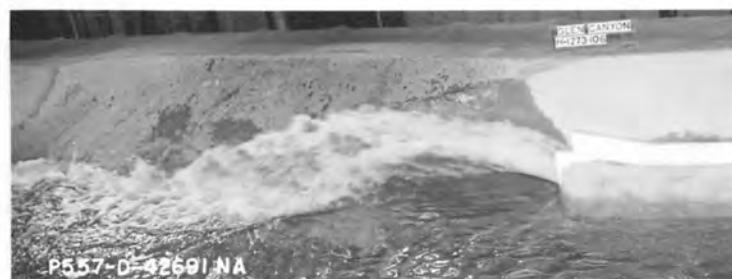
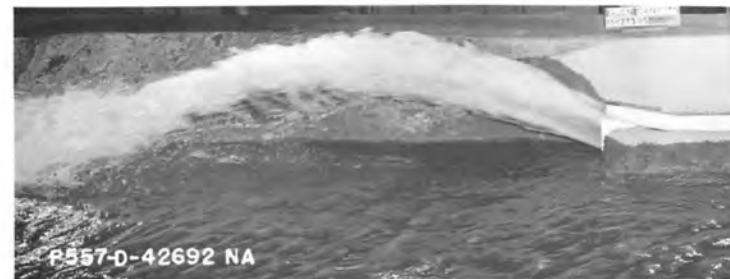
Discharge = 25,000 cfs

Discharge = 138,000 cfs

GLEN CANYON DAM SPILLWAYS
1:63.48 Scale Model
Flow in Right Flip Bucket - Second Revision

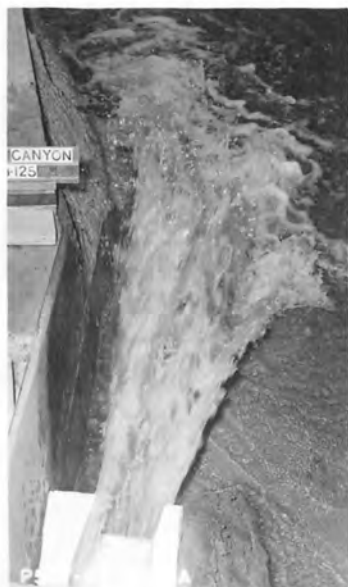
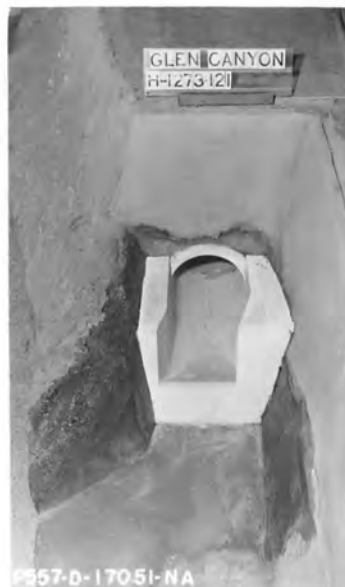
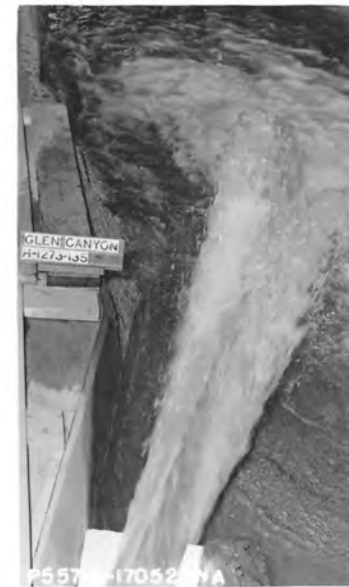
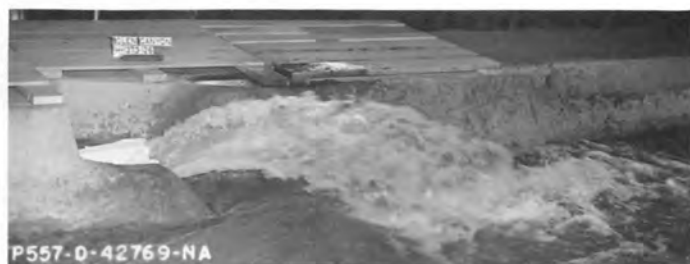
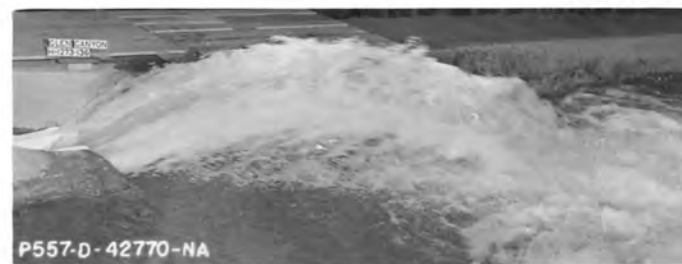
Discharge = 25,000 cfs

Discharge = 138,000 cfs

GLEN CANYON DAM SPILLWAYS
1:63.48 Scale Model
Flow in Left Flip Bucket - Third Revision

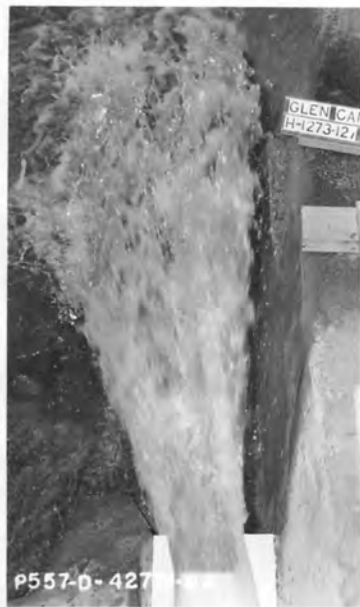
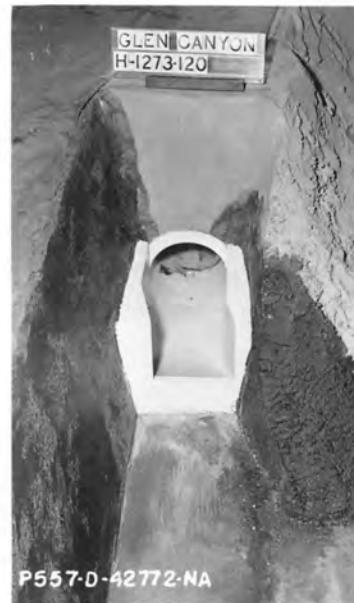
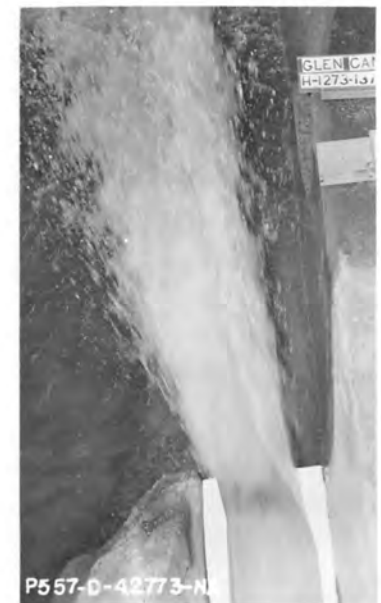
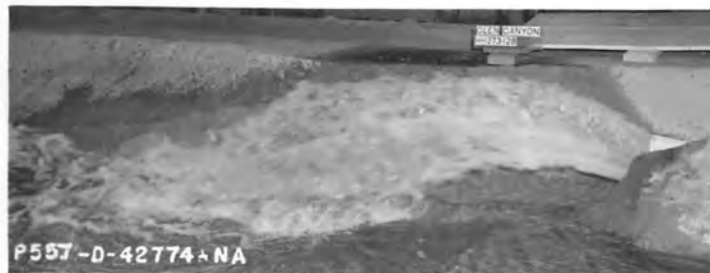
Discharge = 25,000 cfs

Discharge = 138,000 cfs

GLEN CANYON DAM SPILLWAYS
1:63.48 Scale Model
Flow in Right Flip Bucket - Third Revision

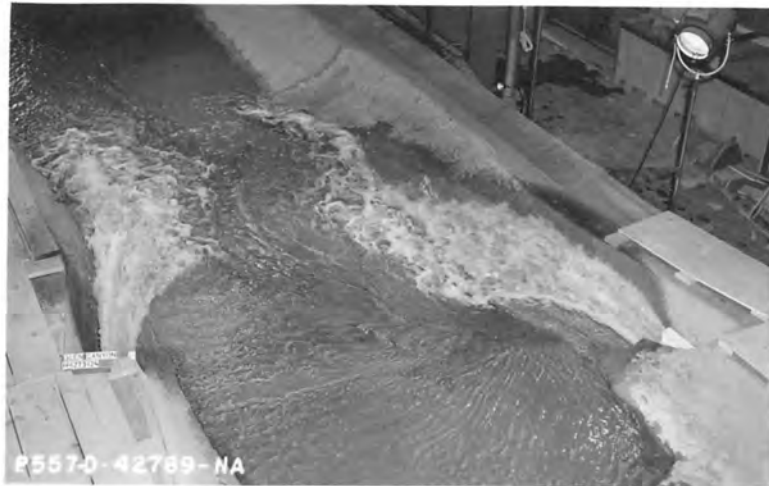
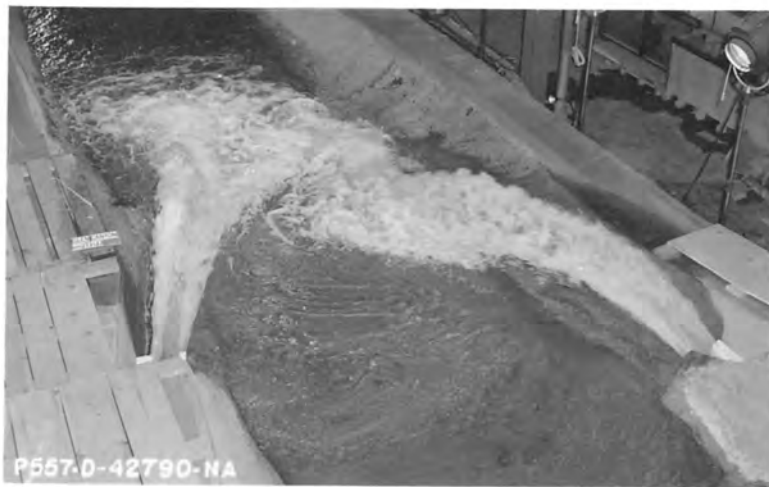
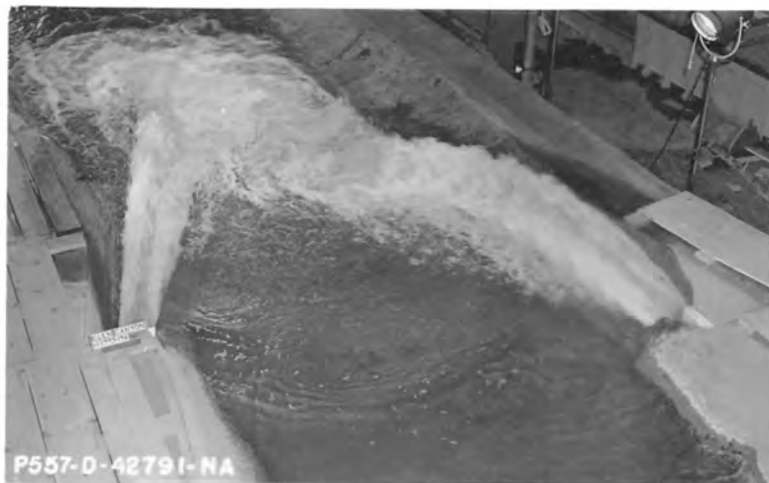
Discharge = 25,000 cfs

Discharge = 75,000 cfs

Discharge = 138,000 cfs

GLEN CANYON DAM SPILLWAYS

1:63.48 Scale Model
Flow from Both Flip Buckets - Third Revision

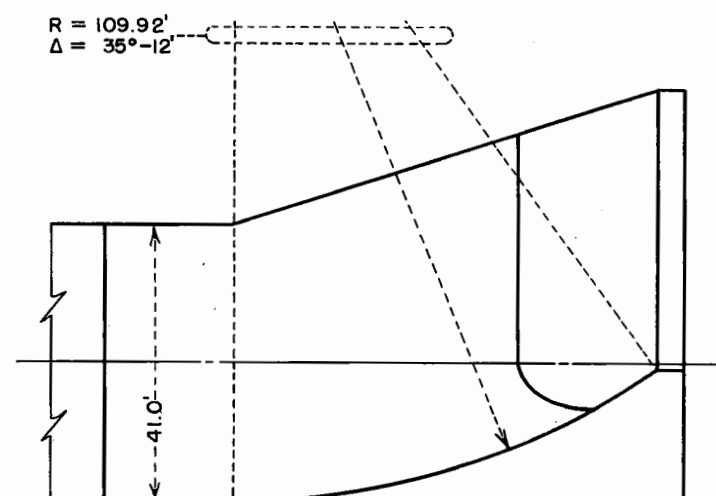
PLAN

SECTION A-A
LEFT HAND BUCKET

SECTION B-B
RIGHT HAND BUCKET

GLEN CANYON DAM SPILLWAYS
1:63.48 SCALE MODEL
FLIP BUCKETS - FOURTH REVISION

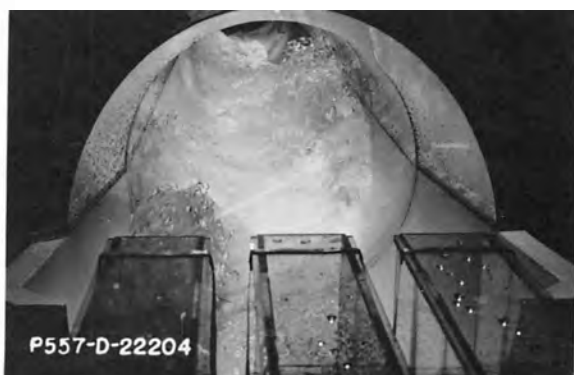
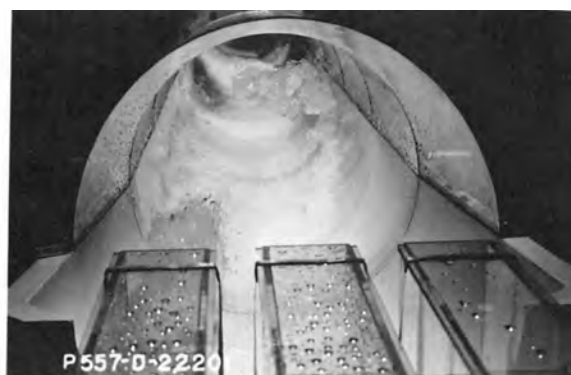
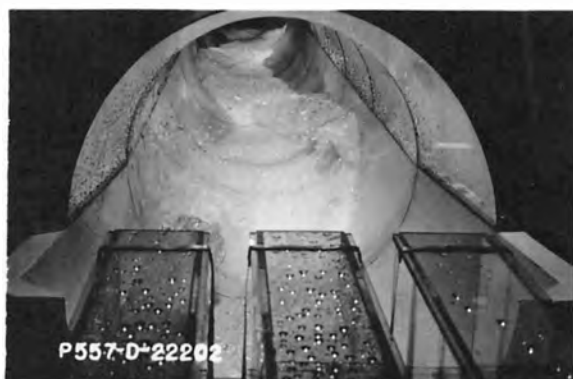
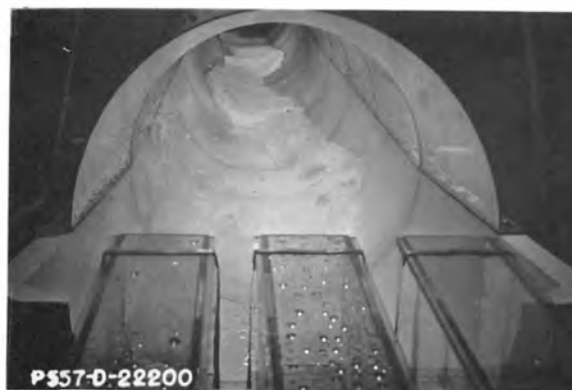
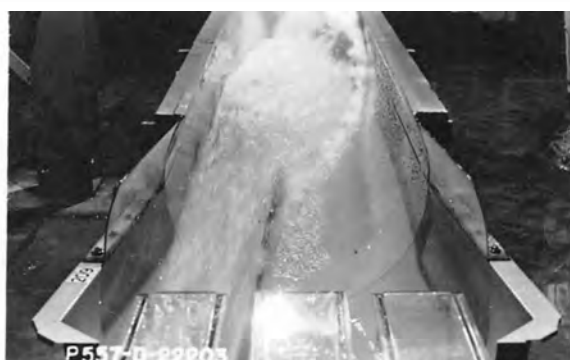
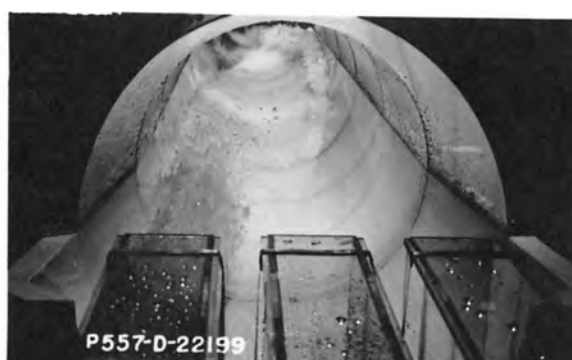
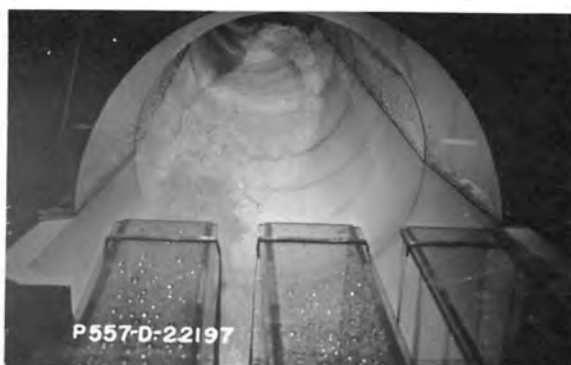
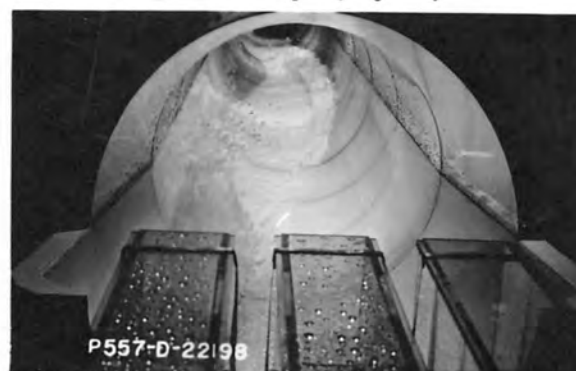
A. 100 Foot Head

B. 350 Foot Head

GLEN CANYON LEFT DIVERSION TUNNEL OUTLET WORKS

Tunnel Flow Conditions With Parallel Conduits - Left Gate Only
1:24 Model

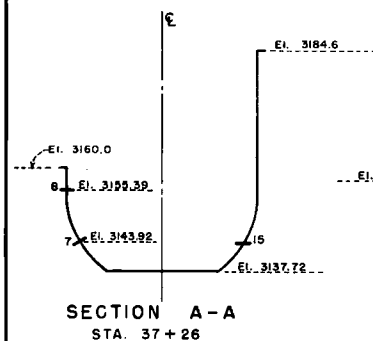
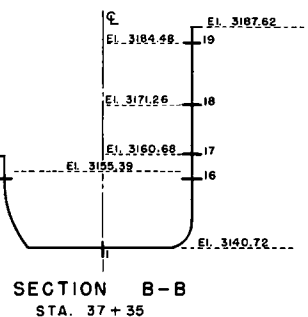
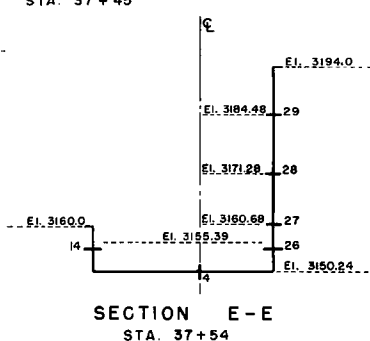
Note: For Details of Bucket
See Figures 60, 61, 62, 63

GLEN CANYON DAM SPILLWAYS

1:63.48 SCALE MODEL

PIEZOMETERS AND PRESSURES IN RECOMMENDED LEFT BUCKET

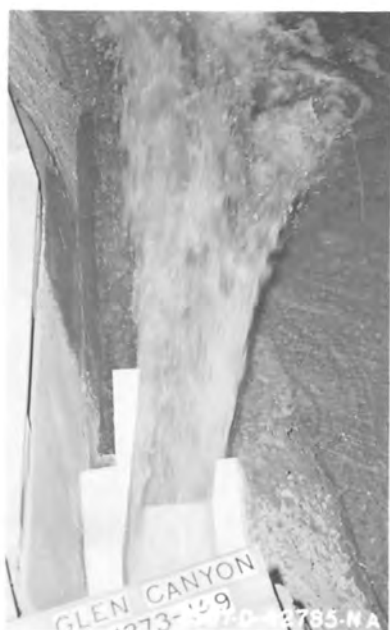
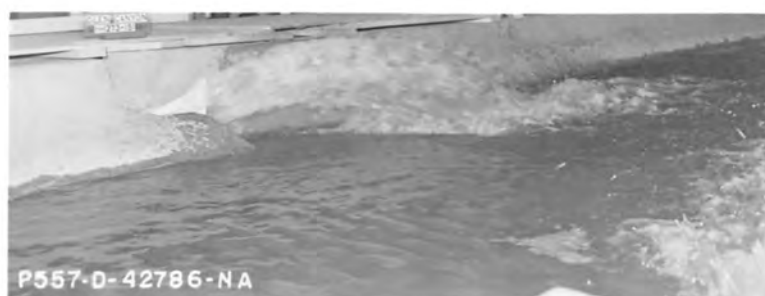
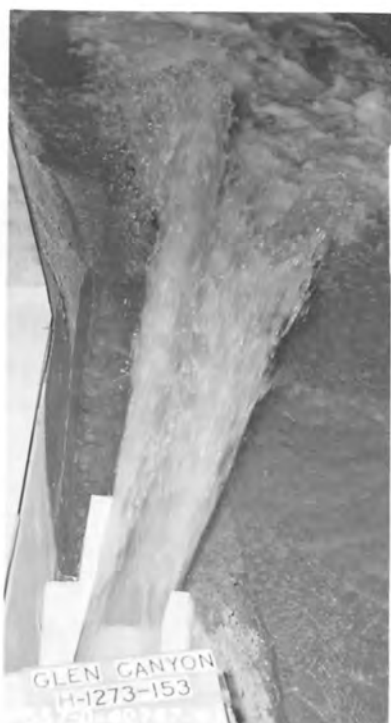
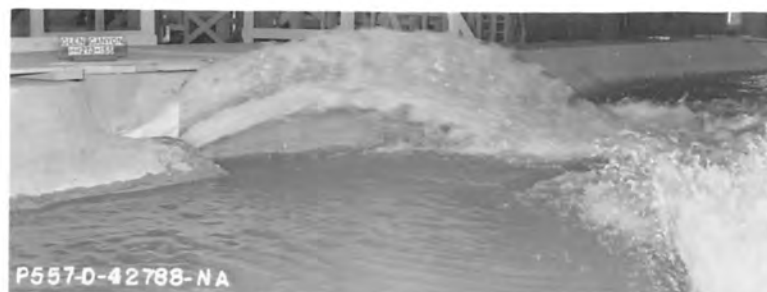
Discharge = 25,000 cfs

Discharge = 75,000 cfs

GLEN CANYON DAM SPILLWAYS

1:63.48 Scale Model
Flow in Recommended Left Flip Bucket

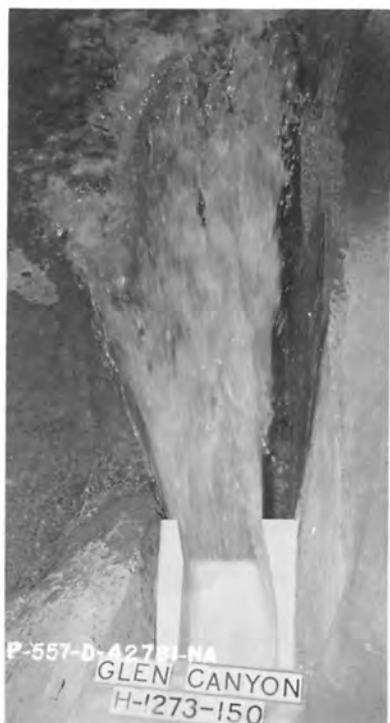
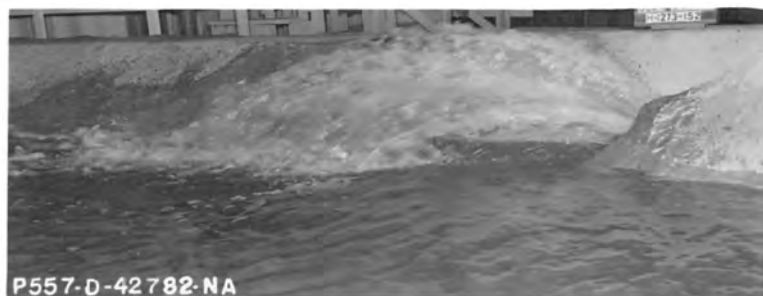
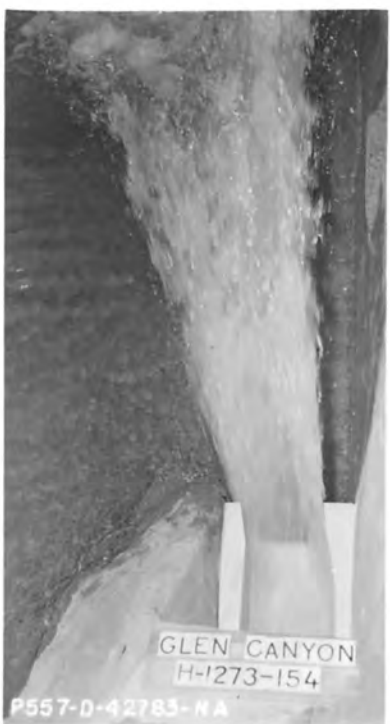
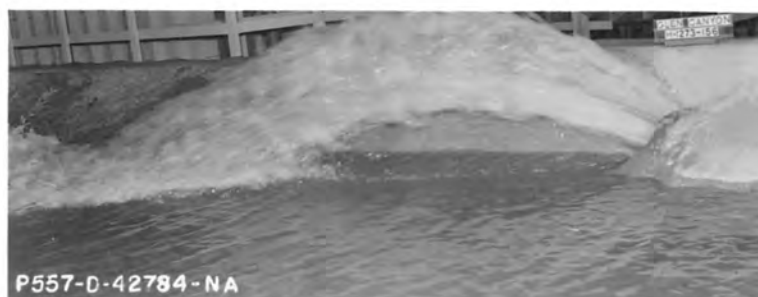
Discharge = 25,000 cfs

Discharge = 75,000 cfs

GLEN CANYON DAM SPILLWAYS

1:63.48 Scale Model
Flow in Recommended Right Flip Bucket

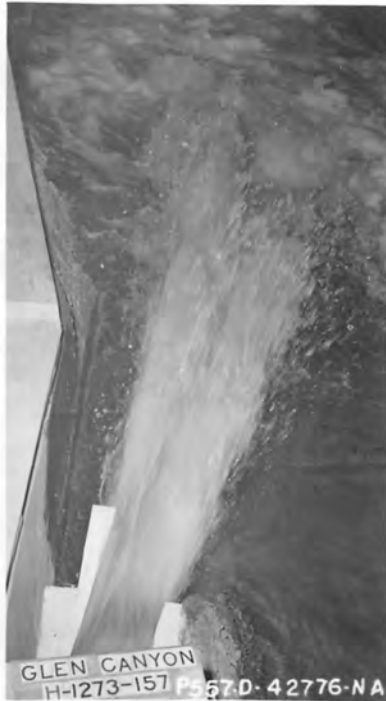
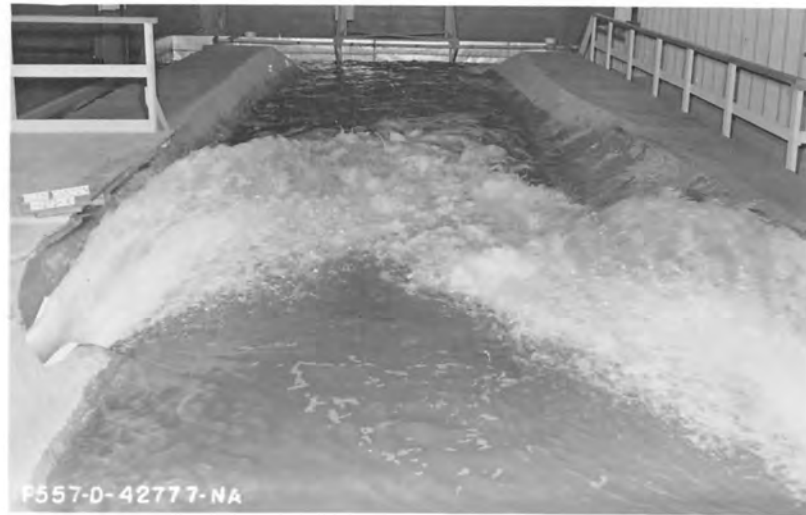
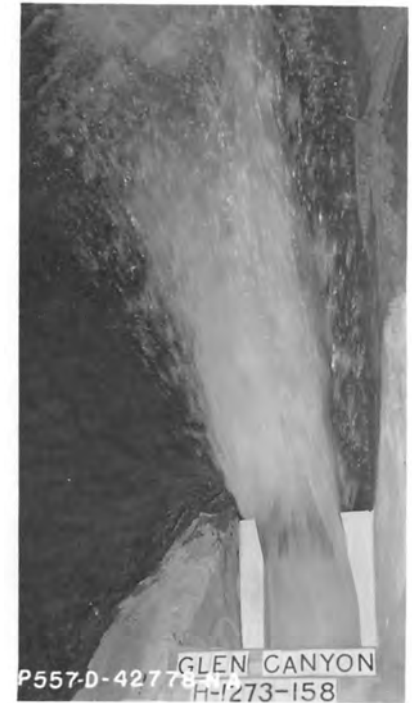
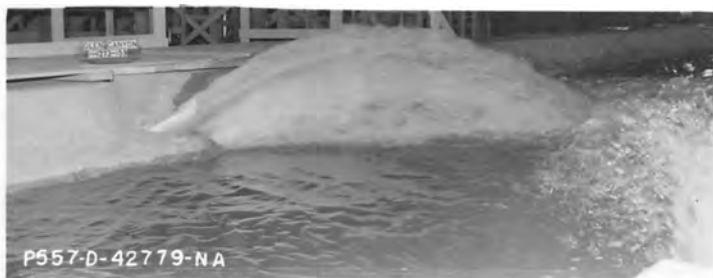
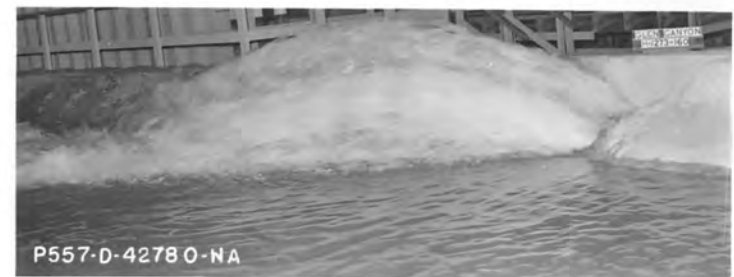
Discharge = 138,000 cfs each bucket
Tailwater Elevation = 3180.0

Left Bucket

Right Bucket

GLEN CANYON DAM SPILLWAYS
1:63.48 Scale Model
Operation of Recommended Flip Buckets
at Maximum Discharge

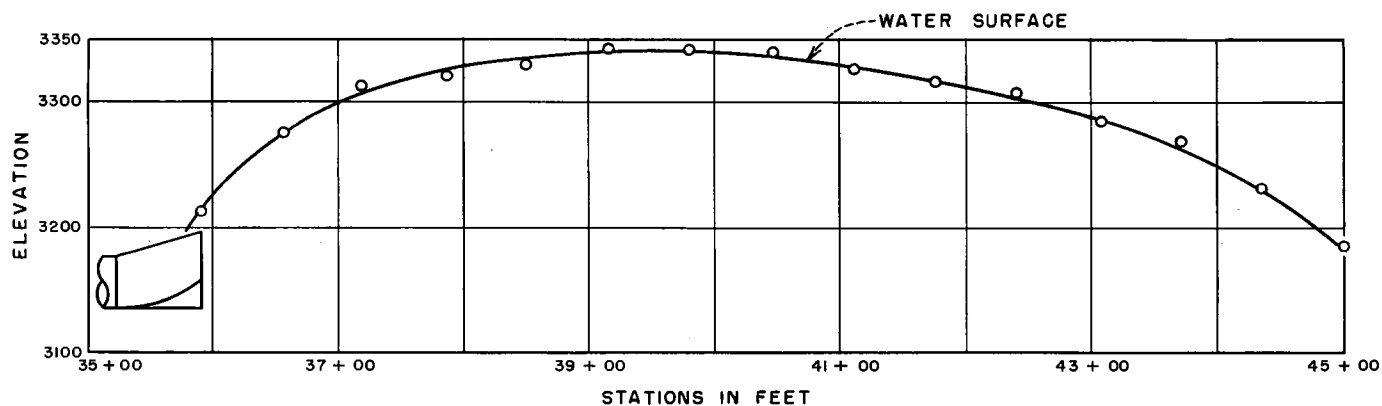
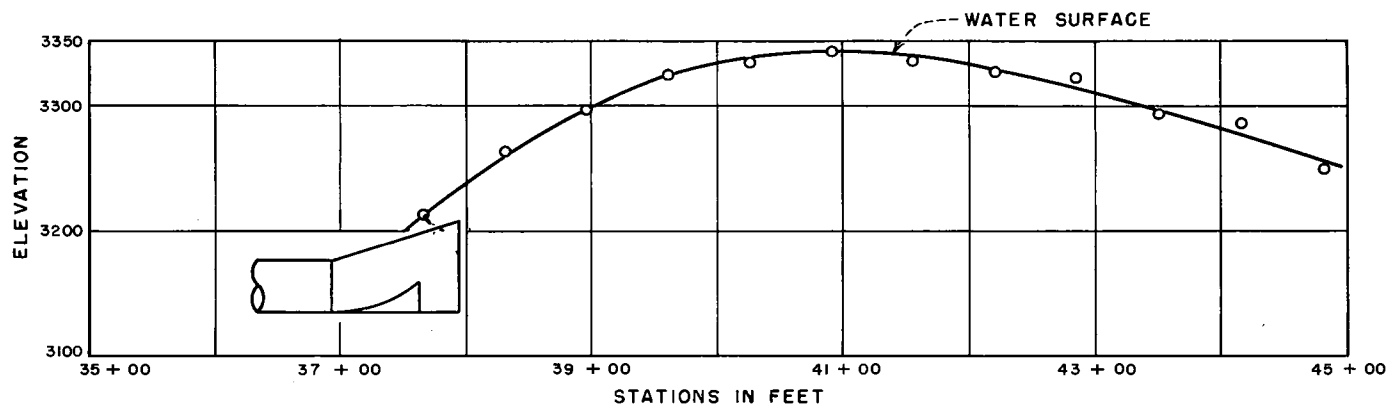
RIGHT SPILLWAY

Note: Profiles taken at maximum discharge, 138,000 c.f.s. each spillway, T.W. elev. 3180.0.

LEFT SPILLWAY

WATER SURFACE PROFILES FROM RECOMMENDED FLIP BUCKETS

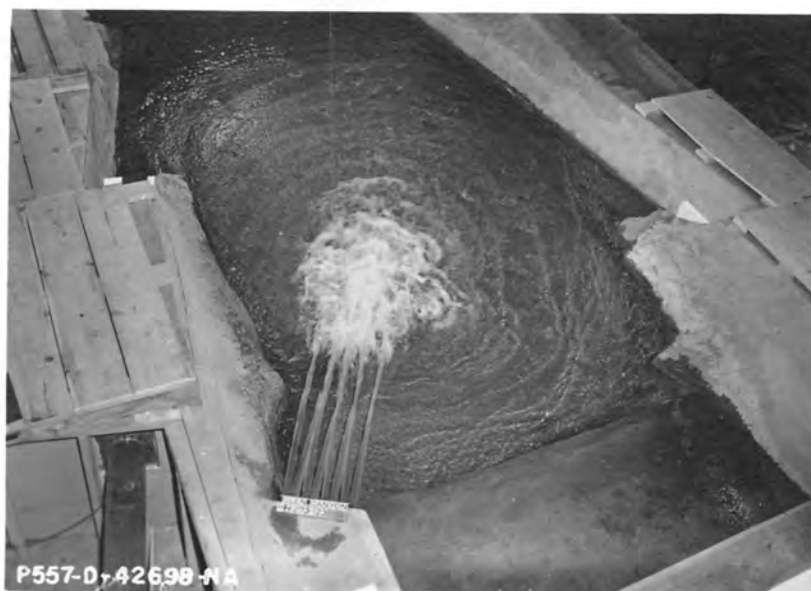
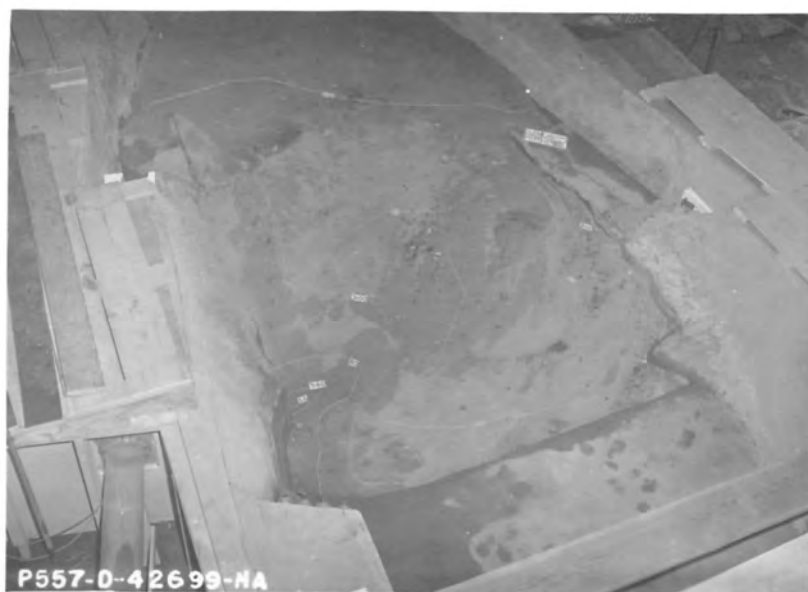
River outlets discharging 15,000 cfs.

Erosion after 3 hours (model time) operation
at 15,000 cfs.

1:63.48 Scale Model
Operation of River Outlets, Preliminary Design

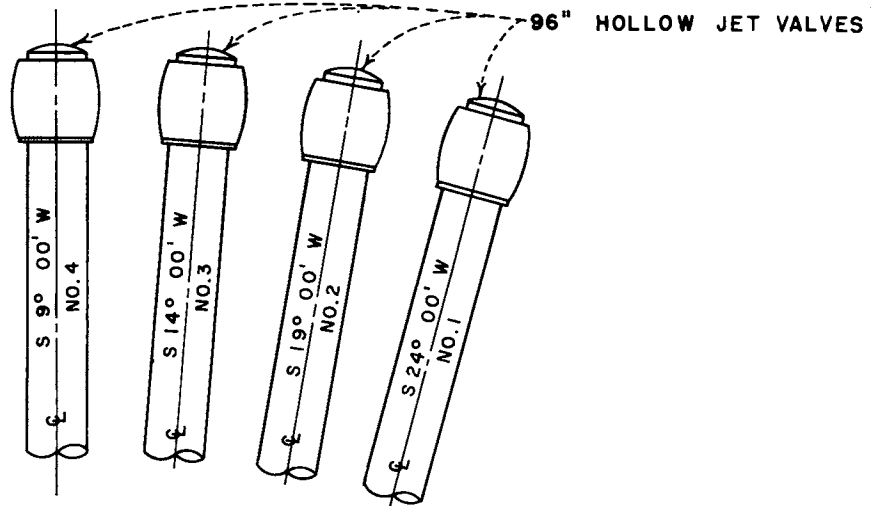
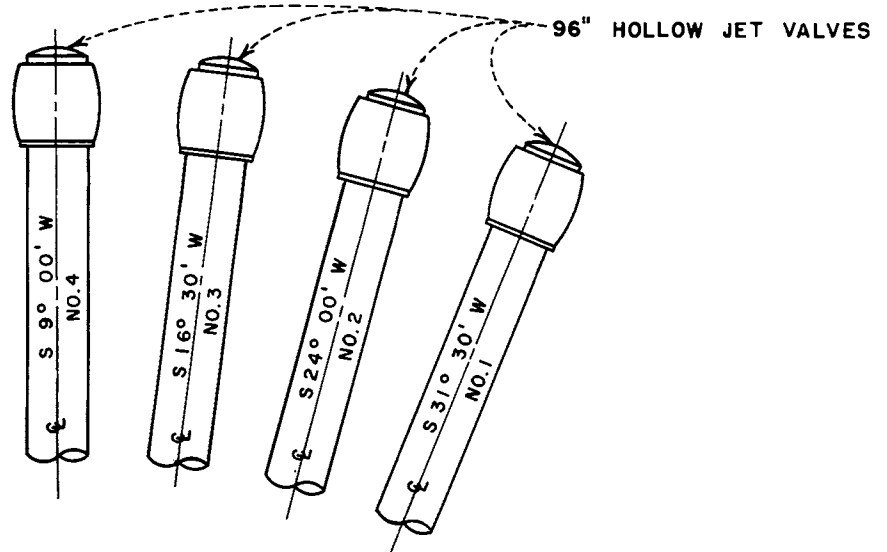
A. FIRST REVISION

B. RECOMMENDED

RIVER OUTLETS-VALVE ALINEMENT

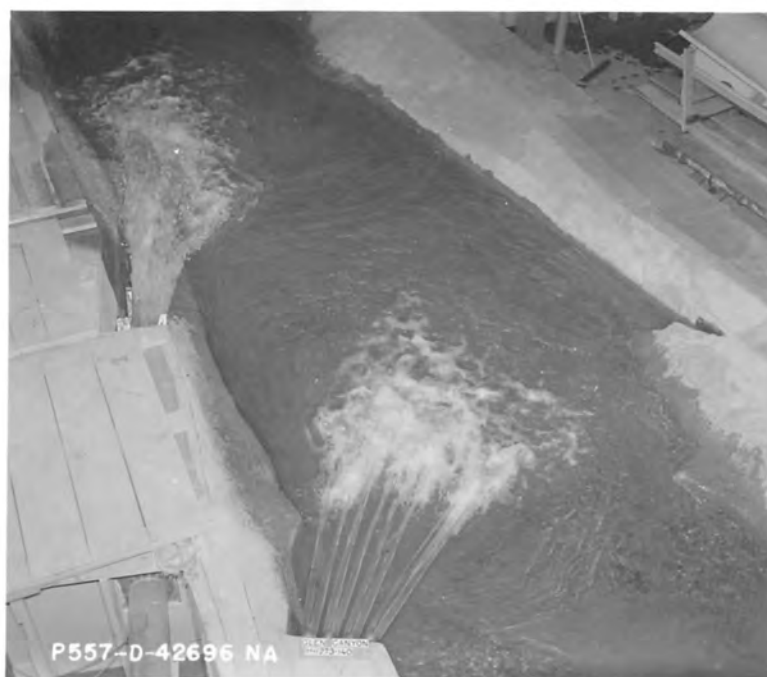
Discharge = 15,000 cfs from River Outlets;
32,000 cfs from T.P.O. W. , 24,000 cfs
through powerhouse.

1:63.48 Scale Model
Operation with Recommended Valve Alinement

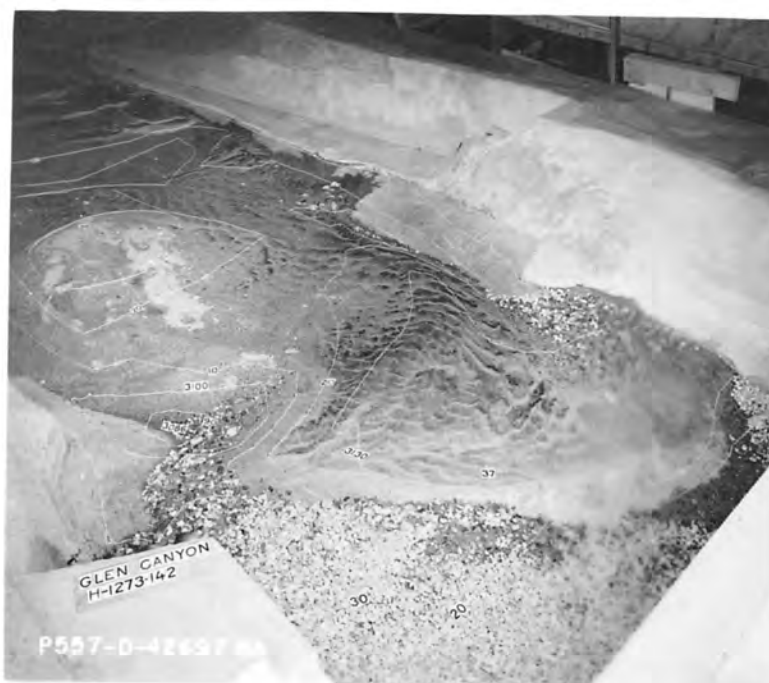
Erosion after 10 hours operation **under**
above flow conditions.

GLEN CANYON DAM SPILLWAYS

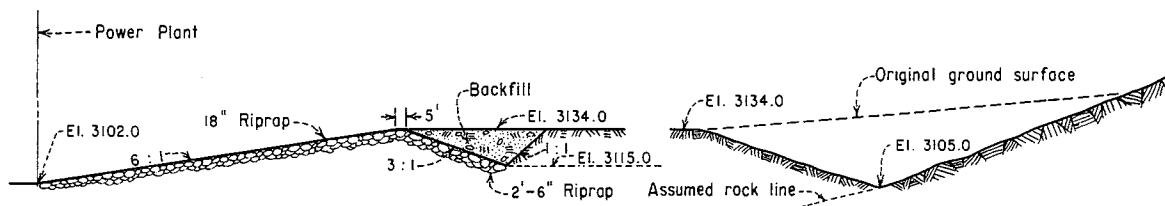
PLAN

SECTION A-A

SECTION B-B

1:63.48 SCALE MODEL

PRE-EXCAVATED AREA IN AFTERBAY

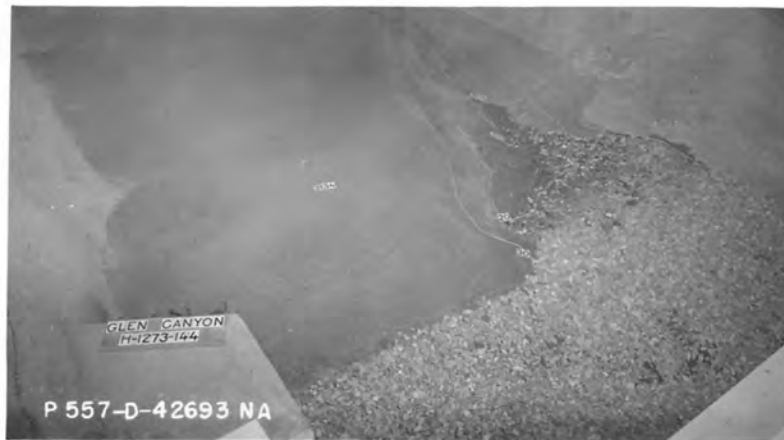
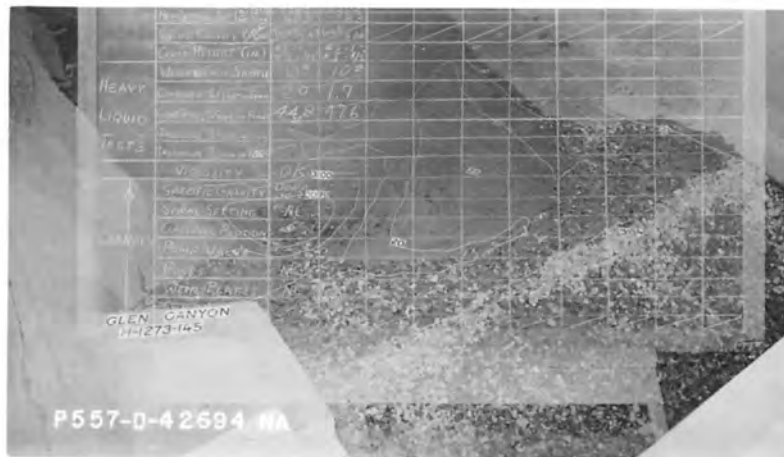
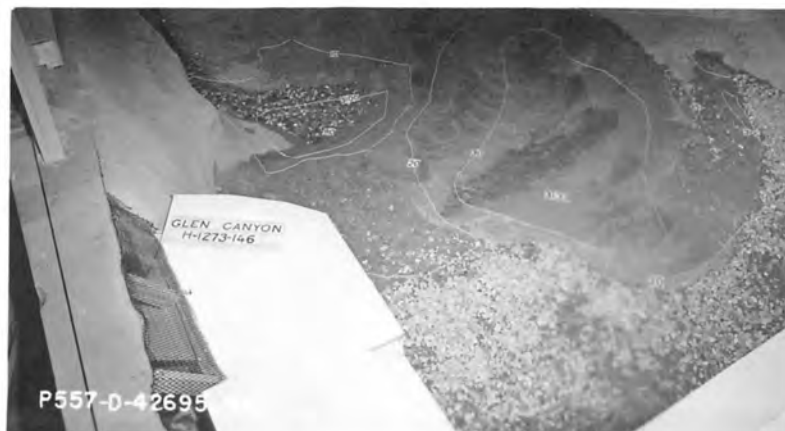
A.

Pre-excavated erosion hole along right bank in powerplant afterbay.

B.

Erosion after 16 hours operation, 24,000 cfs thru powerplant, 15,000 cfs thru river outlets, 32,000 cfs thru left spillway. No sand moved into afterbay.

C.

Erosion after 7 hours operation. Valves 3 and 4 discharging 7,500 cfs, 24,000 cfs thru powerplant. 32,000 cfs thru left spillway. About 5,000 yards of material moved into afterbay.

GLEN CANYON DAM SPILLWAYS

1:63.48 Model Studies
Results of Erosion Studies in Powerplant Afterbay

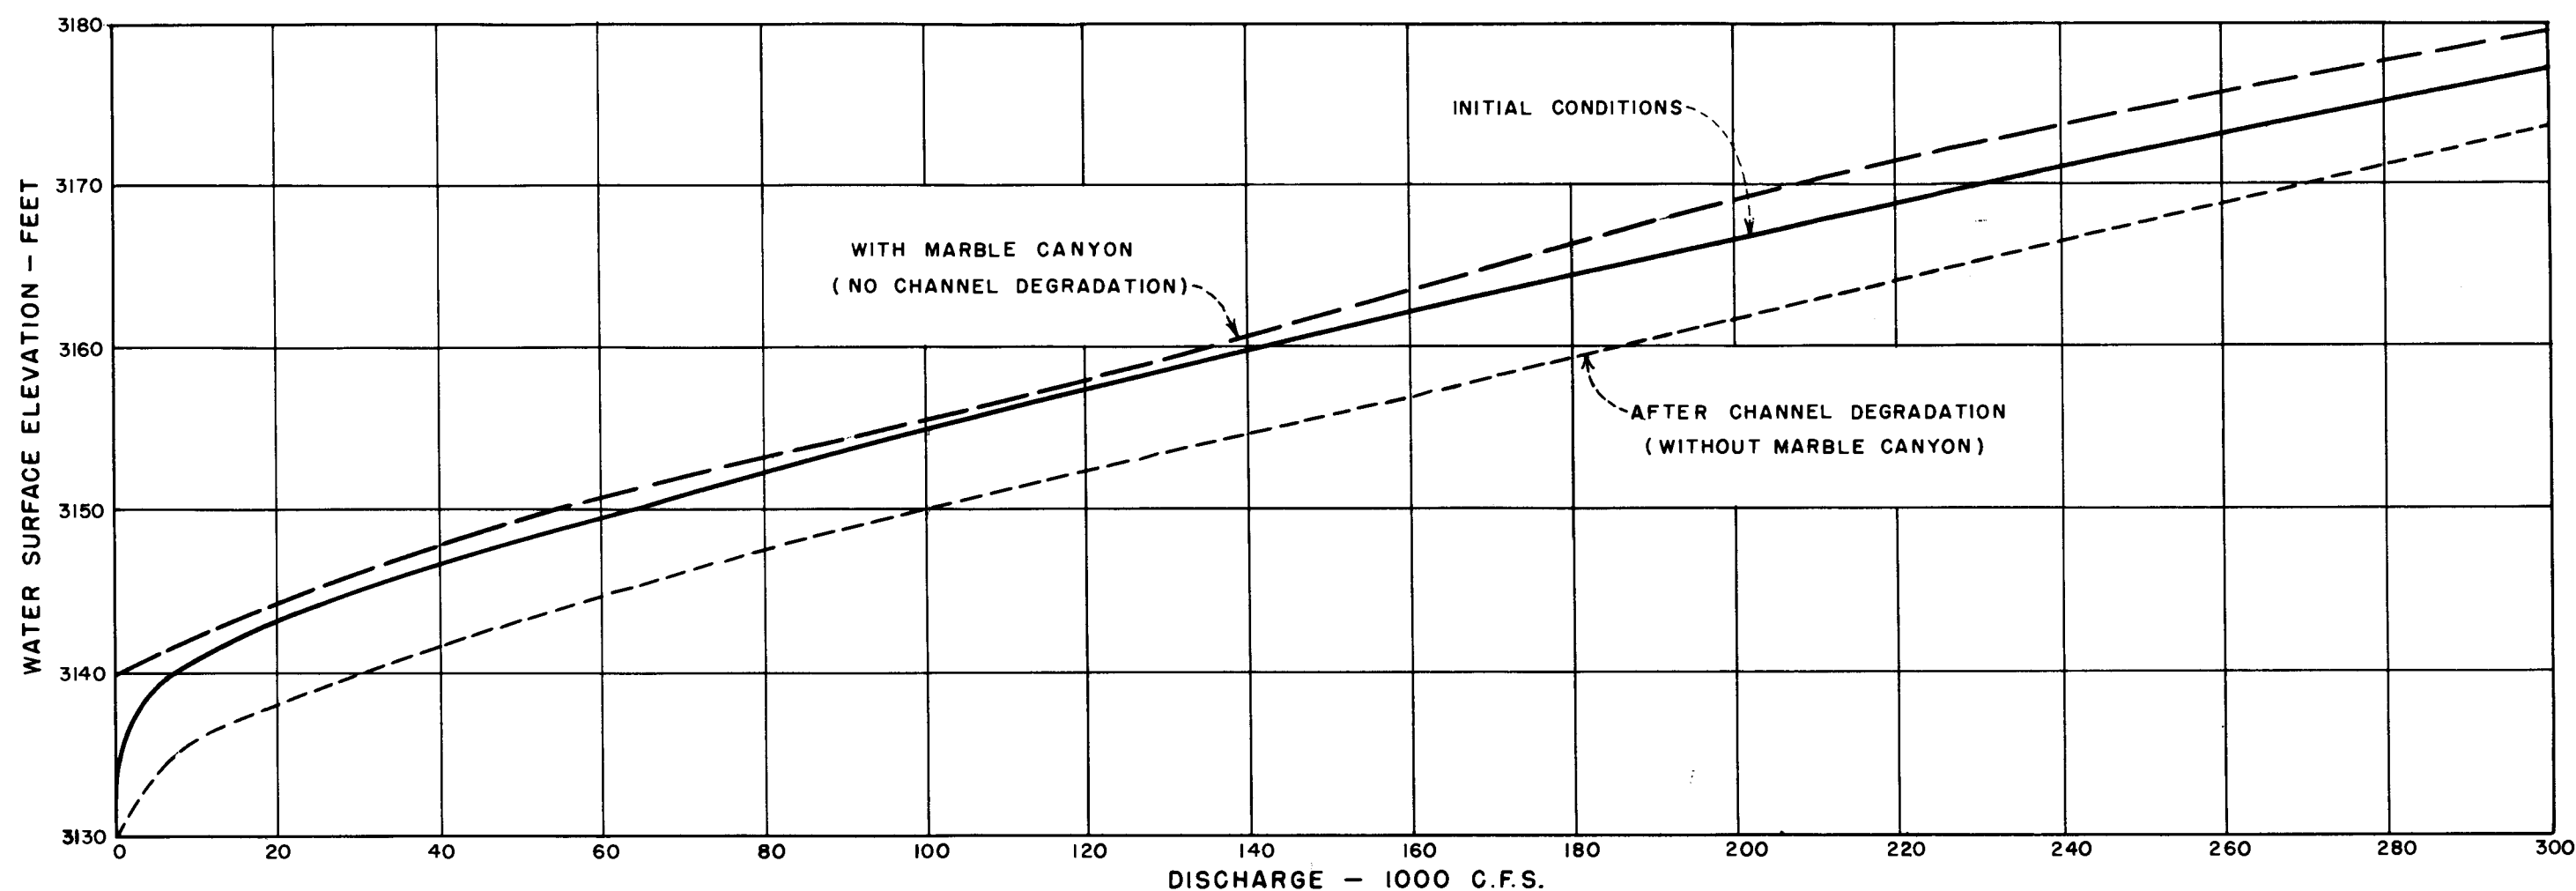
1. Condition with Marble Canyon built considers Marble Canyon W.S. at the dam at elev. 3145 at 280,000 c.f.s. — elev. 3143 at 200,000 c.f.s. and elev. 3140 at 100,000 c.f.s. and under.
2. Channel degradation based on removal of sands overlying gravels.
3. Condition with Marble Canyon is approx. same with as without channel degradation. Also assumes that sediment retention will be provided on Paria River.

TAILWATER CURVES
COLORADO RIVER
R-20
(APPROX. 3400 FT. BELOW DAM AXIS)
Prepared in Hydrology Branch, Denver
