HYDRAULIC MODEL STUDIES OF THE SPILLWAYS
AND OUTLET WORKS--GLEN CANYON DAM
COLORADO RIVER STORAGE PROJECT, ARIZONA

Report No. Hyd-469

Hydraulics Branch
DIVISION OF RESEARCH

February 18, 1964

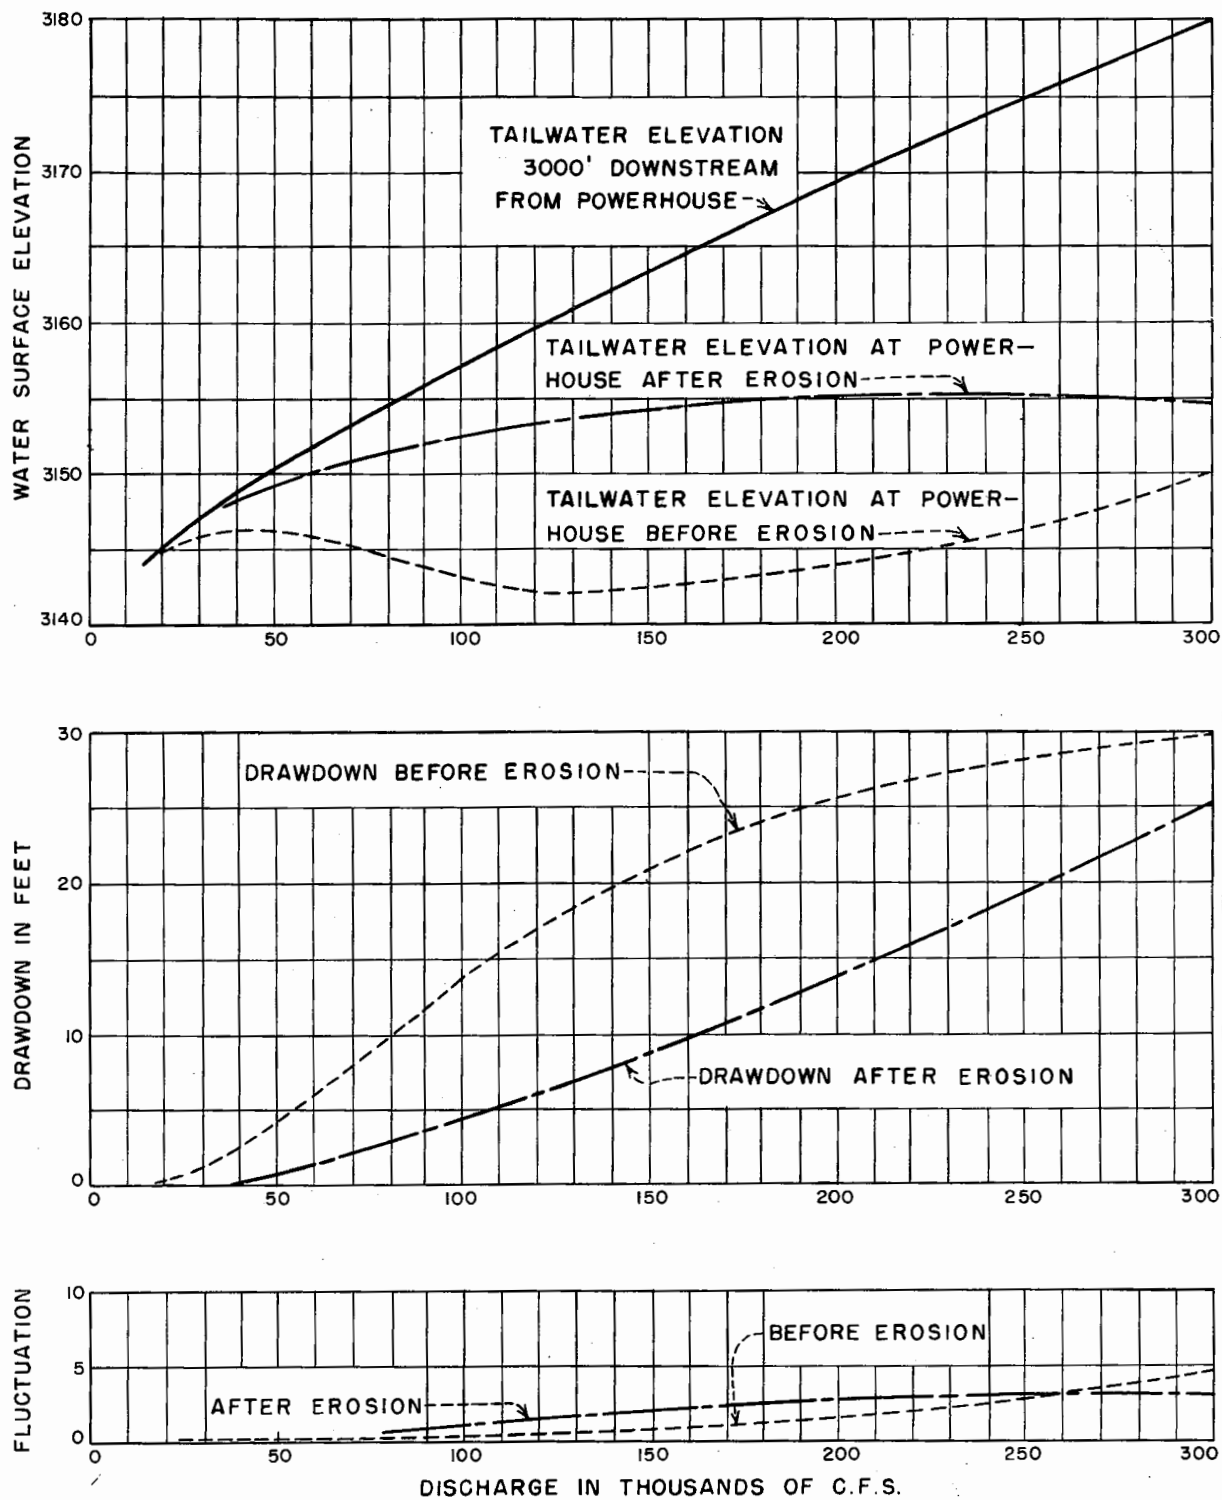
FIGURE 77
REPORT NO. 222

GLEN CANYON DAM SPILLWAYS
1:63.48 SCALE MODEL
WATER SURFACE DRAWDOWN TESTS

18. Uplift pressures on the tailrace concrete slab were found to be 3 feet of water or less, Figure 77.

of 8 minutes (all values are prototype), ultimately discharging 15,000 cfs, giving a total flow of 39,000 cfs. Operation was continued at this flow for about 7 hours. The recorded water surface profiles with respect to time, Figure 77, showed that at Stations 1 and 2 the water surface dropped about 1 foot in the first 45 minutes, dropped another foot in the next 75 minutes, and stable for the remainder of the test. The water surface at Station 3 dropped 1 foot before the valves were fully opened, increased to the original elevation during the ensuing 15 minutes, then gradually dropped about 5 feet during the next 200 minutes, and then fluctuated between 4 and 5 feet for the remainder of the test. The water surface at Station 4 dropped 3 feet as the valves were opening, recovered about 1-1/2 feet during the next 10 minutes, then gradually dropped about 3-1/2 feet over the ensuing 60 minutes, at which time the measuring device became inoperative due to a sandbar that formed directly under it. The water surface at Station 5 raised 1 foot during the time the valves were being opened, then remained constant for the duration of the test, which represented the normal rise in tailwater elevation for this increase in discharge. This test showed that for this operating condition, the most critical period for uplift would be while the valves were being opened and the drop in the water surface at the end of the apron would be about 2 feet.

The water surface profiles, Figure 77, indicated that the water level at Station 1 rose less than 1 foot in the first hour and then remained constant until the spillway flow ceased. At Stations 2, 3, and 4 the water level rose 1-1/2 feet in the first hour, remained constant until the spillway flow increased to 30,000 cfs, then dropped about 0.25 foot and remained constant until the spillway gates were closed. The water surface level at Station 5 increased 1.5 feet as the spillway discharge increased to 15,000 cfs, remained constant until the spillway flow was increased to 30,000 cfs when the water level raised an additional 1.5 feet. The water level at Station 5 dropped as the spillway flow was shut off.

The recorded water surface profiles, Figure 77, showed that the water level at Stations 1 through 4 would increase about 1 foot as the spillway flow increased. When the spillway flow reached 29,500 cfs, the water level slowly dropped about 1.5 feet over a period of 45 minutes. When the powerhouse flow was shut off, the water level at Stations 1 through 4 dropped about 4 feet in a period of 10 minutes. The water level was stable at these stations until the river outlets were opened. As the river outlets were opened, the water level dropped 2 feet at Stations 1 and 2 and 5 feet at Stations 3 and 4. During the first 25 minutes of the river outlet operation, the water level rose about 1.5 feet at Stations 1 and 2 and 2.5 feet at Stations 3 and 4. When the river outlets were closed, the water level rose about 2.5 to 3.5 feet. The water level at Station 5 increased 3 feet as the spillway flow increased, dropped 2 feet when the powerplant was closed, and rose 1.5 feet when the river outlets were opened.

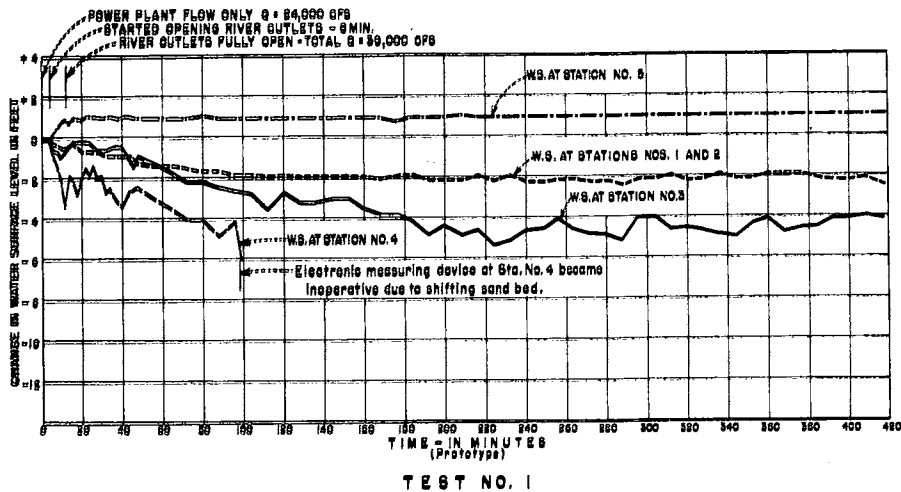
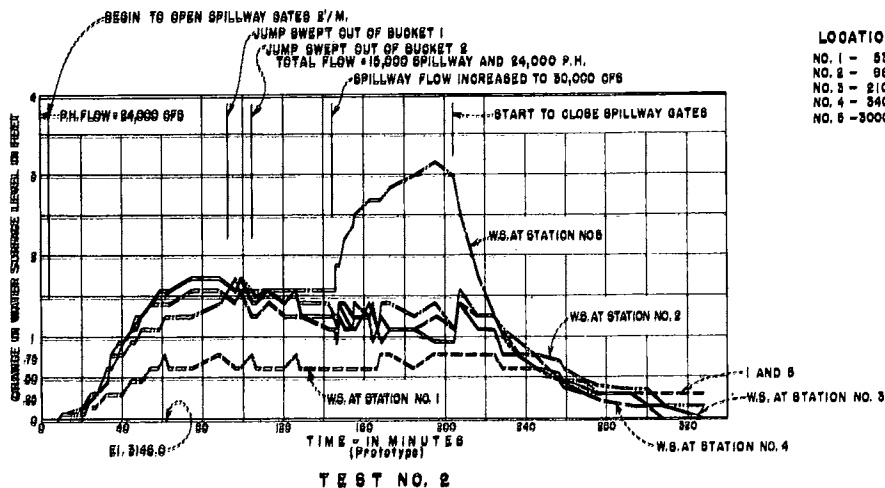
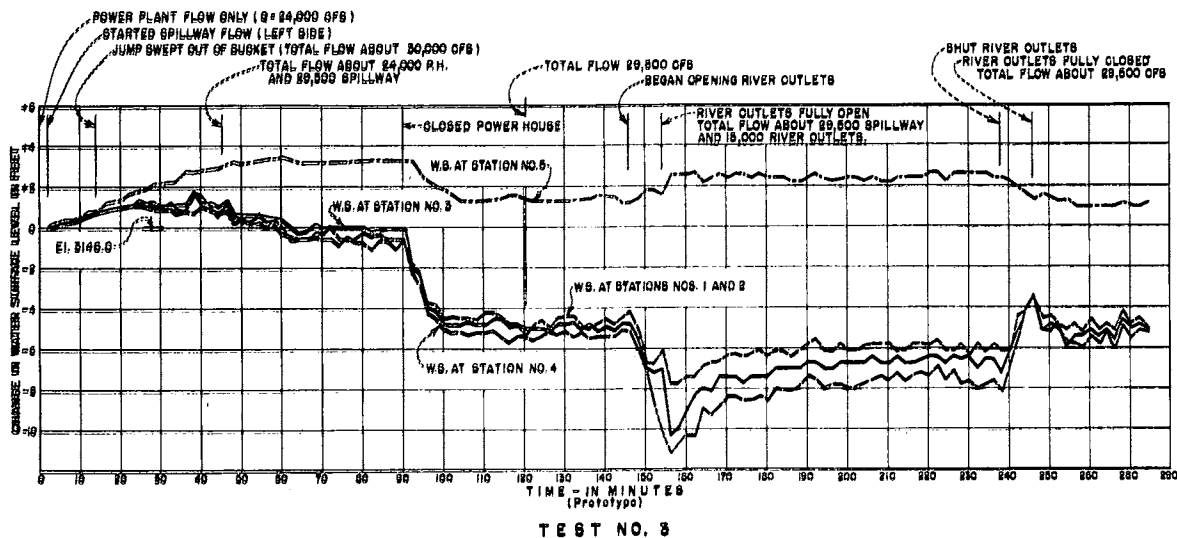
LOCATION OF MEASURING STATIONS
NO. 1 - 53 FT. DOWNSTREAM FROM POWER HOUSE
NO. 2 - 98 FT. DOWNSTREAM FROM POWER HOUSE
NO. 3 - 210 FT. DOWNSTREAM FROM POWER HOUSE
NO. 4 - 340 FT. DOWNSTREAM FROM POWER HOUSE
NO. 5 - 3000 FT. DOWNSTREAM FROM POWER HOUSE

GLEN CANYON DAM SPILLWAYS
1:63.48 SCALE MODEL
WATER SURFACE DRAWDOWN
AT POWERHOUSE AFTERBAY
